PHASE II ENVIRONMENTAL SITE ASSESSMENT

FORMER NAVAL GYMNASIUM, LOT NAVAL AIR

STATION AGANA 19

Tiyan, Guam

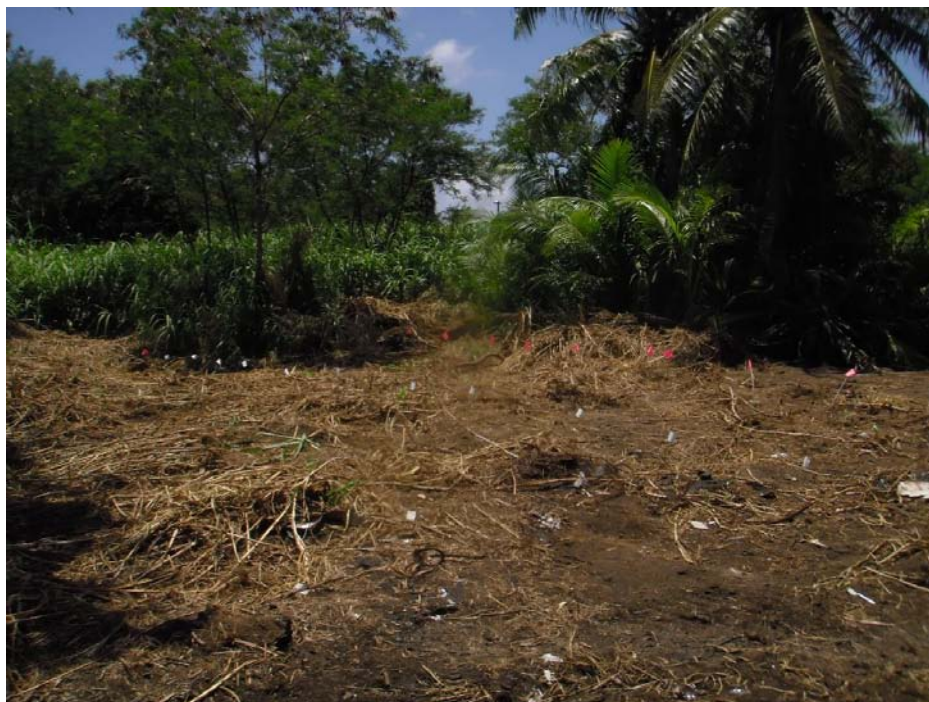
DU 1 Cleared and Marked for Increment Sample Locations

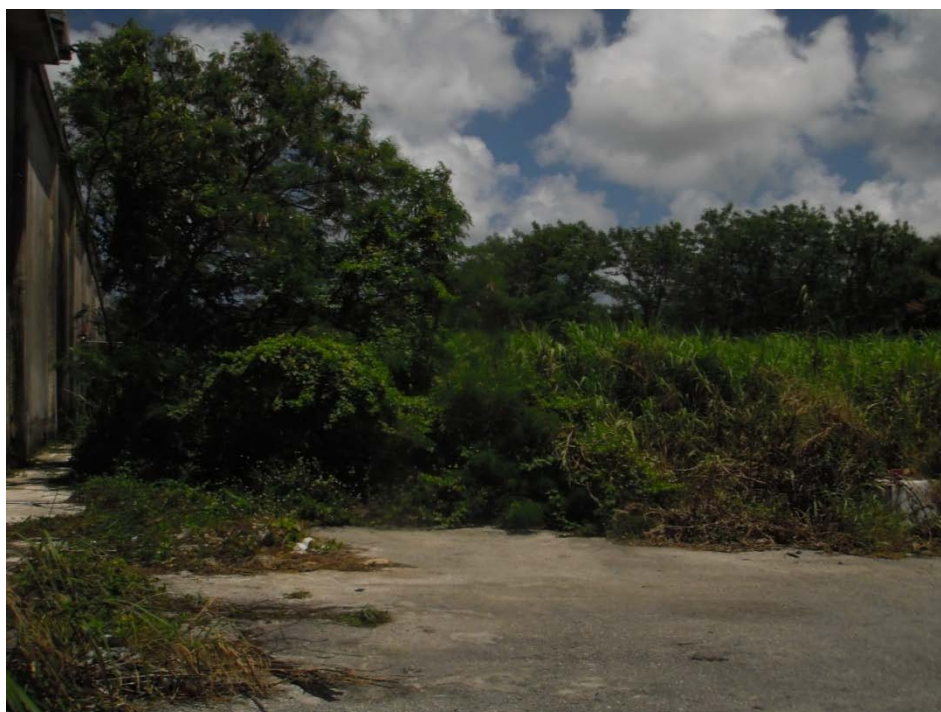
DU 2 Prior to Clearing

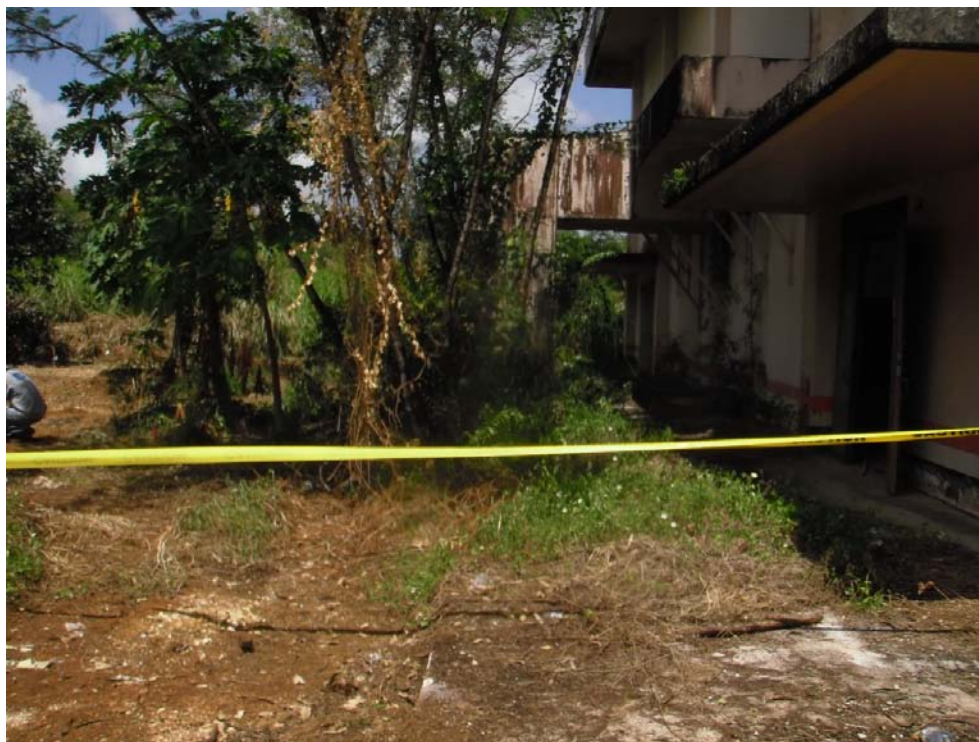
Incremental Sample Collection DU 3 Located North of Former Gym

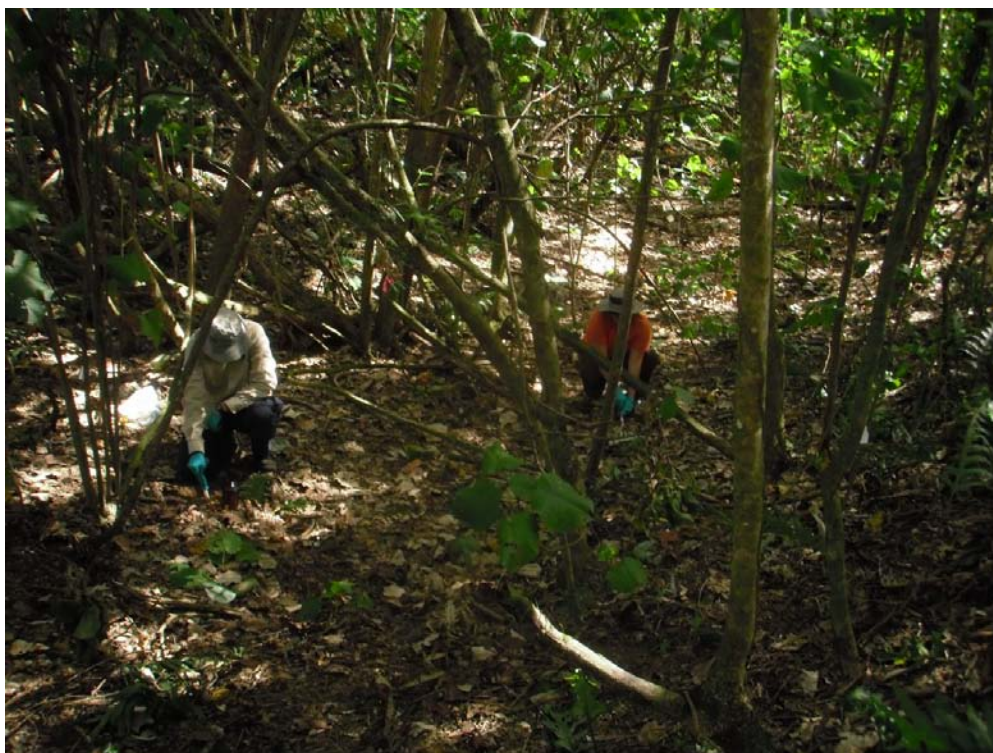
DU 4 Incremental Soil Sample. DU 4 Located Near Northern Boundary of Subject Site.

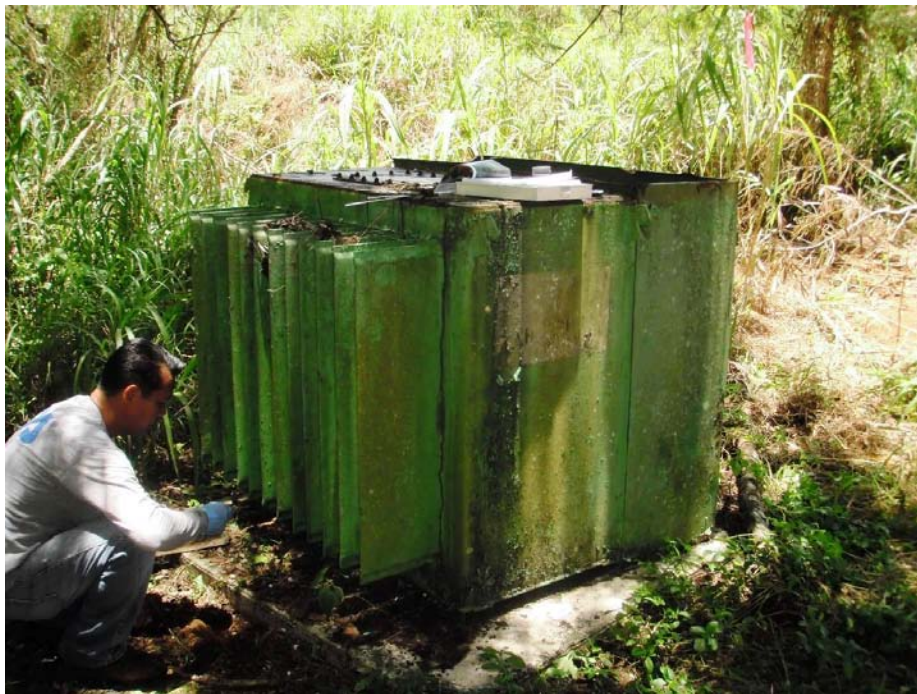
Grab Sample Collected Near Electrical Transformer North of Gym Building

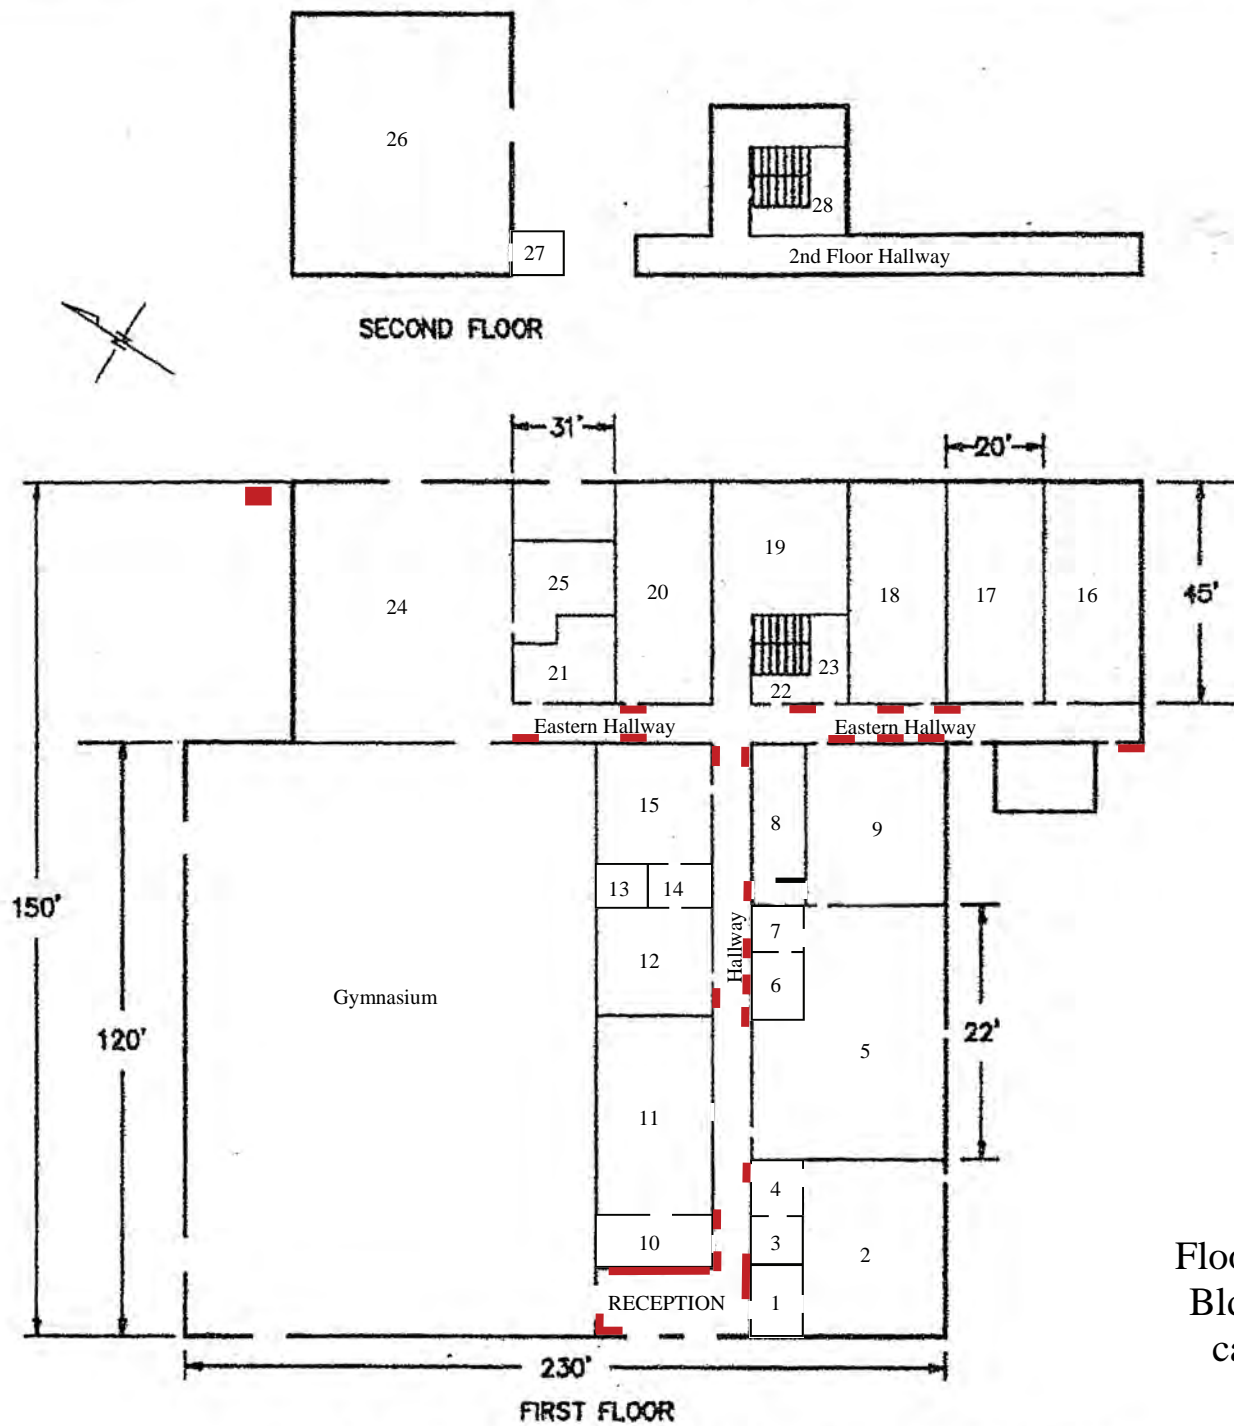
Diagram 3
 Floor Plan of Former Naval Gymnasium,
 Bldg. 15-6107, Tiyan, GU; Relative Lo-
 cations of Surfaces with Lead-Based
 Paint (LBP)

Test results indicate LBP to be present on various building components (Appendix B). At this time there are no federal or state regulations that specifically identify testing procedures for non-residential structures scheduled for renovation. The OSHA lead in construction standard found at 29 CFR 1926.62 states that workers impacting materials identified as either LCP or LBP are potentially at risk for exposure to lead. Current OSHA regulations require that lead-containing surfaces that may be affected by building renovation activities be identified prior to conducting these activities.

The disturbance (including demolition) and/or removal of LBP on structures must also be performed in accordance with OSHA lead standards (29 CFR 1926.62) and well as US EPA/Guam EPA hazardous waste regulations (40 CFR Parts 261). The lead-containing ceramic tiles as well as the metallic sheets on the roof plumbing vents are technically not LBP and do not meet the definition of a lead-based paint hazard. Left intact, these materials are not anticipated to pose a health threat to occupants of the facility. However, if the materials were to be cut, broken, drilled, crushed, abraded, or otherwise disturbed to generate dust, exposures to lead could result. The materials are therefore identified in this report along with LBP.
