Subject: Compliance Assessment – Order Items 3.a and 3.b; July 29, 2021 Notice of Violation / Compliance Order / Penalty Order

August 30, 2021 (revised September 1 to include response from designer)

SUBJECT: Site Inspection at Samsung Mangilao Solar Project, August 30, 2021

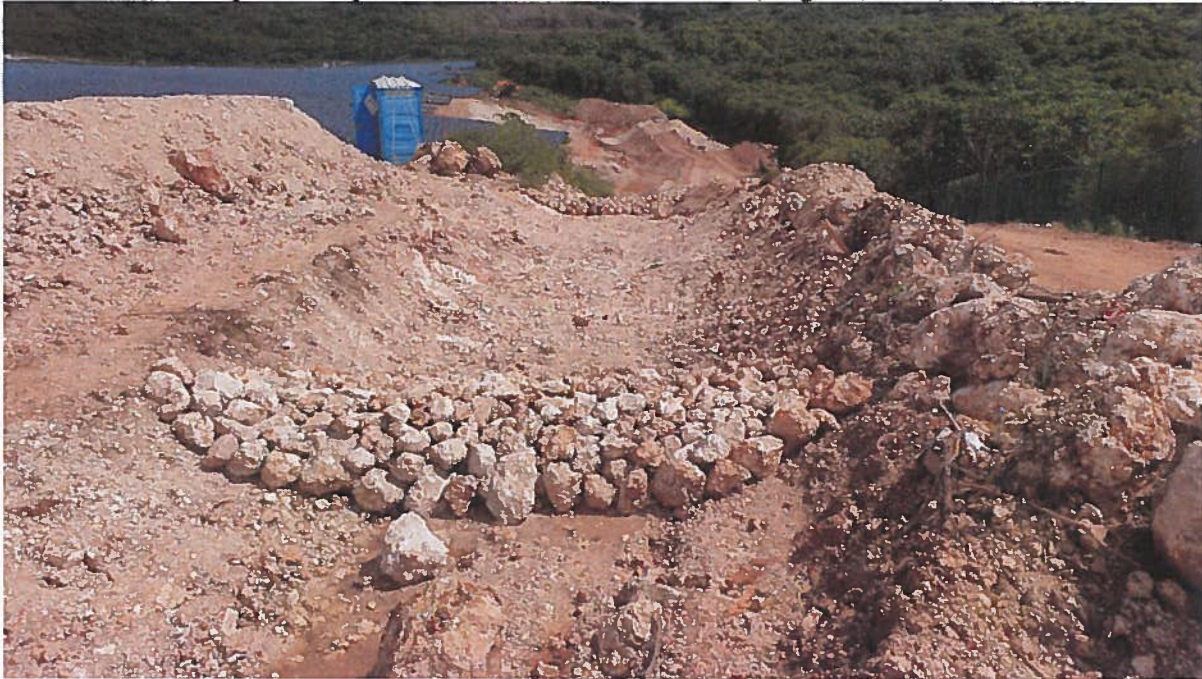
We then proceeded on foot to Pond 5. On the way there, we observed the placement of stone check dams in the perimeter swale, which appeared to have been installed per the standard details. Pond 5B has not been completed: the berm has been completed to final dimensions and elevation, but the overflow weir (spillway) has not been constructed. Per Samsung's earlier communications, they intend to utilize the Pond 5B berm as an access road for the future cleanup of Marbo Cave. The pond had a significant amount of sediment which had washed in from the slopes of the project site above the pond, primarily in the form of coarse-grained materials that appeared to be base course materials, which Mr. Kim stated was from the site roads that are slated to be paved, as soon as DPW approves. I agreed with Mr. Kim that paving roadway surfaces needs to be completed because it is a recognized form of stabilization. I stated that Samsung would need to remove the accumulated sediment on a regular basis to prevent the pond from losing capacity. Pond 5A appeared to be complete, based on the approved plans.

Stone check dams placed in perimeter swale above Pond 5B (Aug. 30, 2021)

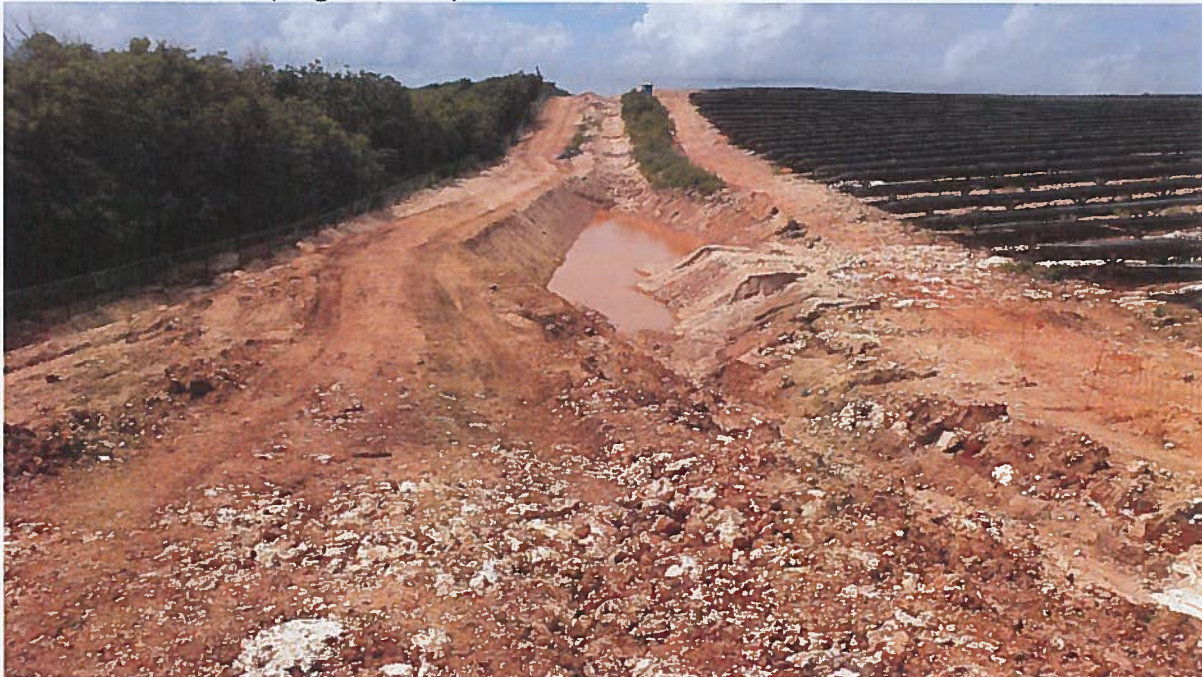
On the way back, I asked Mr. Kim how high the water level had gotten in Pond 5B, because it appeared that sediment had accumulated as high as the top of the berm. Mr. Kim stated that Pond 5B had been overtopped, but in his words the overflow was “minor”. I did not observe any evidence of damage to the silt fence beyond Pond 5B, but it was difficult to distinguish between any potential recent discharge and older sedimentation (prior to our initial July 23 inspection) beyond the project boundaries.

Pond 5B showing final berm height, and accumulation of sediment (right) that requires removal. According to Mr. Kim, this pond overflowed during recent rain events, but in his words, the overflow was minor. (Aug. 30, 2021)

- c. Respondent must provide frequent inspection and maintenance of Pond 5A to consist of the following, at a minimum:
 - i. Inspection on a daily basis
 - ii. Repair of embankment as needed
 - iii. Removal of accumulated sediment before it reduces pond capacity by more than approximately 10 percent
- d. Respondent must complete construction of swale inlets and inter-pond connection swale in accordance with the approved plans within fourteen (14) days of this letter.
- e. Respondent must implement stabilization measures (for example, erosion control blankets, hydroseeding, etc.) to prevent erosion of final embankment slopes, swales, and other disturbed ground surfaces in the area of Pond 5.
- f. Respondent must complete installation of the armored overflow weir within 14 days following the completion of the Marbo Cave cleanup, whenever that occurs.

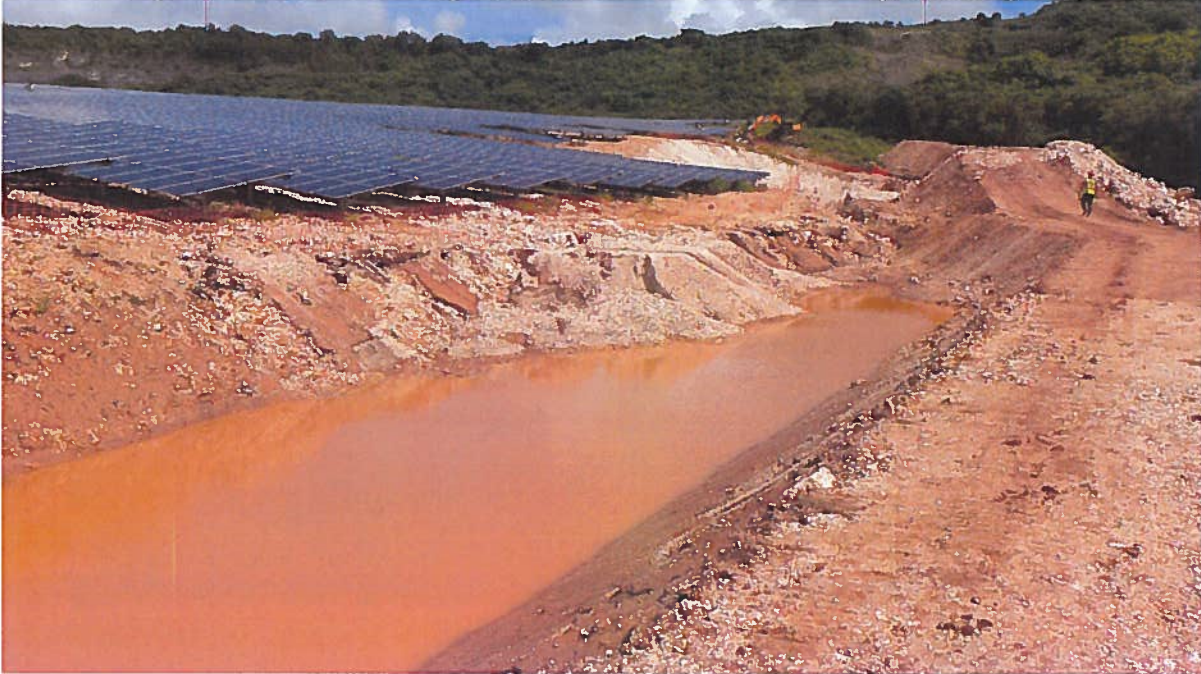
Pond 5: Respondent has completed final grading of Ponds 5A and 5B, but has not completed construction of the overflow weir, stone armored inlets, or interconnecting swale. Respondent has requested a time extension for the installation of Pond 5A overflow weir for the purpose of leaving the pond embankment available as a potential vehicle access route into the Marbo Cave area for future cleanup activities. GEPA grants this request with the following conditions:

View of Pond 5B, looking toward Pond 5A. Pond 5B overflow weir has not been constructed per Samsung's request to leave the Pond 5B berm available as a potential access route for the Marbo Cave cleanup. The swale connecting Ponds 5A and 5B is also not complete. (Aug. 30, 2021)

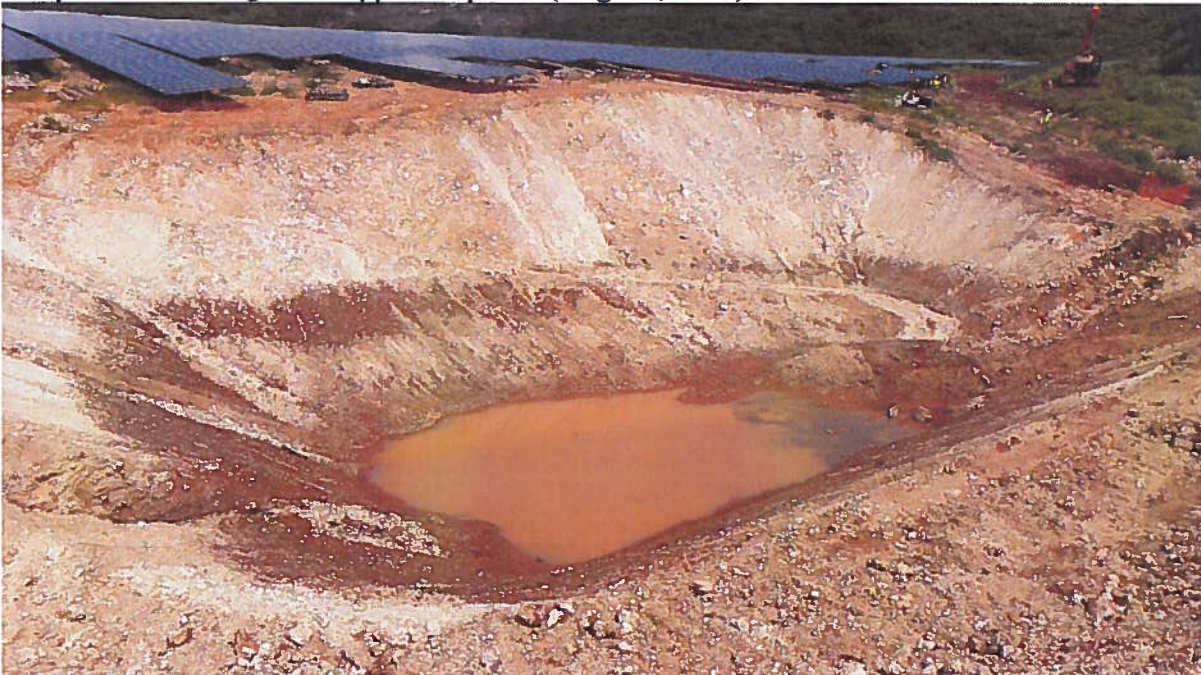
Pond 5A grading appears to be complete. The swale inlet (right) and inlet riprap has not been completed according to the approved plans. (Aug. 30, 2021)

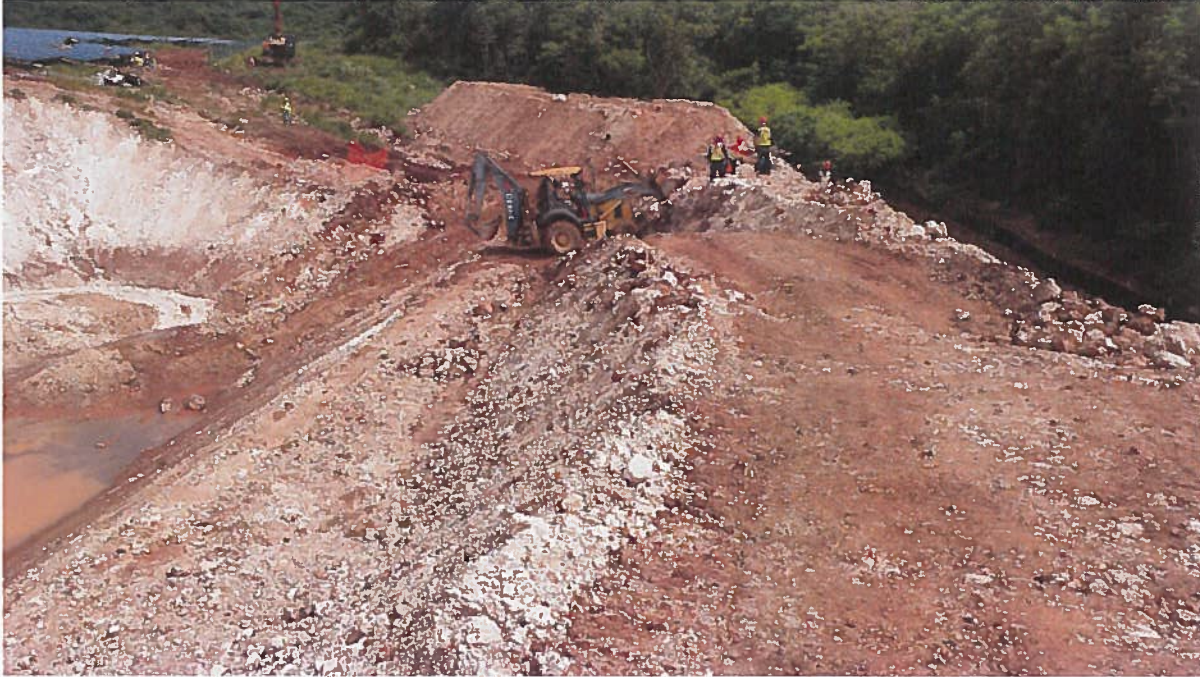
The temporary berm remains in place behind Pond 5A, however this provides no additional protection at this time because Pond 5A overflows to Pond 5B, which is at a significantly lower controlling elevation than the top of the temporary berm shown here. (Aug. 30, 2021)

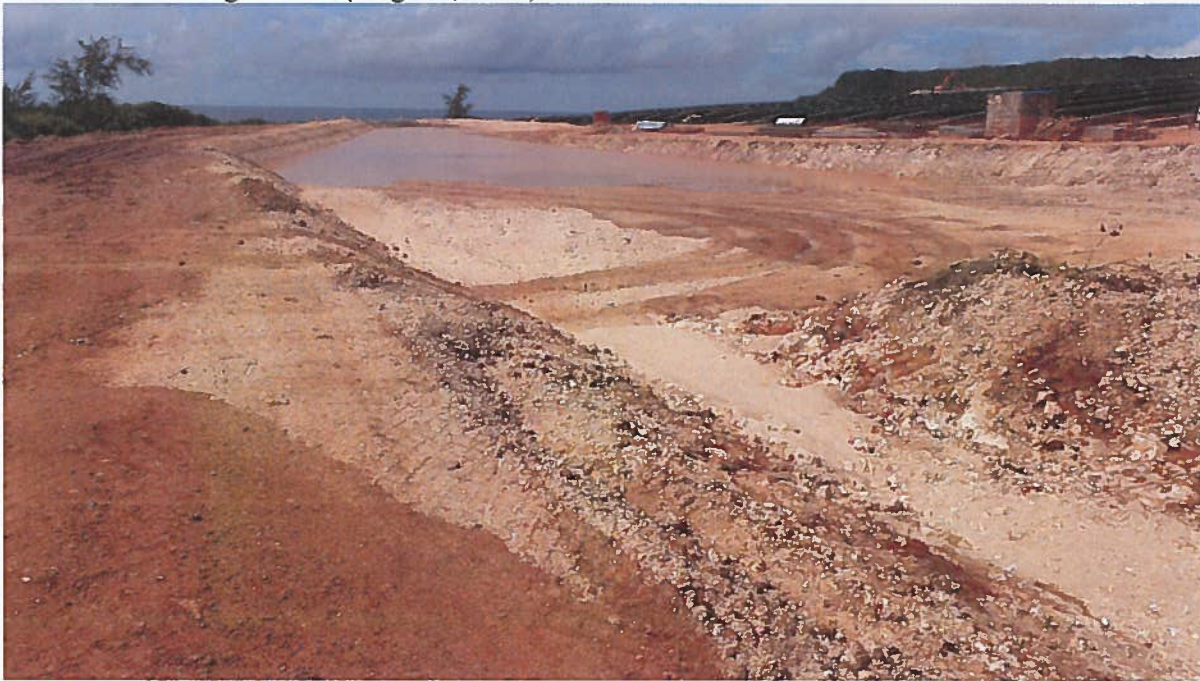
Pond 4: Respondent had completed work on Pond 4, however the overflow weir (spillway) was not completed to the required minimum depth of one (1) foot below the top of the embankment, as specified in the GEPA-approved erosion & sediment control (E&SC) plans. Respondent provided to GEPA a copy of additional details contained in the E&SC plans which specified a different weir depth of four (4) inches, which conflicts with the pond plan drawing which clearly specifies a weir depth of one (1) foot, by means of contours and grading elevation call-outs.

We then walked to Pond 4. With the assistance of Mr. Charfauros, I measured the length of the overflow weir (spillway) and the depth. The measured length was greater than the 85 feet shown on Samsung’s 2021 plans, but the depth of the weir was generally less than the 1 foot depth that had been approved. Mr. Kim showed me a cross sectional detail drawing from the 2021 plans, which indicated a weir depth of just 4 inches. This is in direct conflict with other portions of the plan and the approved pond calculations. I showed Mr. Kim that in the same plans, the elevation of the weir bottom was plainly labeled 1 foot lower than the adjacent berm top (96.00 feet at the weir bottom, versus 97.00 feet at the adjacent berm top), which matched the design calculation table that I had approved in 2020. I explained that this is important because if the weir is undersized, a large storm event will spill over the sides of the weir and wash out the berm, resulting in a failure of the entire embankment which could cause significant damage to downstream properties. Mr. Kim stated that Samsung would correct this.

Pond 4 final configuration. (Aug. 30, 2021)

- b. Within fourteen (14) days of receipt of this letter, Respondent must correct the construction of the overflow weir and/or pond embankment to provide the required minimum weir depth, while still maintaining the approved pond storage volume. Further, GEPA recommends that Respondent consider providing additional weir depth or “freeboard” above the required minimum one (1) foot to prevent risk of uncontrolled overtopping in the event of a storm larger than the calculated 25-year event.
- c. Respondent must implement stabilization measures (for example, erosion control blankets, hydroseeding, etc.) to prevent erosion of final embankment slopes, swales, and other disturbed ground surfaces in the area of Pond 4.

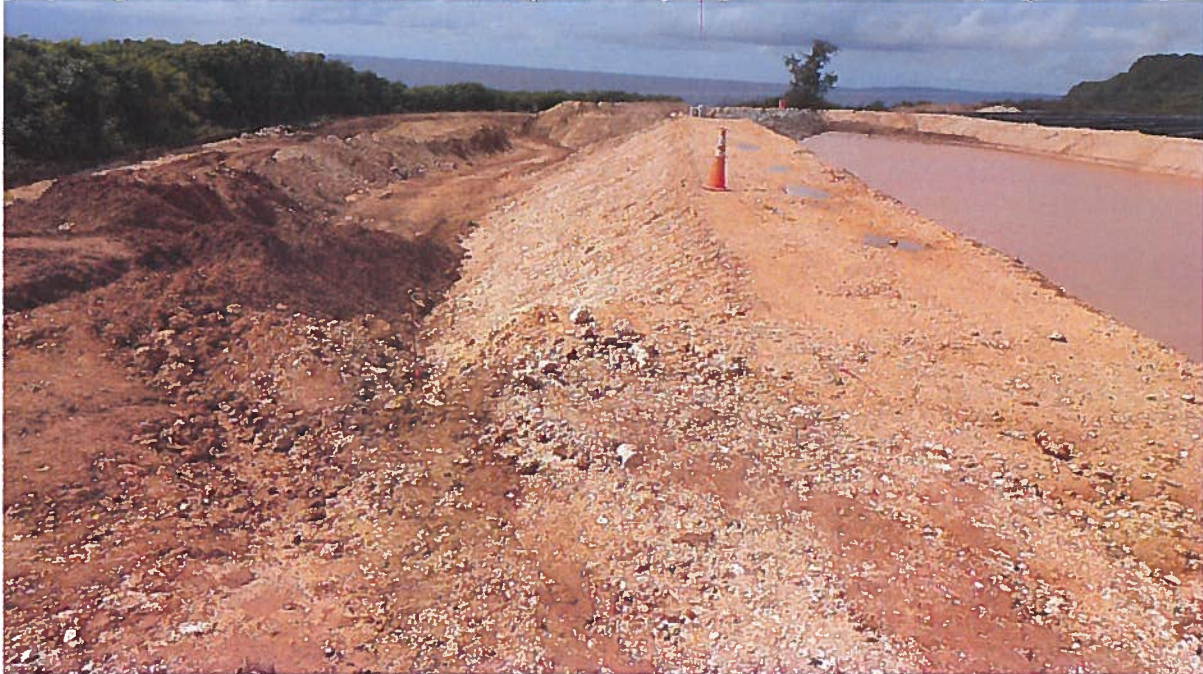
View toward the area behind Pond 4, leading to Pond 2, which is almost directly adjacent and downhill. The removal of the temporary berm is underway as shown on the left side. Samsung is proposing to extend the Pond 2 berm to expand its capacity in the area shown. (Aug. 30, 2021)

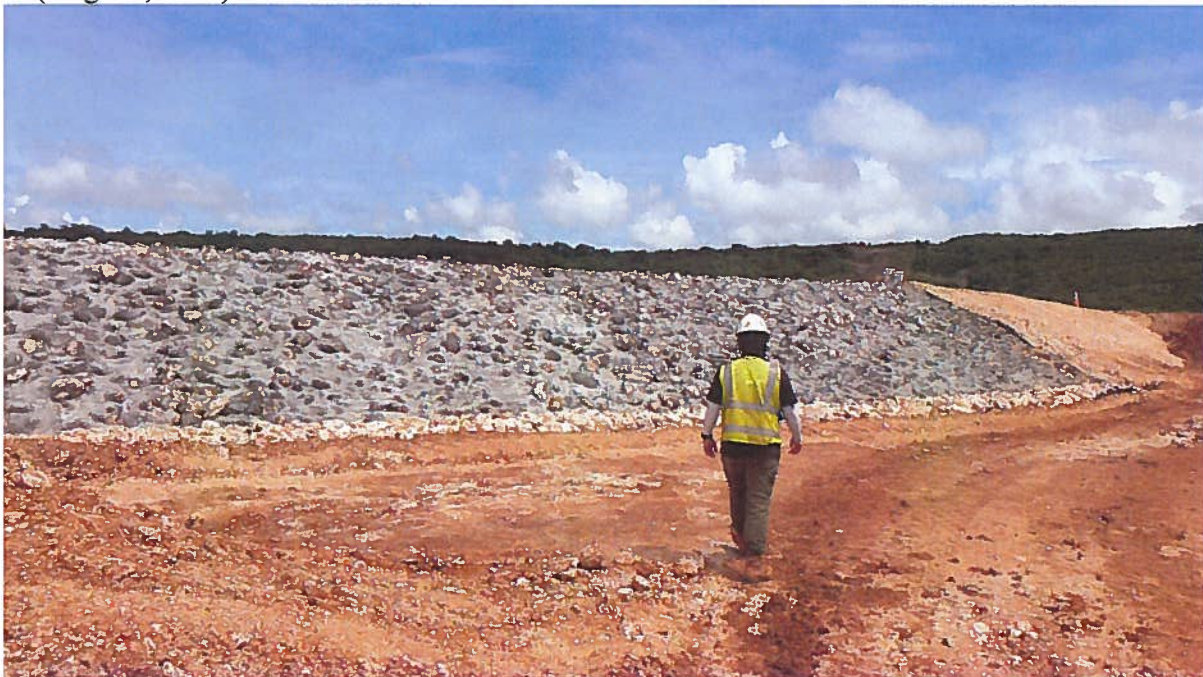
REVISION (Sept. 1, 2021): Based on email clarification from Mr. Kin Flores, P.E., of TG Engineers, PC dated August 31, 2021, the correct weir depth is 1.0 feet as shown on the grading plan.

Pond 4 armored overflow weir (spillway) viewed from the downstream side, directly above Pond 2. (Aug. 30, 2021)

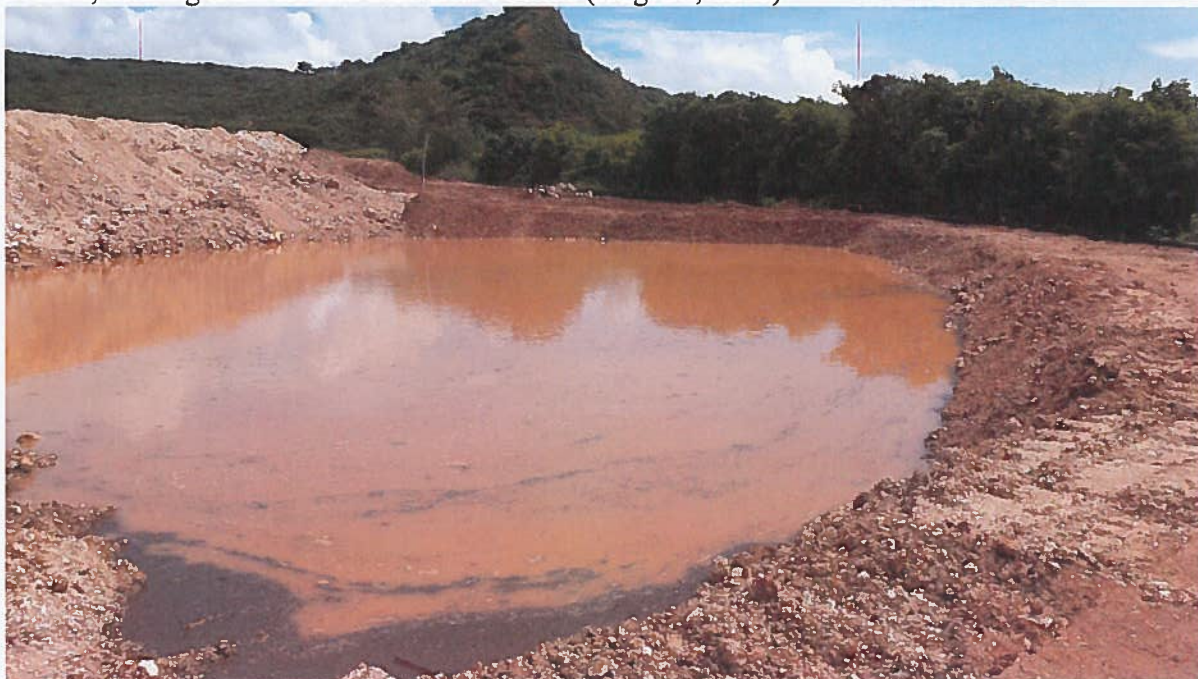
We then examined Pond 2. Mr. Kim stated that by his observation, Pond 2 was receiving too much runoff and needed to be enlarged. He stated that Pond 2 had overflowed. Accumulation of sediment behind the perimeter silt fence at this location was visible, but the fence appeared to have remained in place. He stated that Samsung would create a higher berm and expand the size of Pond 2. I asked him to make sure this is included in the analysis and revised plans, if any, included with the engineering analysis of the site grading and runoff. Samsung had emplaced a stone-armored overflow at the designed outlet to Pond 2, but Mr. Kim explained that he intended to raise the elevation of the outlet to increase storage.

Pond 2, looking back toward the Pond 4 berm. (Aug. 30, 2021)

- a. Respondent shall provide a revised design for Pond 2 within fourteen (14) days of this letter, or with the submission of the engineering evaluation required under Order Item 5, at the time that response becomes due.

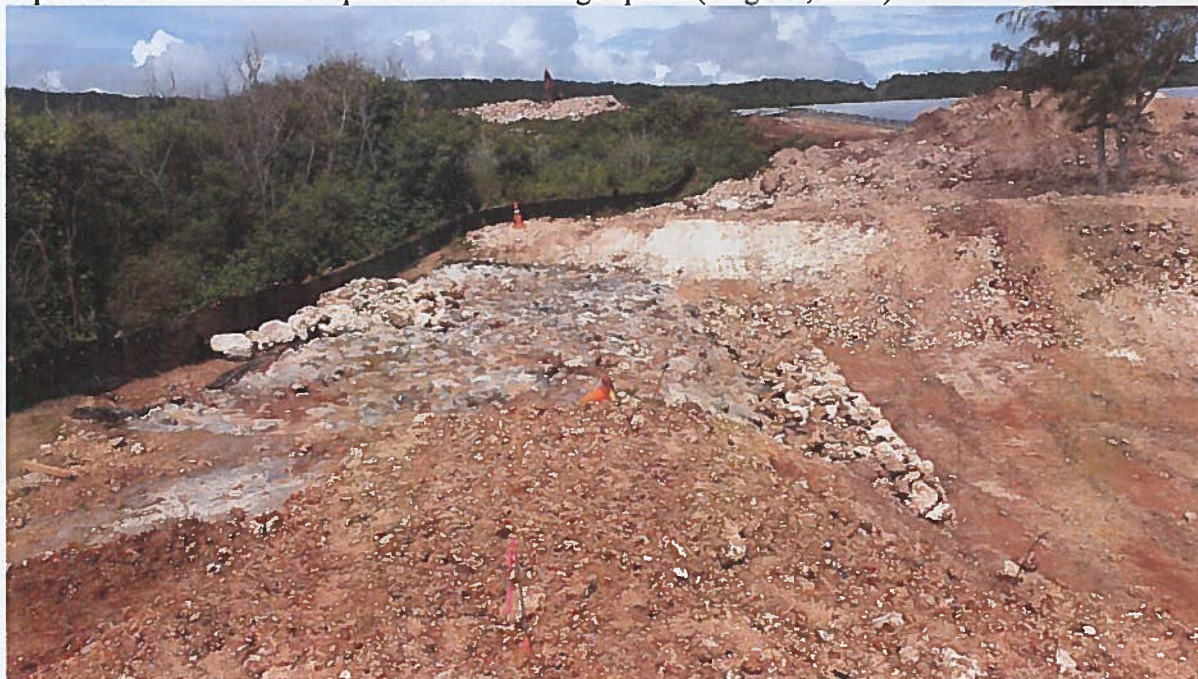
Pond 2: Respondent continues to work on Pond 2. Therefore, pond installation was not completed within the 30 day deadline as required. Respondent stated during GEPA’s August 30 inspection that they intend to increase the size of Pond 2 by extending and raising the elevation of the pond embankment.

Pond 2 armored overflow weir (spillway). Samsung stated they intend to raise the elevation and expand the Pond 2 berm to provide more storage space. (Aug. 30, 2021)

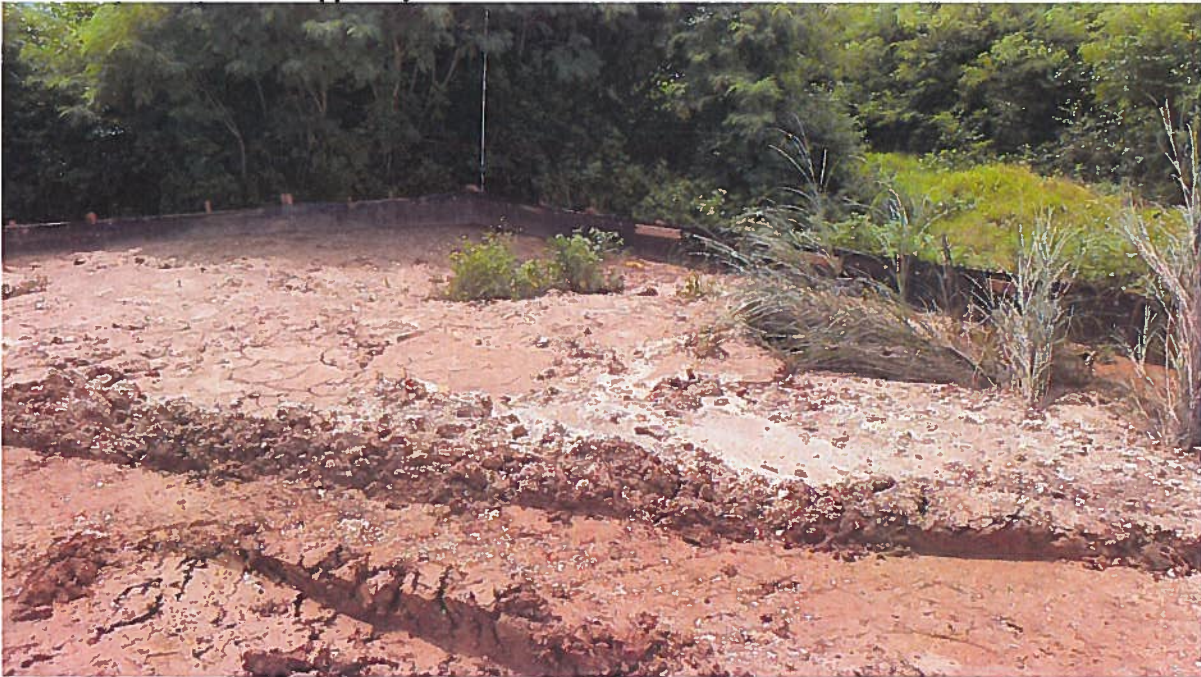
Project perimeter downslope of Pond 2, showing accumulation of sediment from overflow rain events which has been trapped by silt fence in this area.

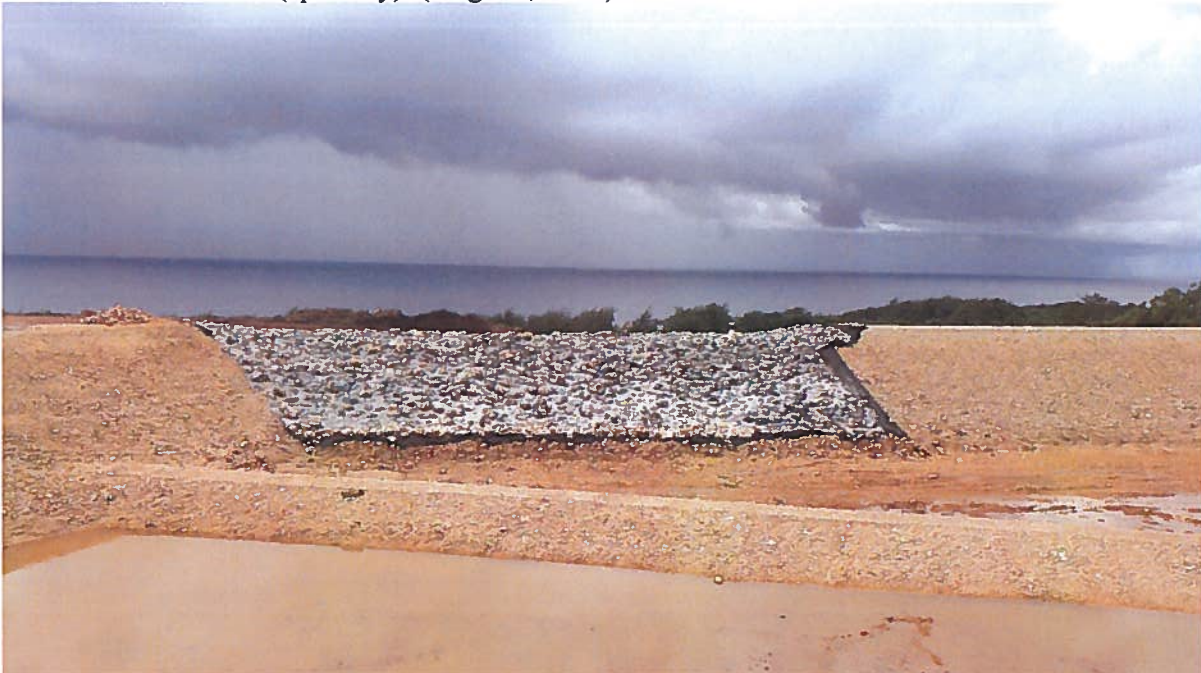
would have to ask for clarification on this, especially for the changes to the pond 3 weir, which was less than half the length shown on the plans we approved by email on June 23, 2020. The weir length on the approved plans was shown as 125 feet, while the plans attached to Samsung's 2021 SWPPP showed a weir length of 55 feet. I showed Mr. Kim the design calculation table that I had approved in June 2020, which showed the weir length of 123.58 feet corresponding to the 25-year storm, and 53.06 feet for the 10-year storm, and commented that it appeared the overflow weir had been downgraded to the smaller storm capacity without informing GEPA. Mr. Kim stated that he believed the 2021 plans had been approved by DPW and stated that he would find the approval documentation and send it to me.

We then proceeded to Pond 3 to measure the overflow weir. Samsung staff assisted Mr. Charfauros with measuring the weir, which at about 64 feet was longer than the 55 feet shown on Samsung’s 2021 plans, but significantly shorter than the 125-foot weir length approved by GEPA in 2020.

Pond 3 overflow weir (spillway). (Aug. 30, 2021)

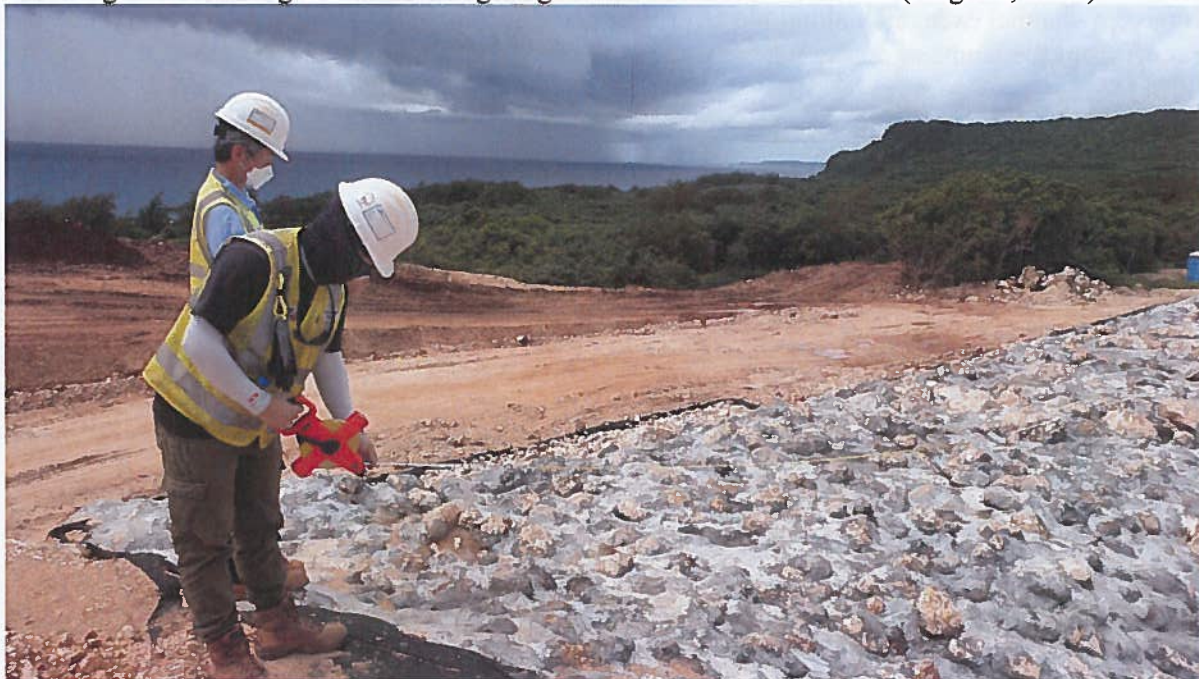
Samsung staff assisting with measuring length of Pond 3 overflow weir. (Aug. 30, 2021)

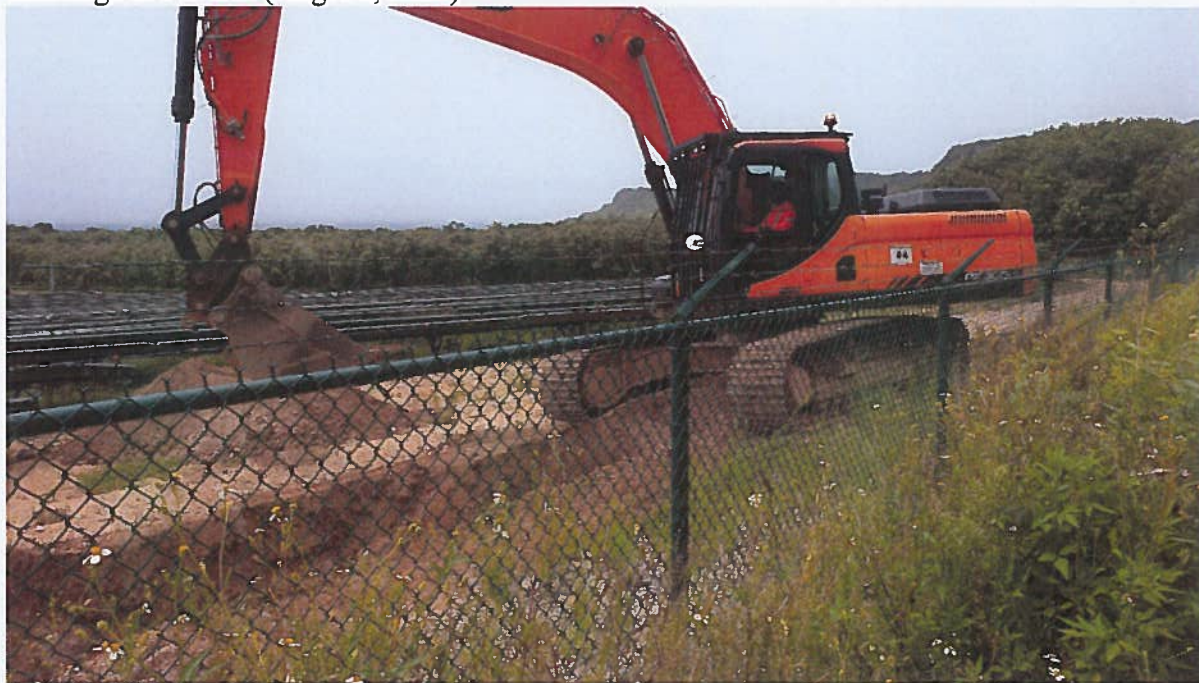
At Mr. Kim’s request, we then visited the upper side of the project in between the two entrances, where Samsung was excavating a trench or swale to capture off-site runoff entering the site from the public highway. Mr. Kim stated that the purpose of this new swale would be to divert off-site runoff which currently enters the site uncontrolled, to Pond 3 which still appears to be receiving

Excavation activities underway at the upper perimeter of the site, to create a channel intended to intercept off-site runoff coming from the public road and divert it to the perimeter swales which discharge to Pond 3. (Aug. 30, 2021)

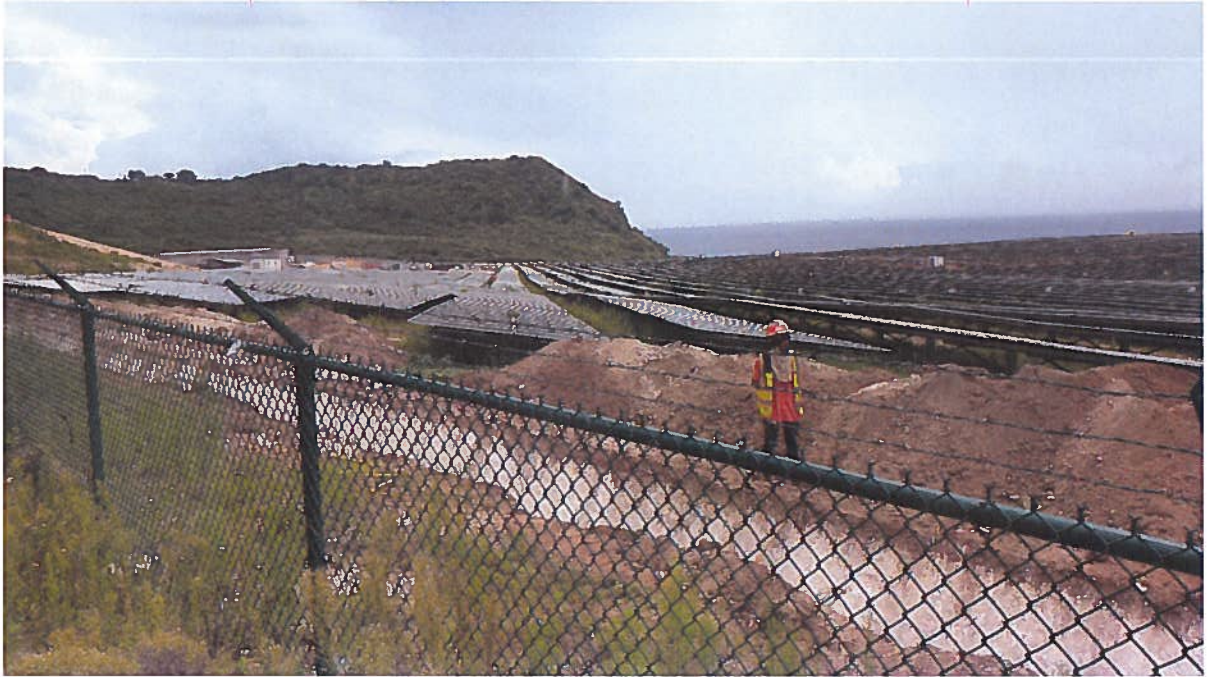
Intercept channel excavated along upper project perimeter intended to capture and divert off-site runoff from the land and public roadway above the site, and send this water to Pond 3. (Aug. 30, 2021).
