NOTICE OF VIOLATION

Project Name: On-going construction of housing units for Core Tech International

Water Pollution Control Program  
Water Division  
Guam Environmental Protection Agency  
Inspection Report

On-Going Core Tech International (Former LADA) Housing Project, Dededo, Guam

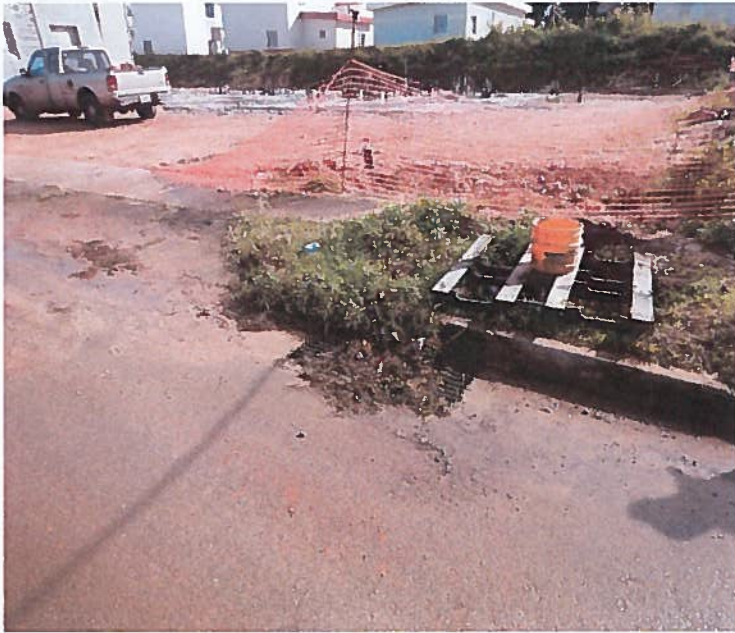
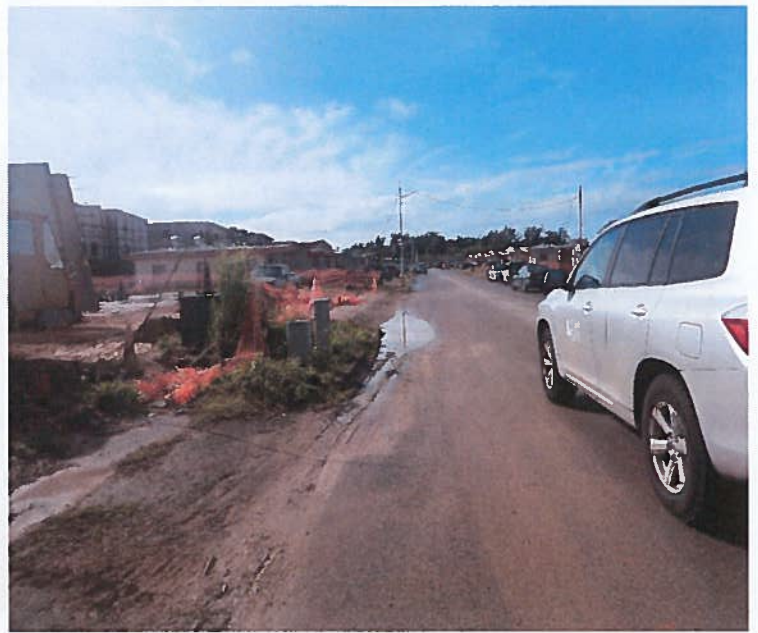
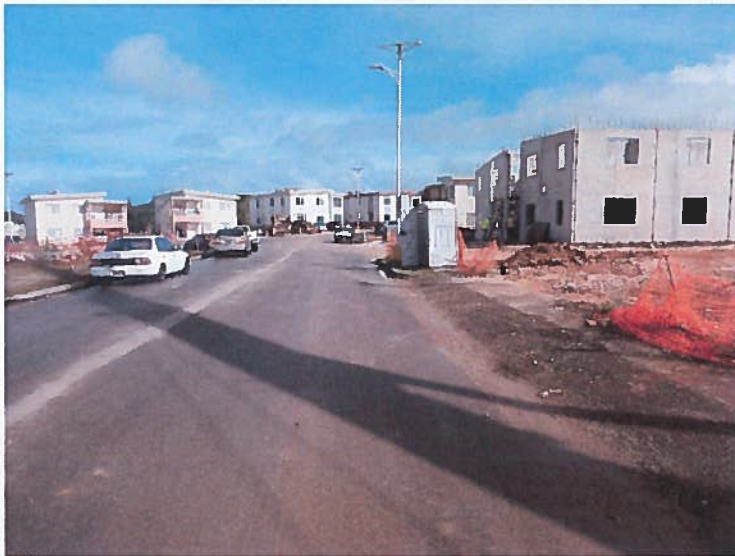
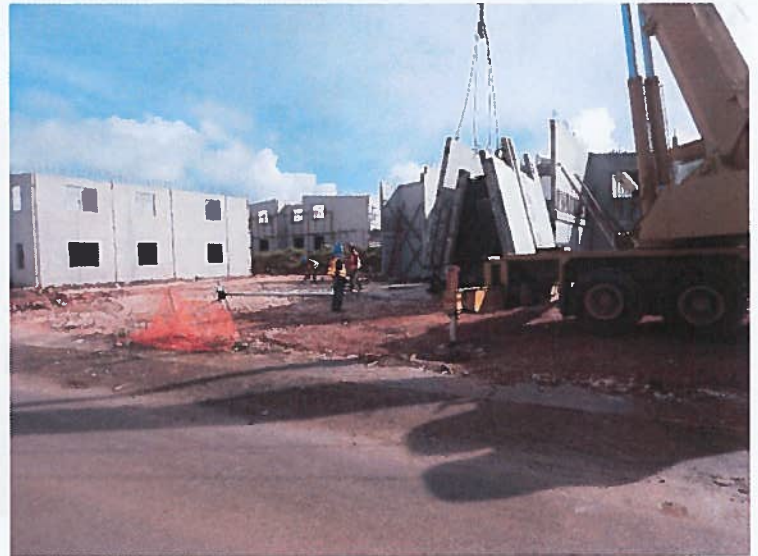
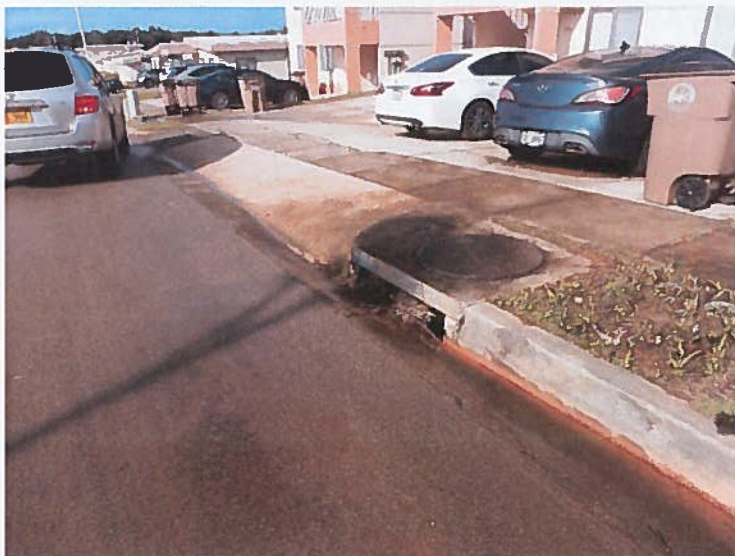
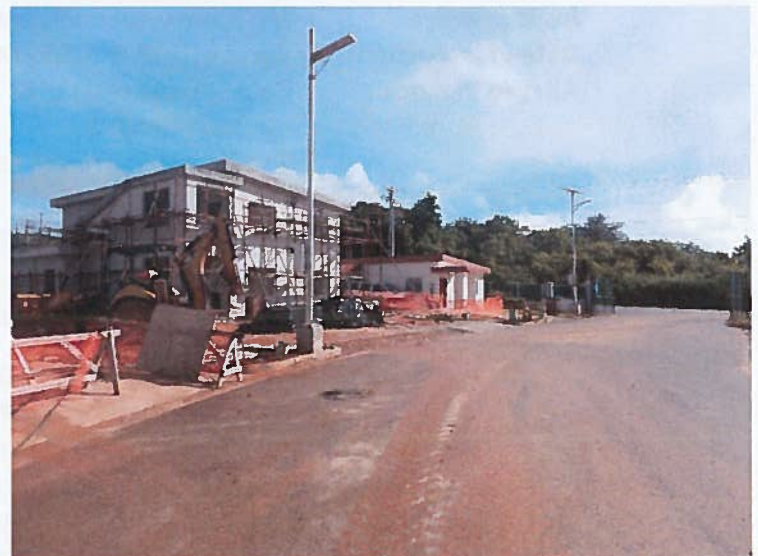
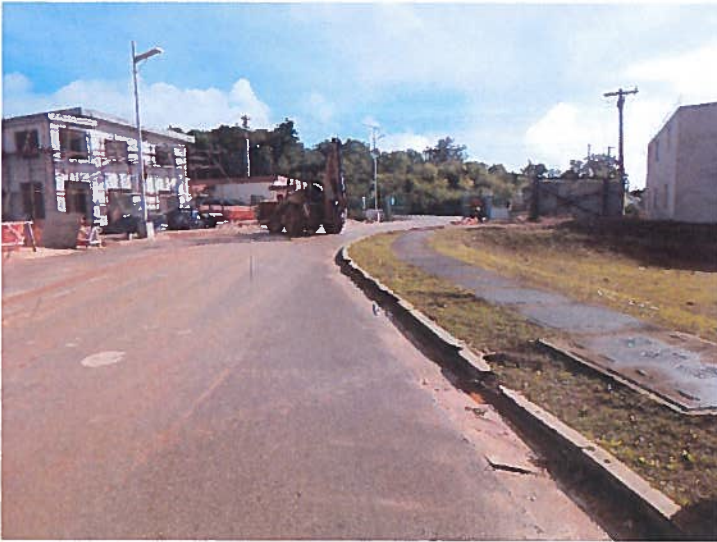
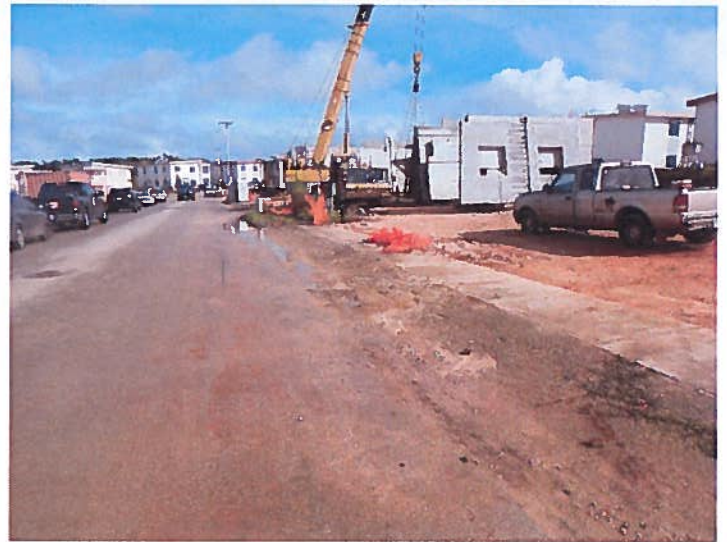
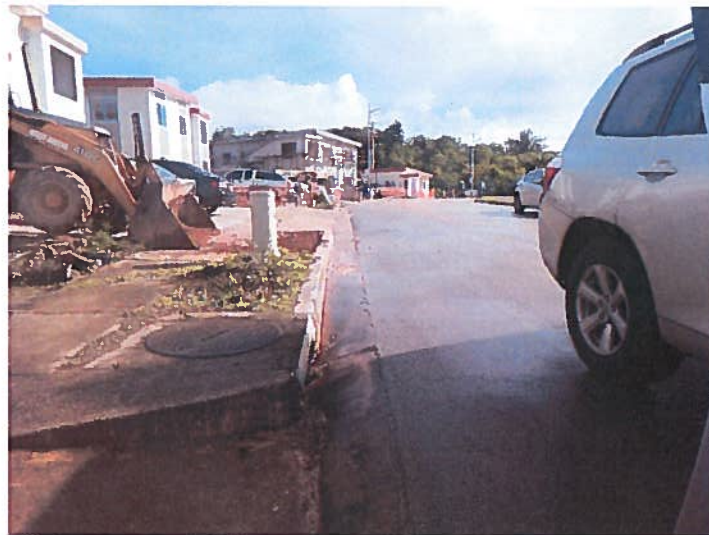
**Finding:**  
 No Sediment Protection and Stormwater Inlet Protection at the on-going construction site.  
*Pls. see picture above*

1. Instruct Mr. Noel Quogna Core Tech Site Project Engineer to install BMP's, sedimentation control and stormwater inlet protection ASAP.
2. Issue NOV to Core Tech International to correct all deficiencies noted during the site inspection no later than Feb. 6, 2019.
3. A follow-up inspection will be conducted by Guam EPA on Feb. 7, 2019 @ 9:00 AM to verify if all deficiencies noted on the NOV/site inspection report have been corrected.

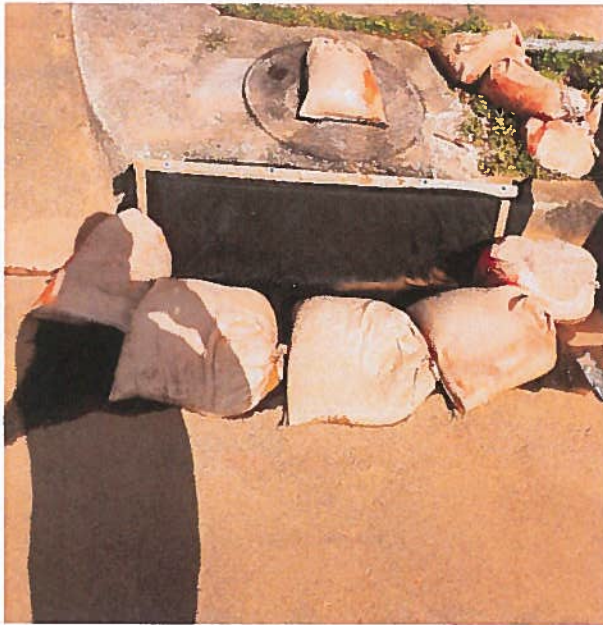
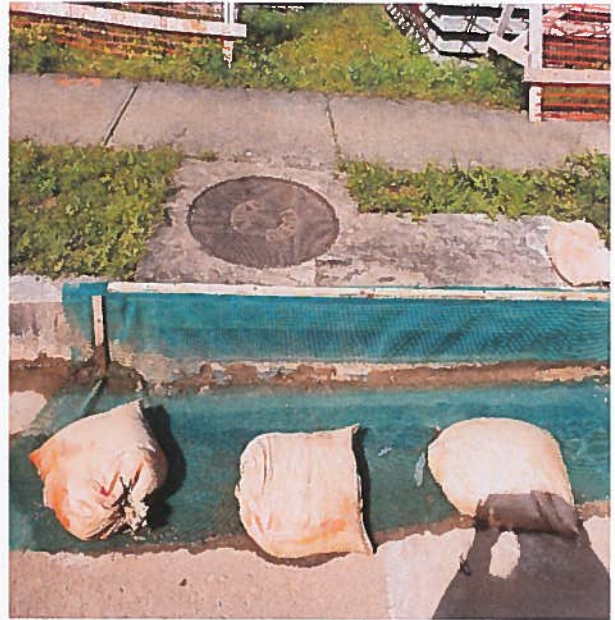
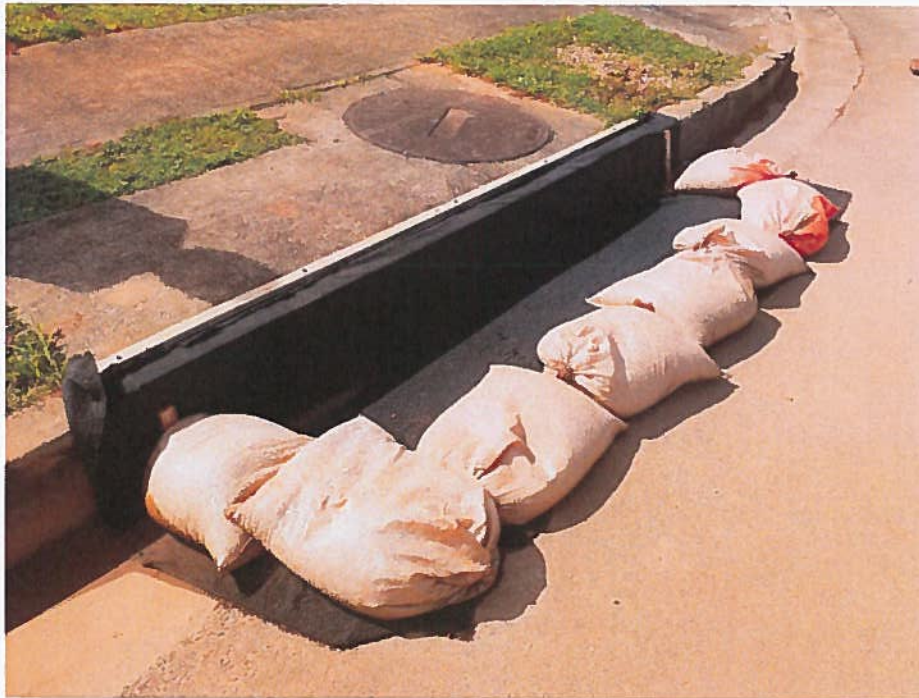
**Photo No. 1**

Erosion Sediment control: Above photo shows Core Tech has redone their BMP's and added fabric for more protection. As per Mr. Noel they will maintain their BMP's on a daily basis.

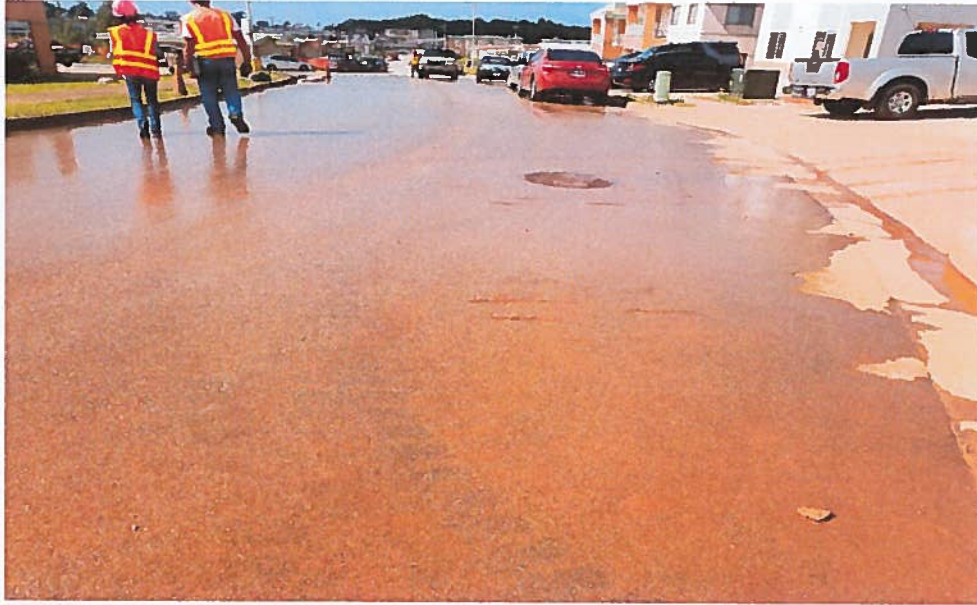
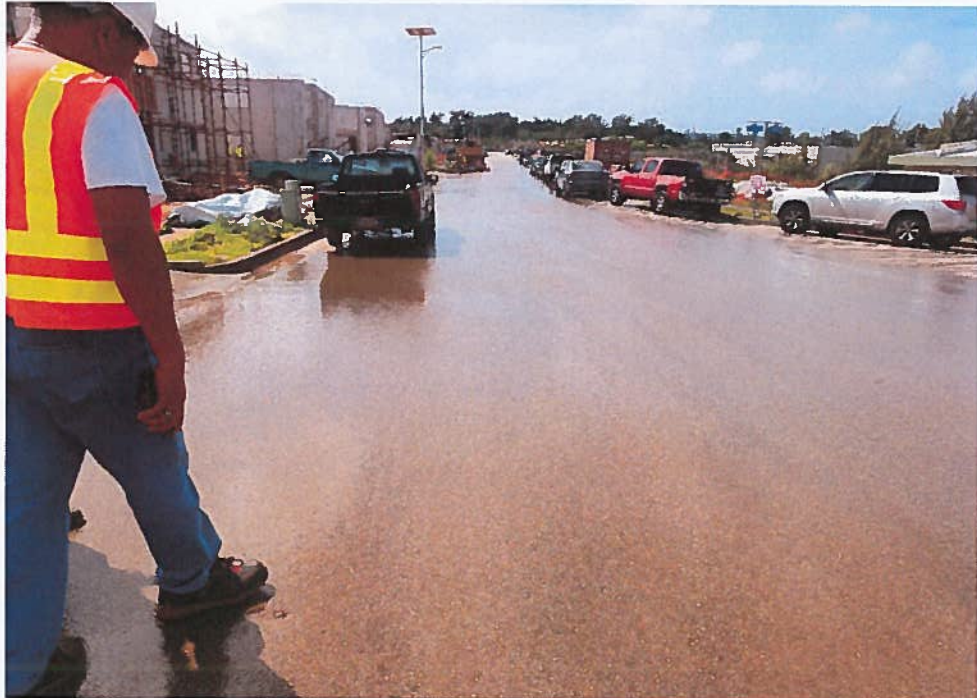
**Photo No. 2**

**Dust control measures:** Core Techs water truck just passed through wetting down the street to control the dust.

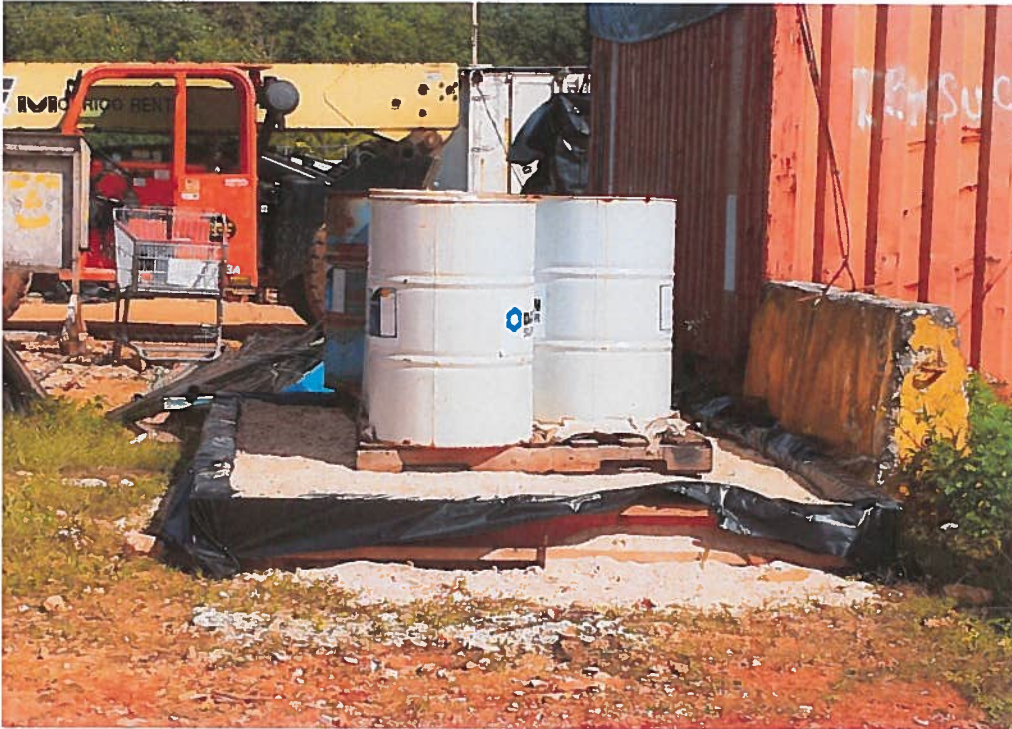
**Photo No. 3**

55 gallon metal drums are now properly contained. As per Mr. Noel they will raise the sides 110%

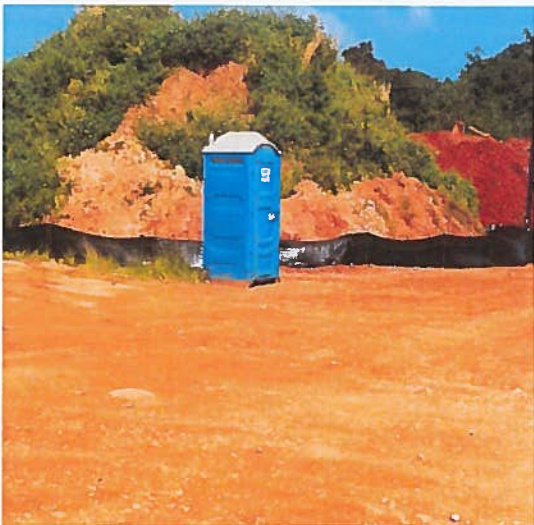
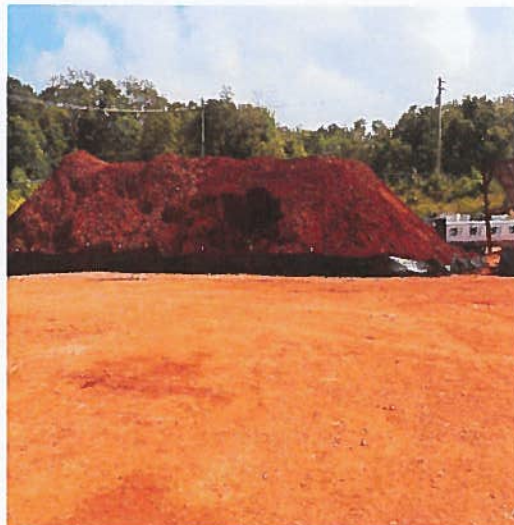
**Photo No. 4**

Erosion sediment control barriers can be seen around their stockpiles.

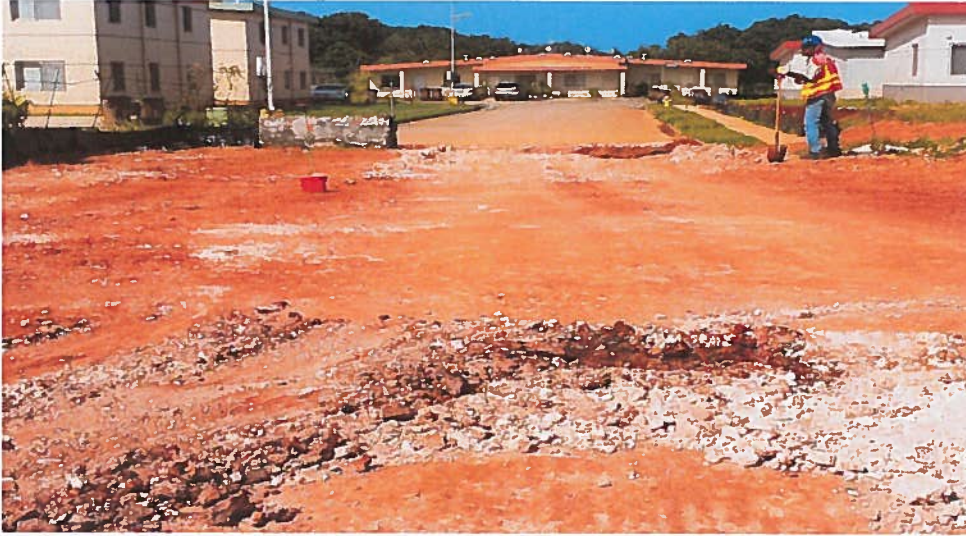
**Photo No. 5**

Swale dug to minimize any runoff from happening. As per Mr. Noel they will work on their Entrance exceed as part of their erosion sediment control barriers.

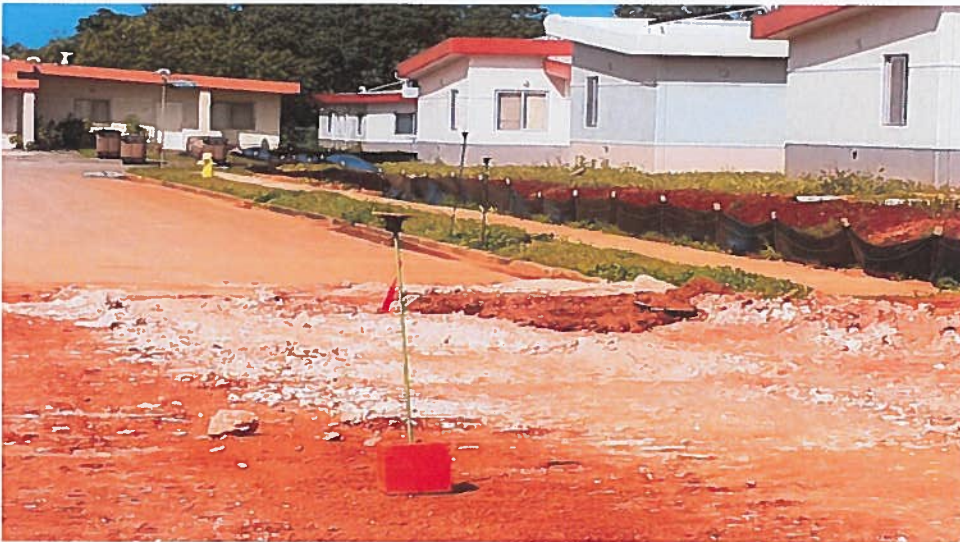
Erosion sediment control barriers being place to prevent runoff and will be maintained and removed once the area is stabilized.
