**Phase I Environmental Site Assessment Report
Old Guam Memorial Hospital (GMH)
Tamuning, Guam**

EA Engineering, Science, and Technology, Inc., PBC
1001 Army Drive, Suite 103
Barrigada, Guam 96913-1402

October 2018
EA Project No. 15672.01

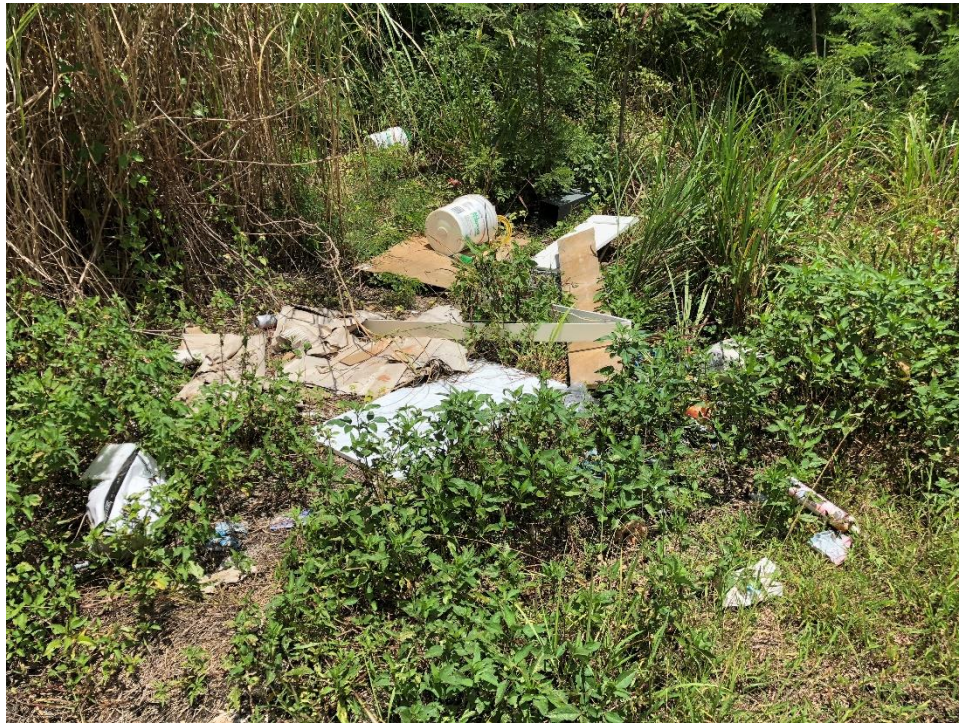
Photo 1: Empty 4.5-gal. buckets of scrap metal and building materials found on the northwestern portion of the subject site, Oka Point, Tamuning Guam

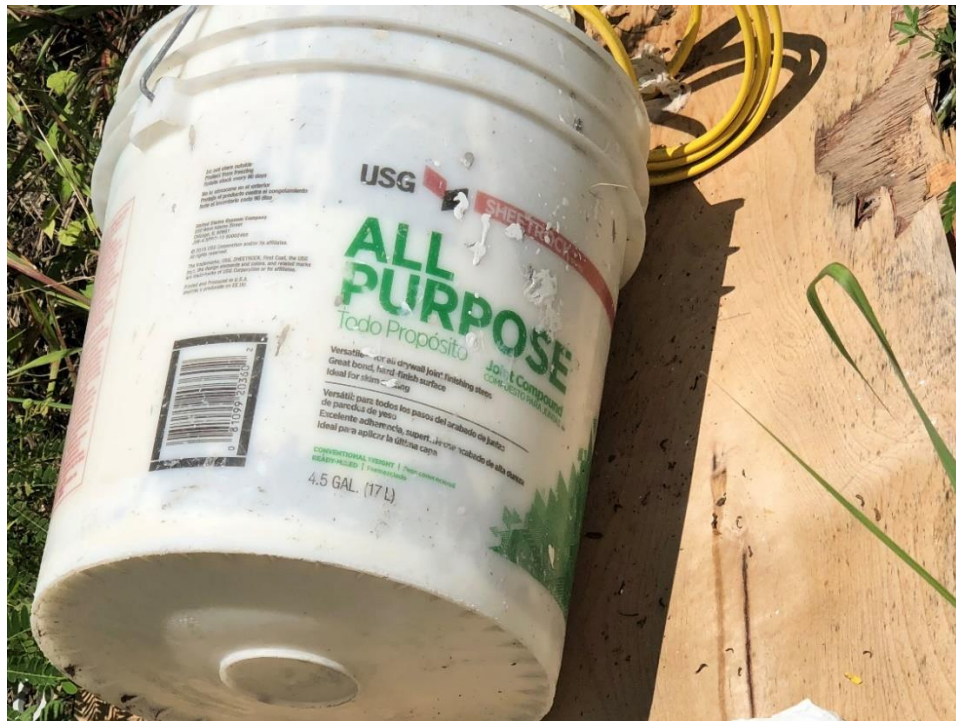
Photo 2: An empty 4.5-gal. bucket of dried sheetrock and scrap building materials found on the northwestern portion of the subject site, Oka Point, Tamuning Guam

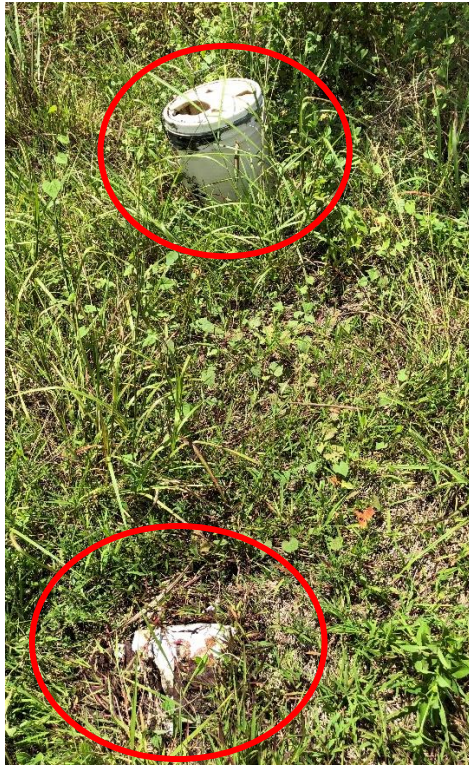
Photo 3: Solidified Paint in Plastic 5-gal. bucket and rusted, 1-gal. metal can found on the northwestern portion of the subject site, Oka Point, Tamuning Guam

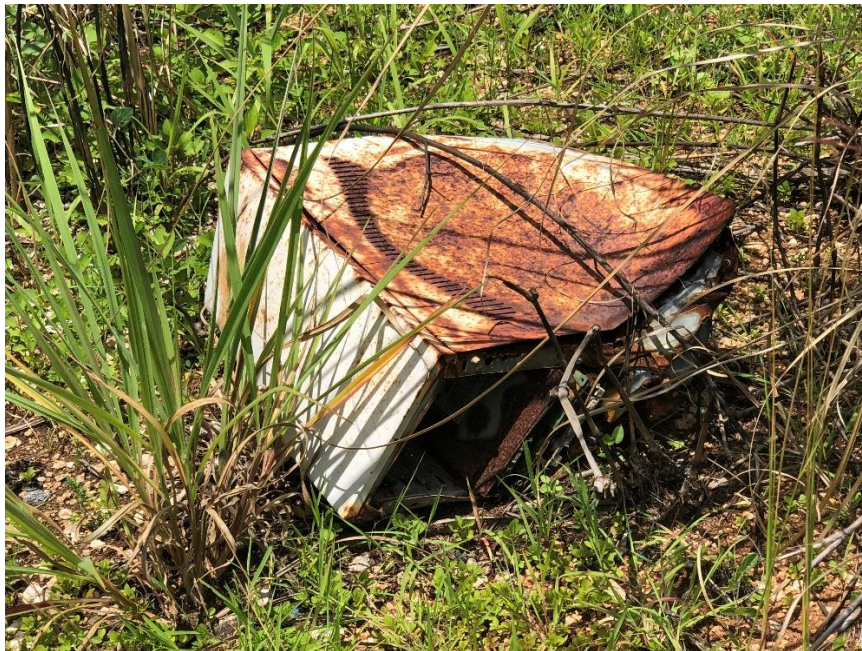
Photo 4: Discarded electrical equipment found on the northwestern portion of the subject site, Oka Point, Tamuning Guam

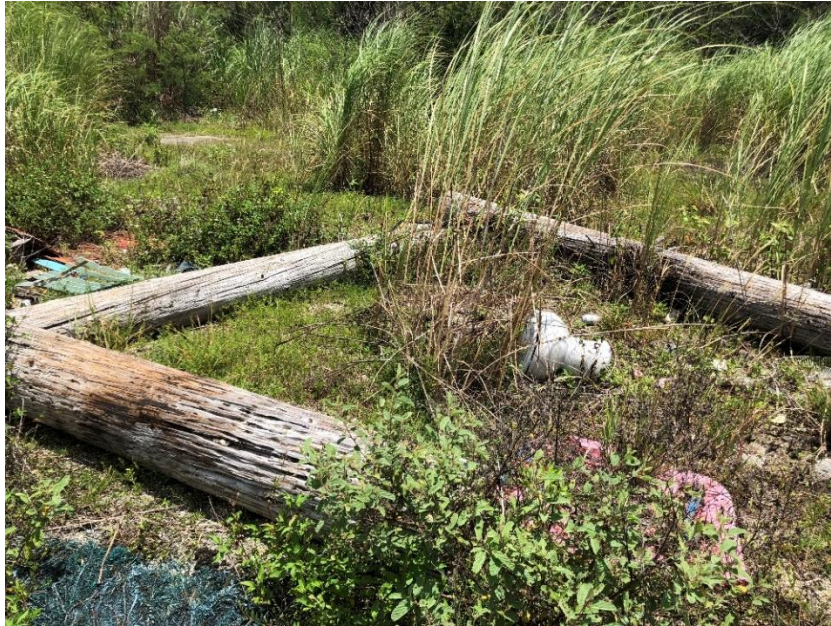
Photo 5: Wooden utility poles and household found on the northwestern portion of the subject site, Oka Point, Tamuning Guam

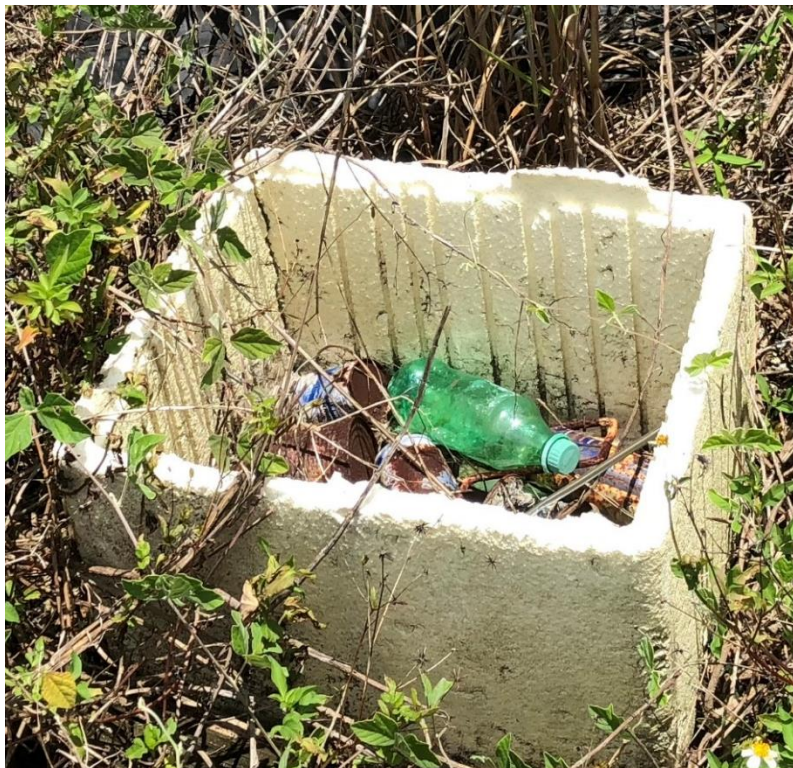
Photo 6: Corroded paint cans, spray paint cans, and aerosol spray lubricant cans inside a Styrofoam box (NE Portion of the Property), Oka Point, Tamuning Guam

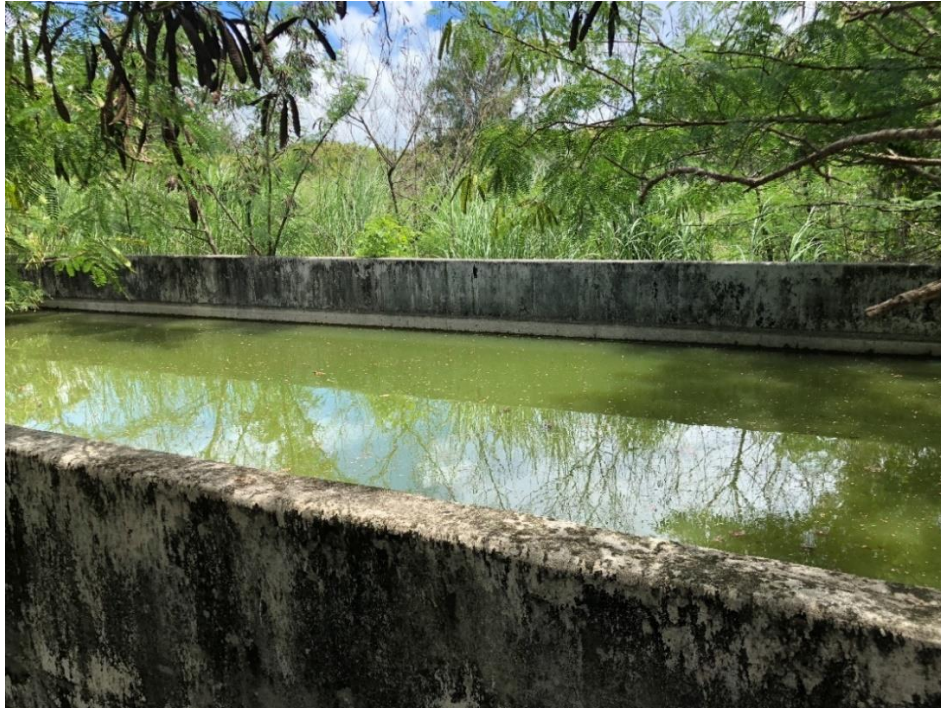
Photo 7: Concrete foundation found near the abandoned generator building that was possibly used as a containment for an Above-ground Storage Tank (AST) at the northwest portion of the subject site, Oka Point, Tamuning Guam

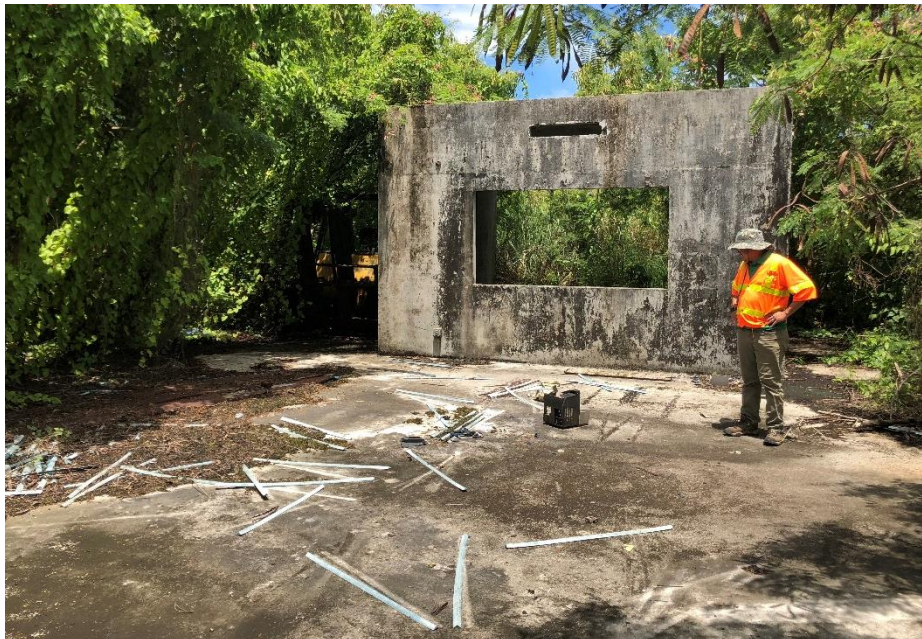
Photo 8: Concrete foundation for the Abandoned Generator Building found at the northwest portion of the subject site, Oka Point, Tamuning Guam

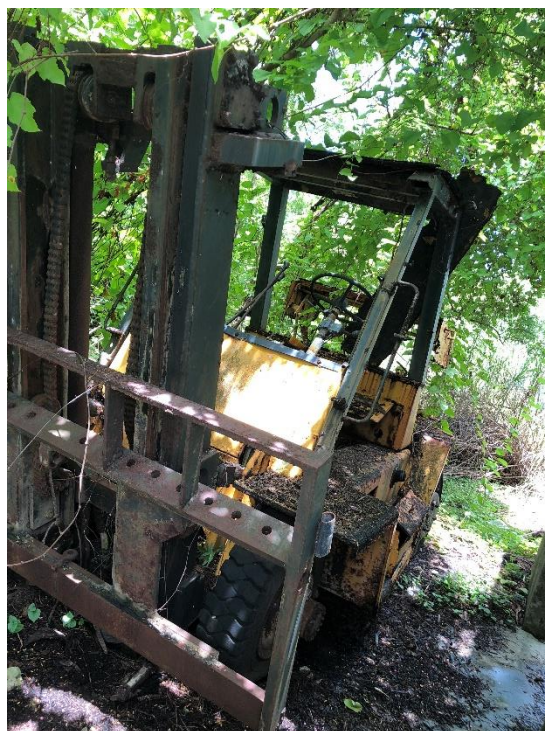
Photo 9: Forklift discovered at the Abandoned Generator Building at the northwest portion of the subject site, Oka Point, Tamuning Guam

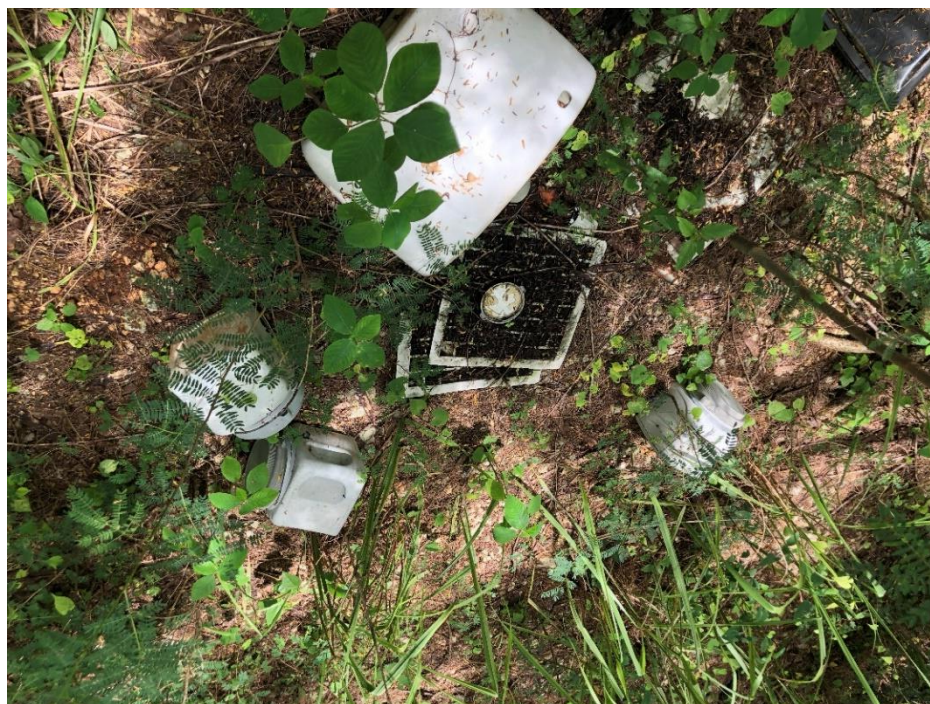
Photo 10: Plastic 1-gal. Paint Buckets and Household Waste, Center of the Property, Oka Point, Tamuning Guam

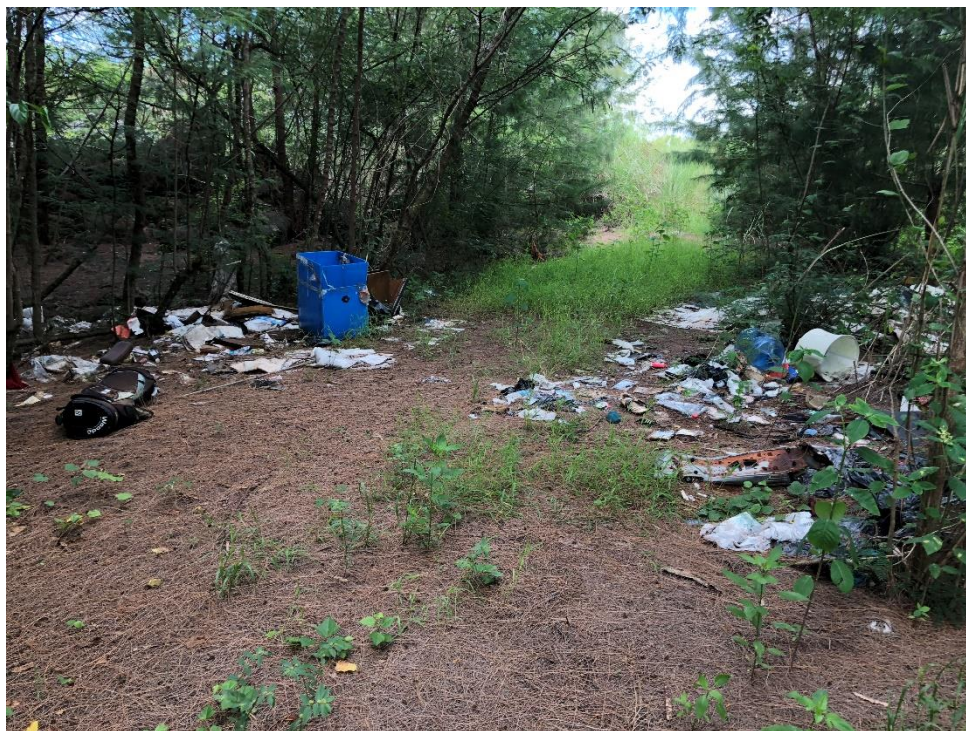
Photo 11: Household trash found at the center of the subject site, Oka Point, Tamuning Guam

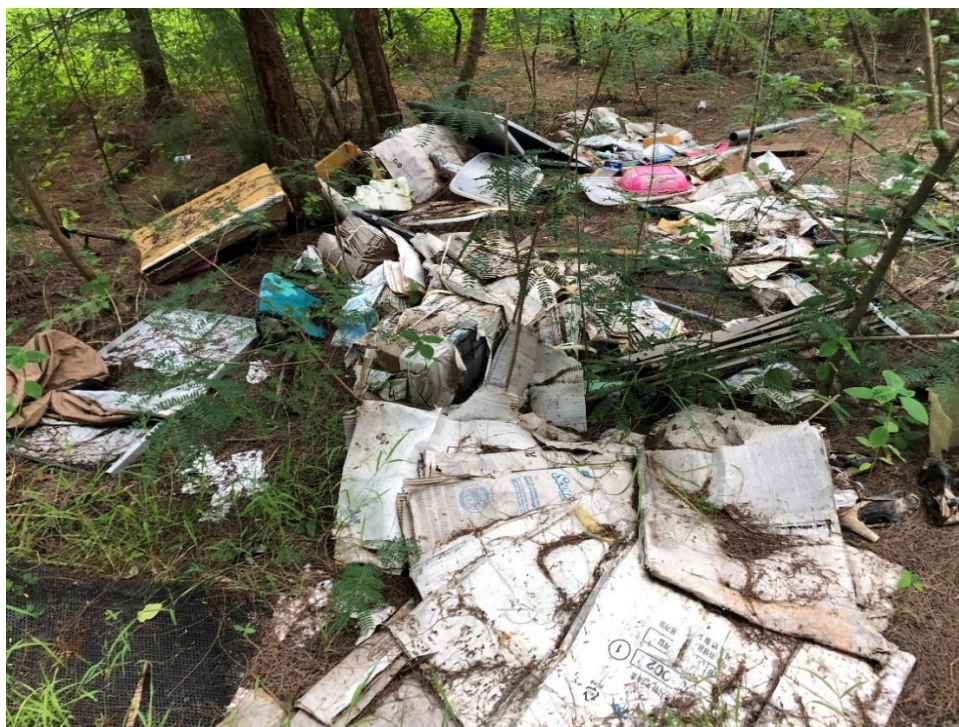
Photo 12: Paper, Metal, and Plastic Waste, Center of the Property, Oka Point, Tamuning Guam

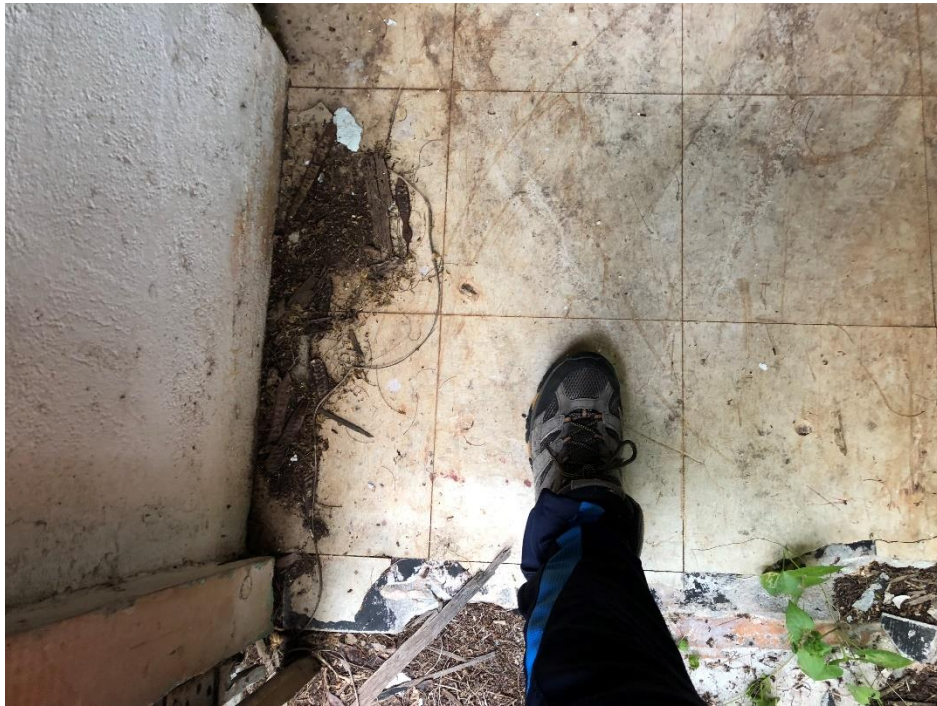
Photo 15: 12-inch floor tiles inside the former GPA field office near the southwest boundary of the subject site, Oka Point, Tamuning Guam

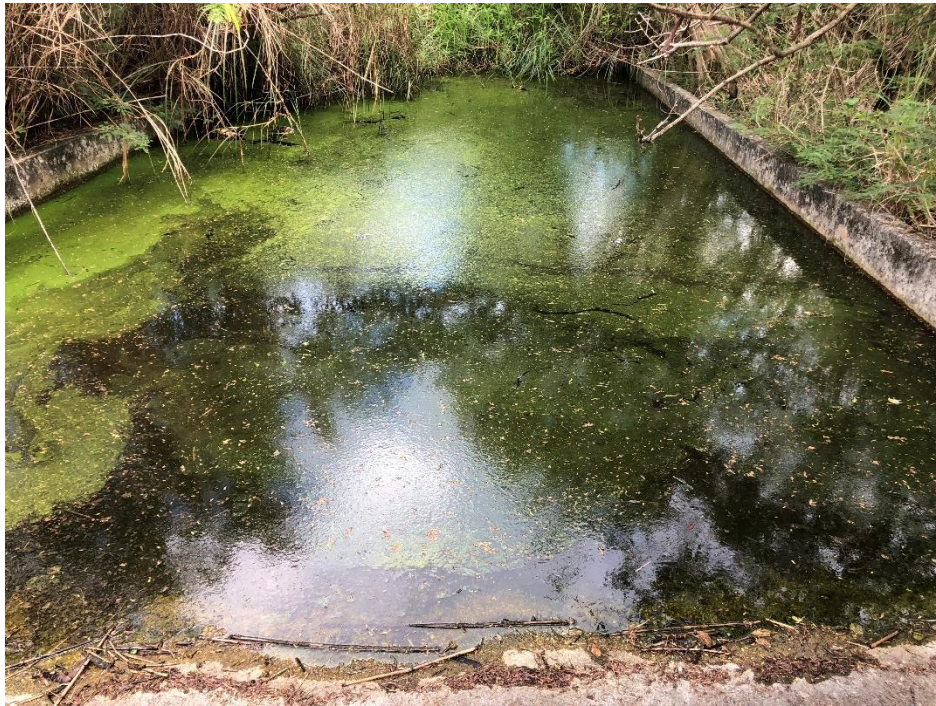
Photo 17: Containment for an Above Ground Storage Tank (AST) near the former GPA field office, near the southwest boundary of the subject site, Oka Point, Tamuning Guam

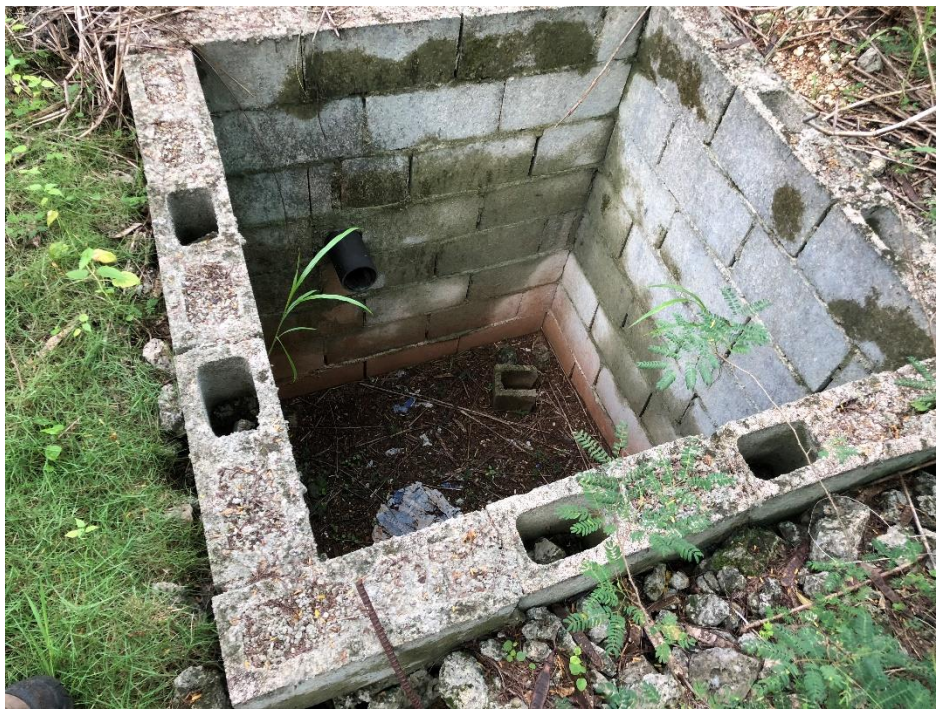
Photo18: Septic tank behind the GPA field office near the southwest boundary of the subject site, Oka Point, Tamuning Guam

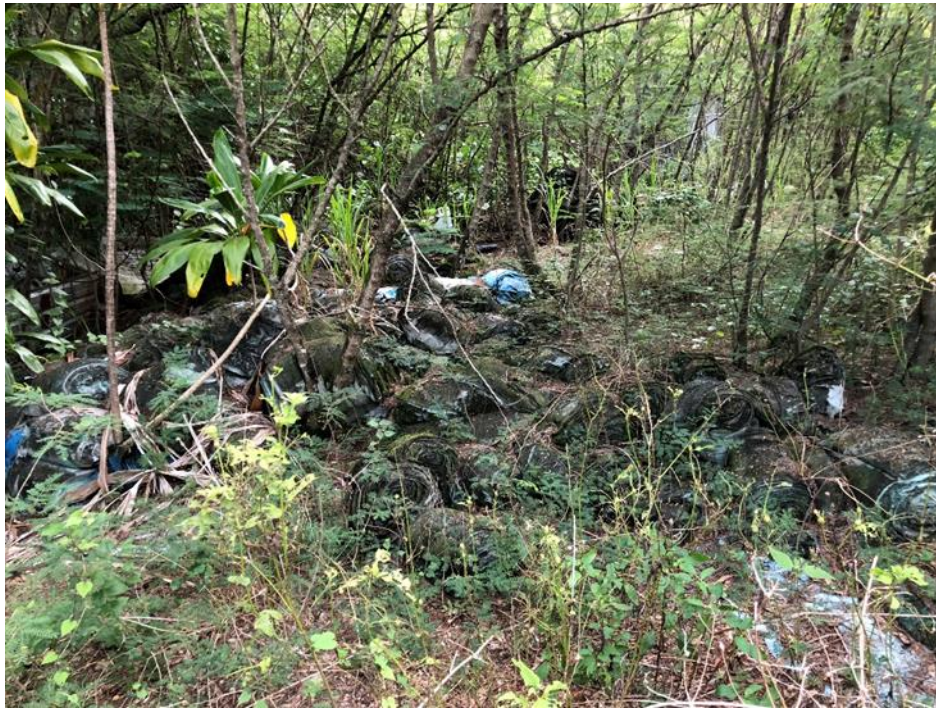
Photo19: Multiple rolls of carpet found behind the former GPA field office, near the southwest boundary of the subject site, Oka Point, Tamuning Guam

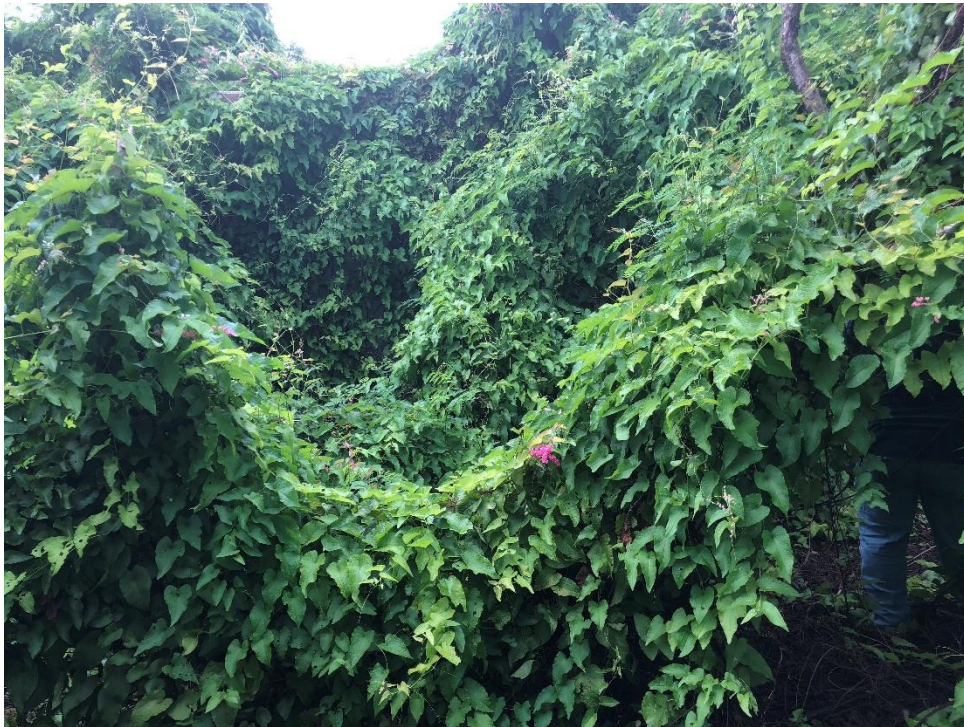
Photo 27: Invasive chain-of-love vine covering Abandoned House “K”, near the western boundary of the subject site, Oka Point, Tamuning Guam

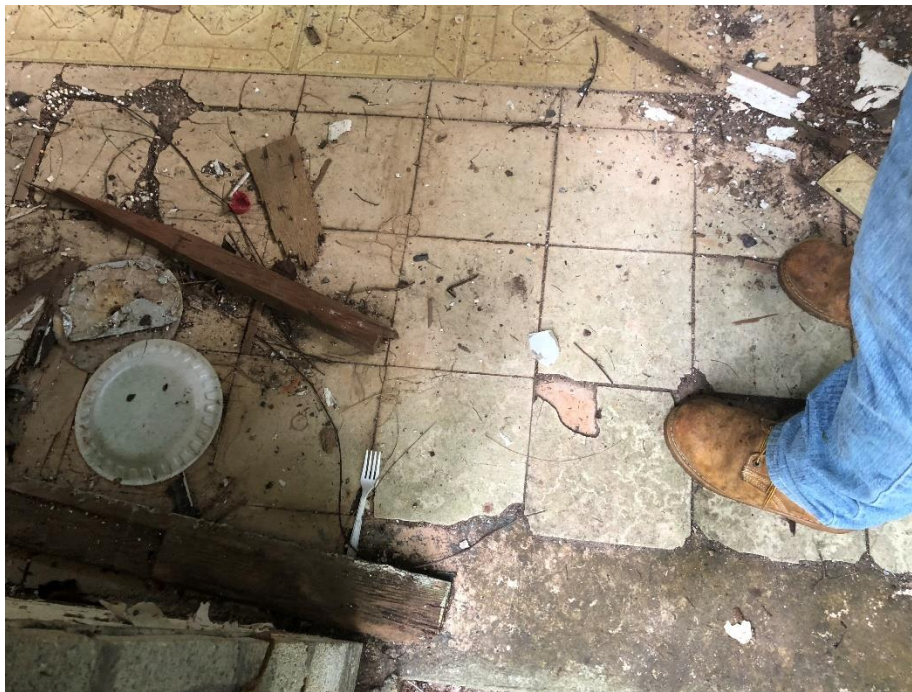
- During the October 15 visit, the site was entered through the southwest boundary of the subject site. The interior of buildings I thru N were observed. Buildings were entered through a vast amount of vegetation. Accessibility of the buildings were very limited. The roofs and walls of majority of the buildings were covered by the invasive vine. Building N was the only building found to have 9-inch tiles.

Photo 28: 9-inch floor tiles found inside Abandoned House “N” near the western boundary of the subject site, Oka Point, Tamuning Guam

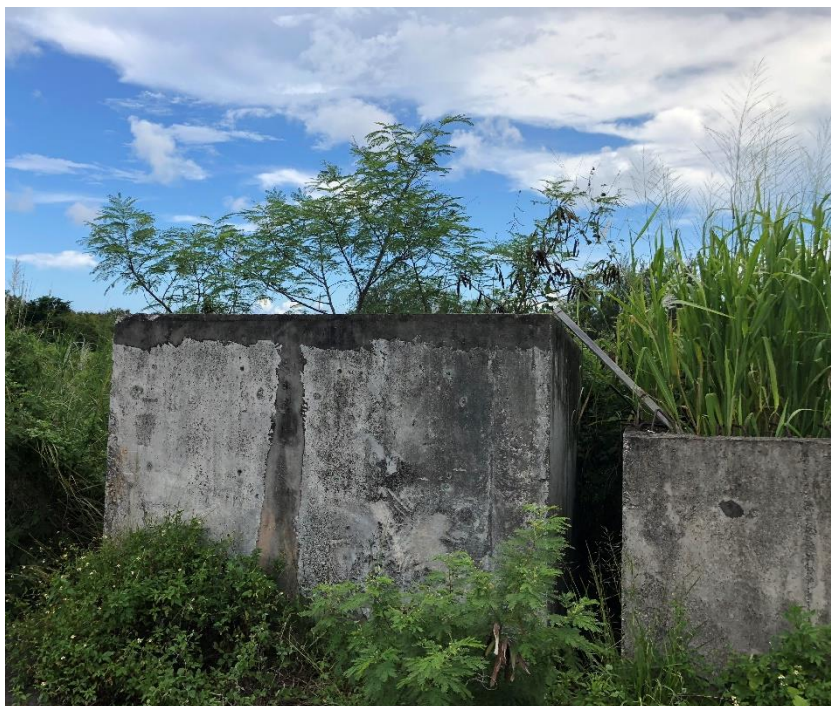
Photo 29: Precast manholes near the southern portion of the subject site, Oka Point, Tamuning Guam

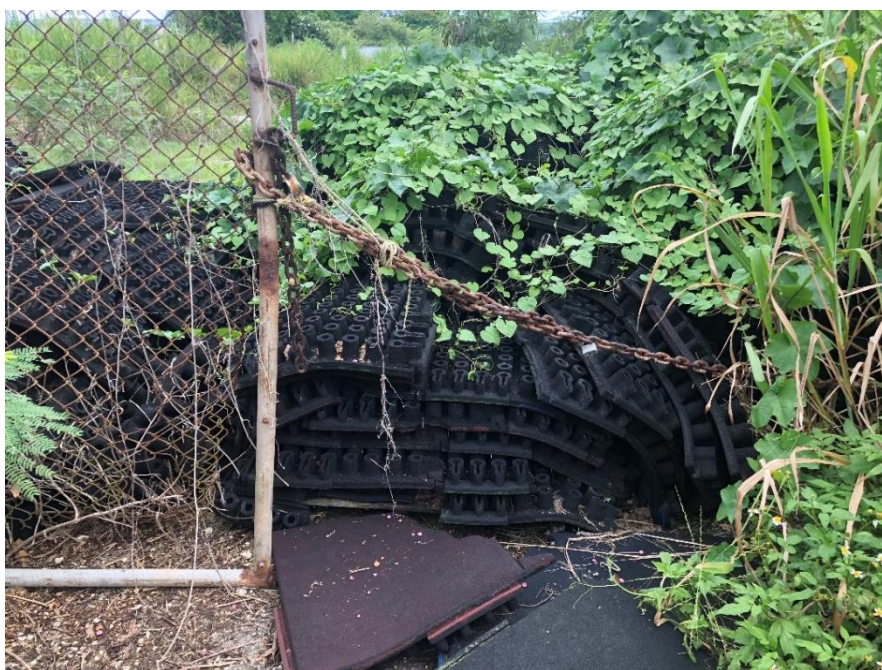
Photo 30: Rubber flooring material at the southeastern portion of the subject site, Oka Point, Tamuning Guam
