RE: Notice of Violation, Order of Compliance, and Administrative Penalty Order  
(NOV/OC/APO) No. SW 21-002

## **Solid Waste Compliance Evaluation Inspection Report**

**Date of Investigation:** July 12, 2021

**Facility Name:** UMS Hardfill

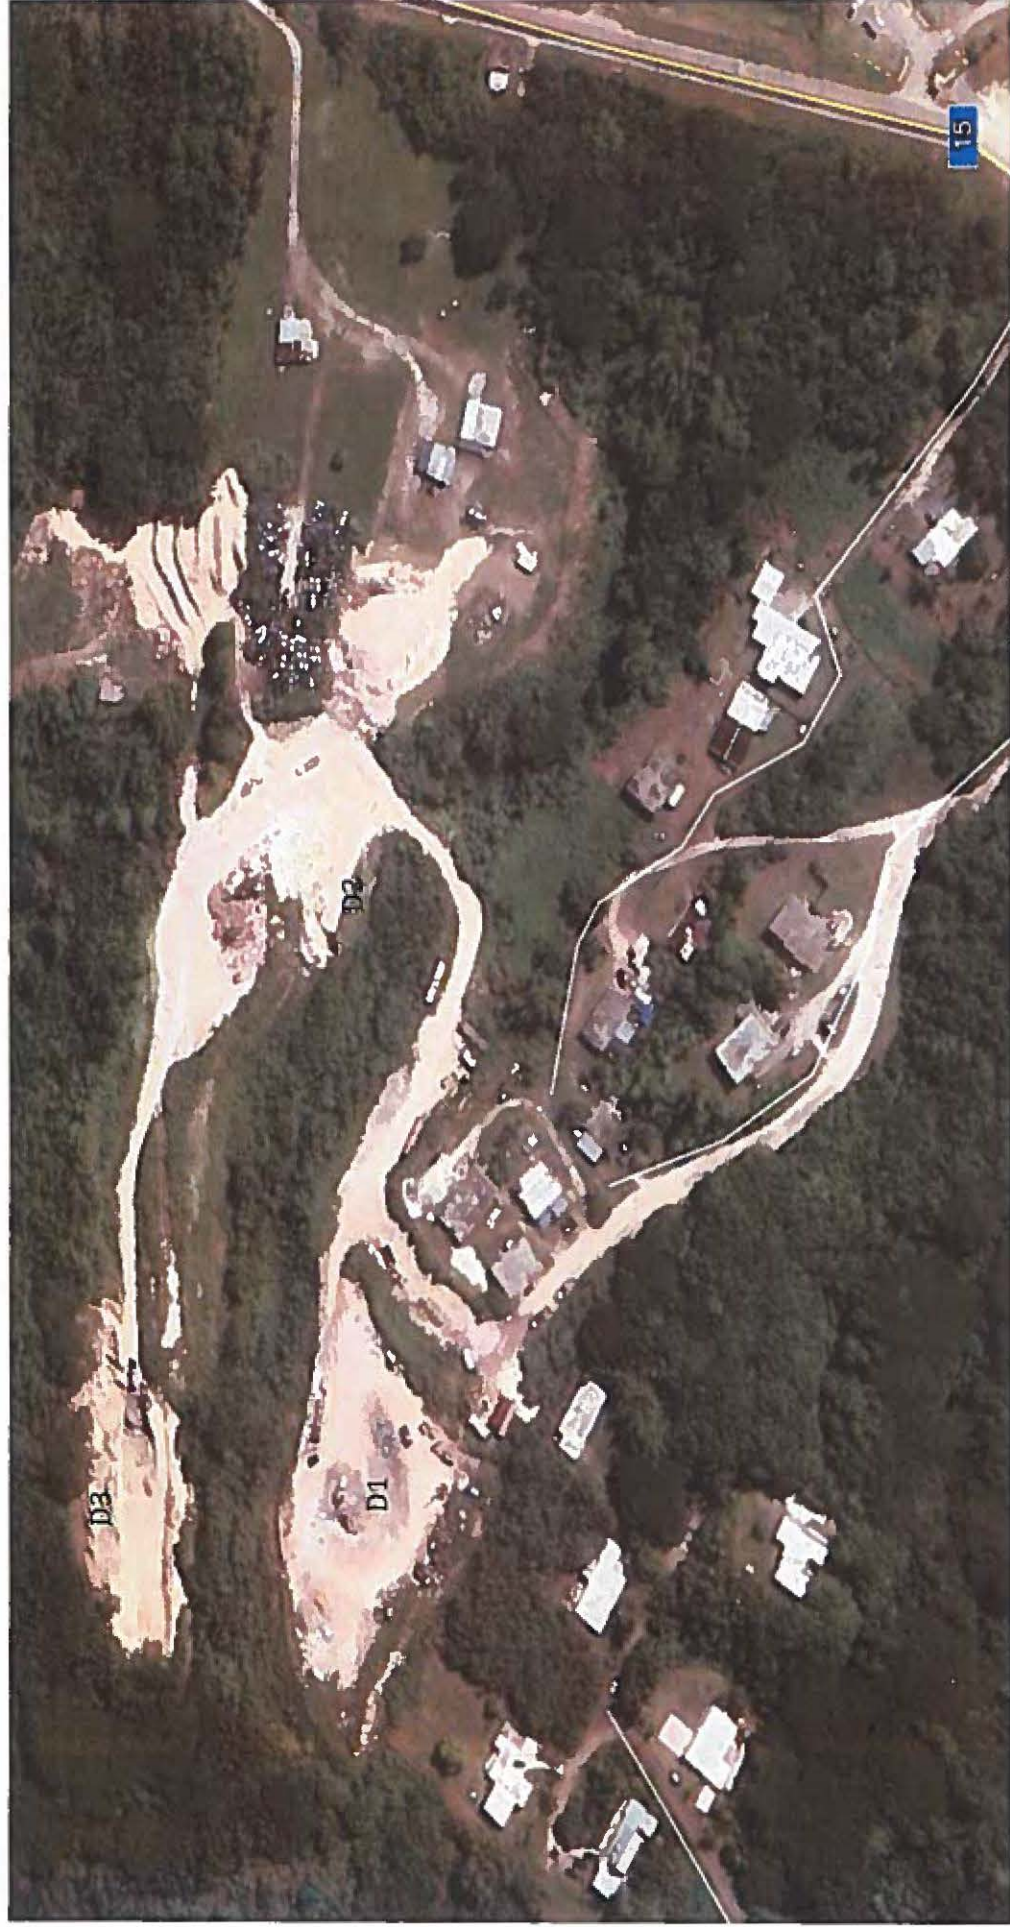
Figure 1: Disposal Site locations: D1, D2, and D3

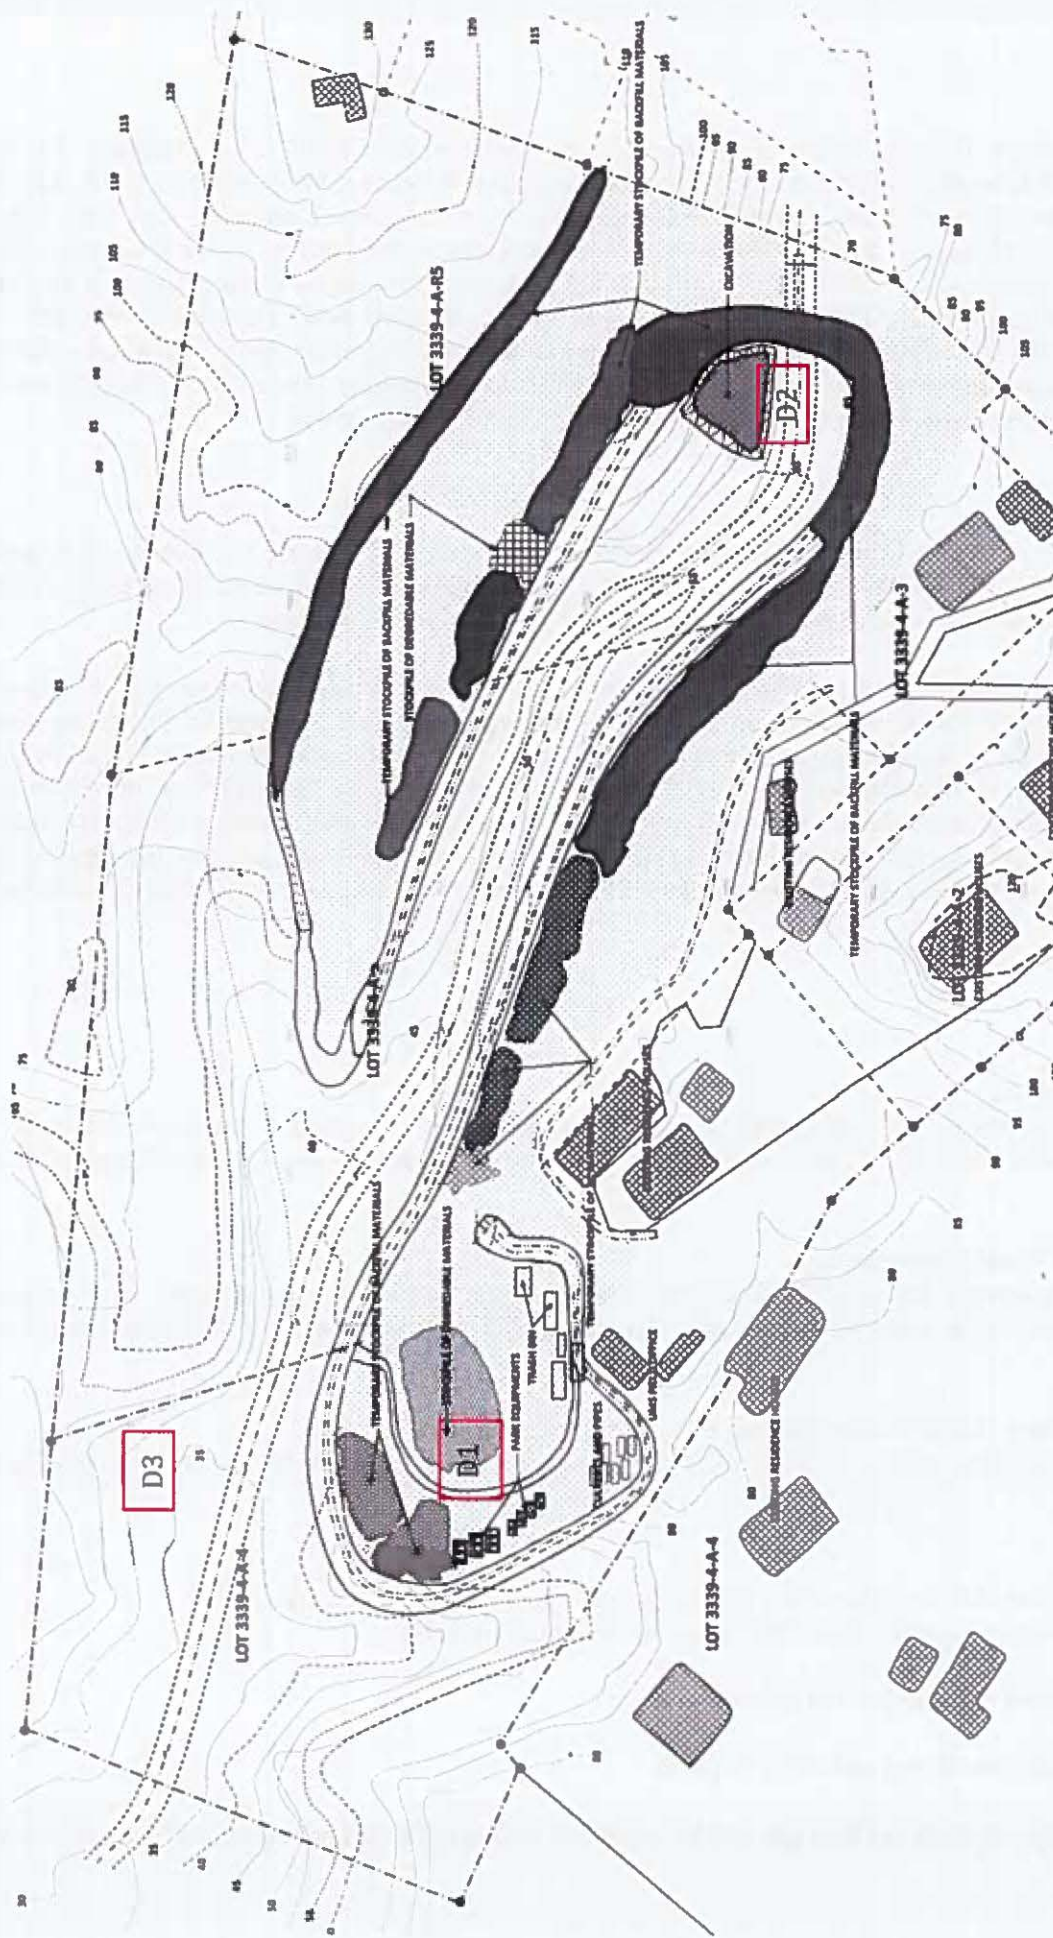
Figure 2: Lot locations: L339-4A-4, L339-4A-5, L339-4A-R5, Mangilao.

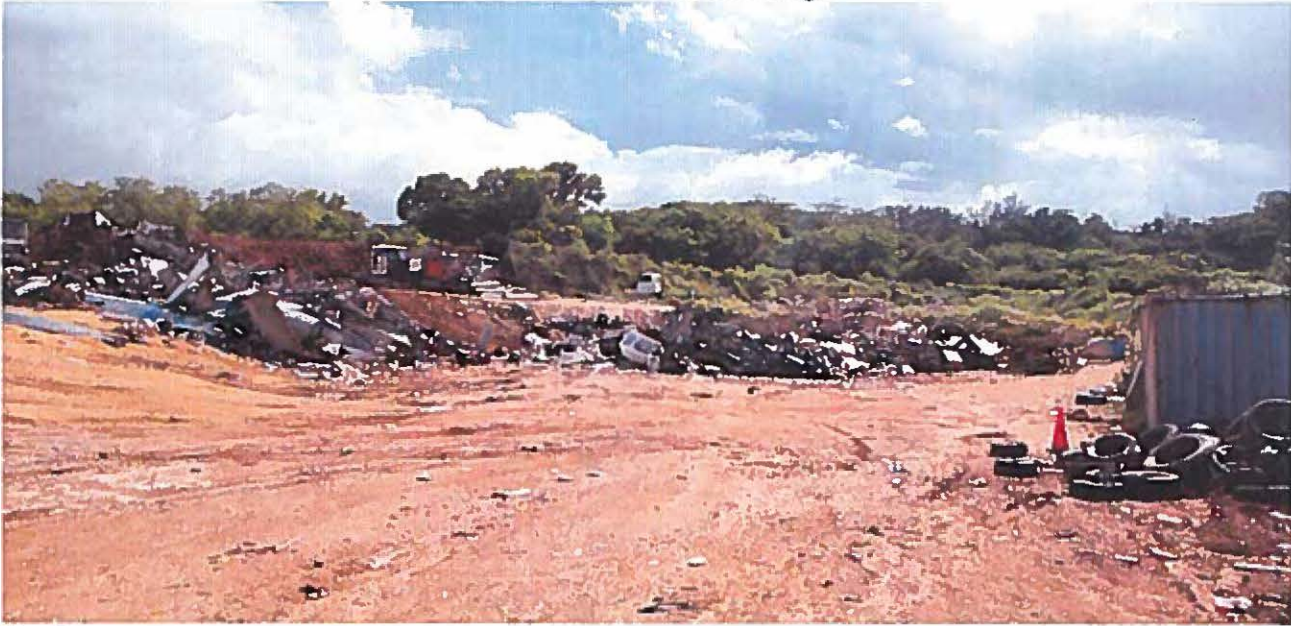
Pic. 1  
Date: July 12, 2021  
Time: 1542 hrs.  
Location: Lot No. 3339-4-A-4 , Disposal Site 1: Screening Area  
Description: Left of the pic. Junk heavy equipment and mixed metals; Center mixed solid waste, Tire piles next to 20' shipping container

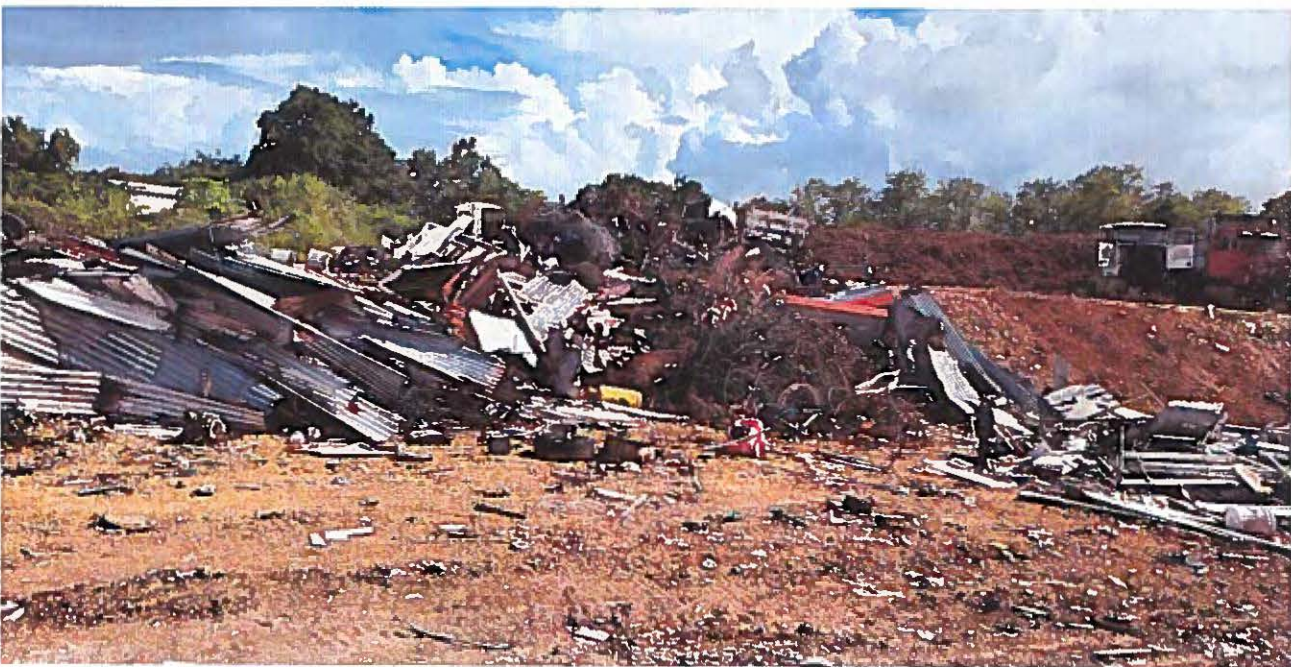
Pic. 2  
Page 6 of 20 NOV/OC

Location: Lot No. 3339-4-A-4 , Disposal Site 1: Screening Area

Description: Left side of screening area: Junk heavy equipment and mixed metals

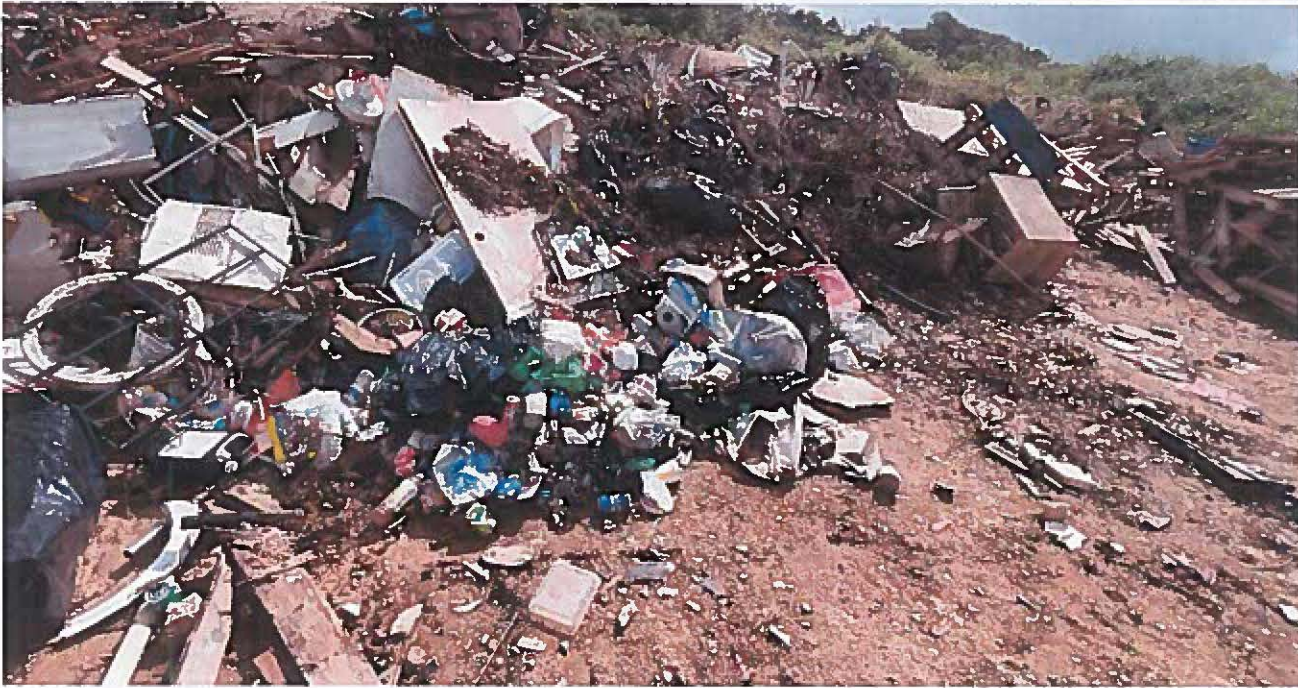
Pic. 3

Location: Lot No. 3339-4-A-4, Disposal Site 1: Screening Area

Description: Center area: Mixed solid waste trash, wood, metal, appliances

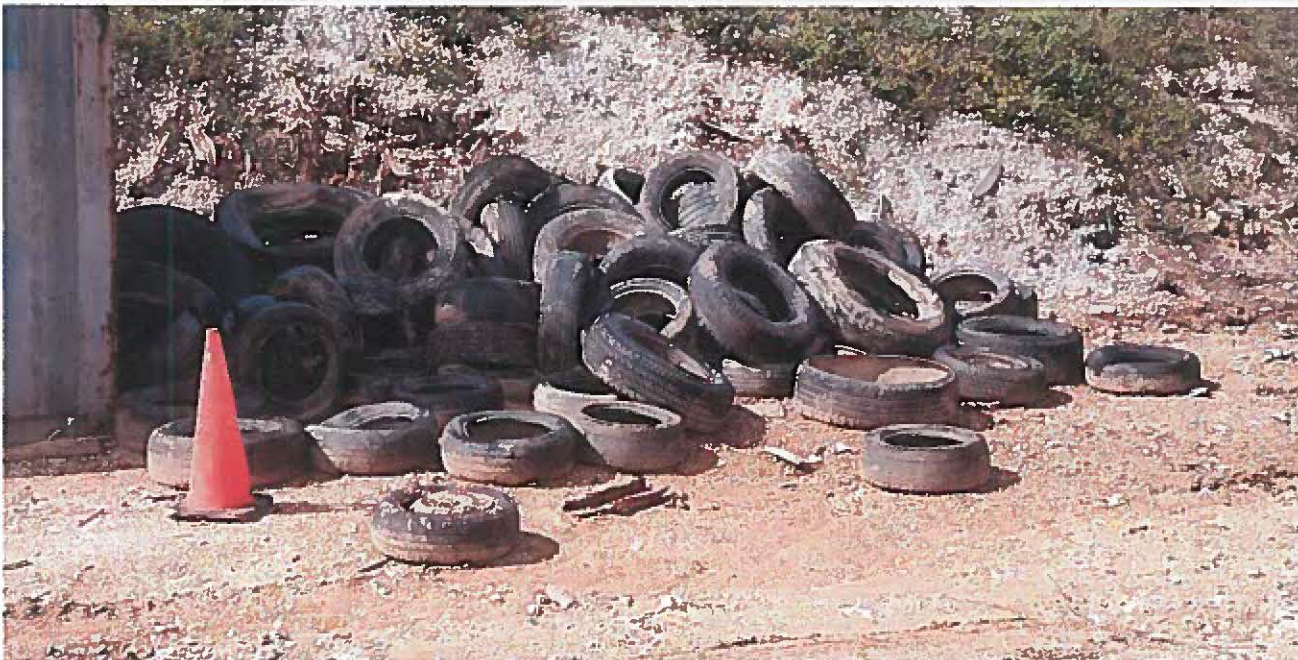
Pic. 4

Location: Lot No. 3339-4-A-4, Disposal Site 1: Screening Area

Description: Right side of screening area: Waste tires by the storage shipping container.

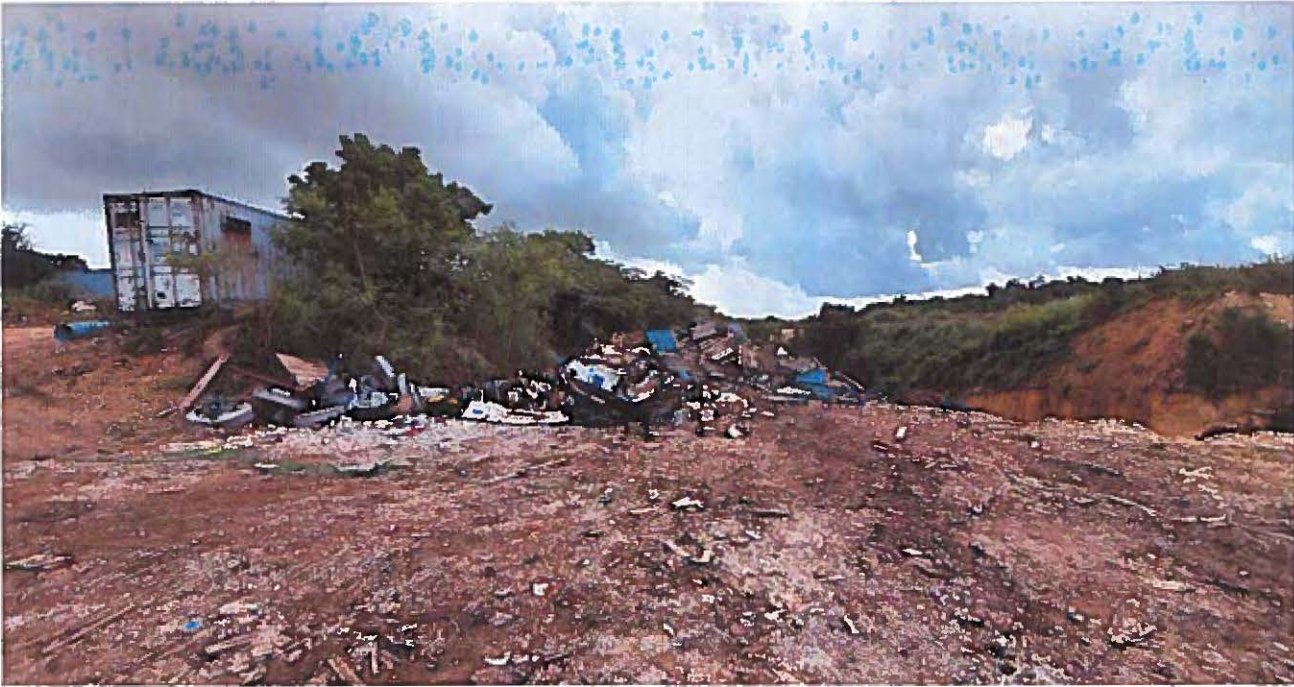
Pic. 5

Location: Lot No. 3339-4-A-R5, Disposal Site 2: Pit area ridge

Description: Comingled waste consisting of trash, cardboard, scrap metal, tires, & wooden/plastic pallets

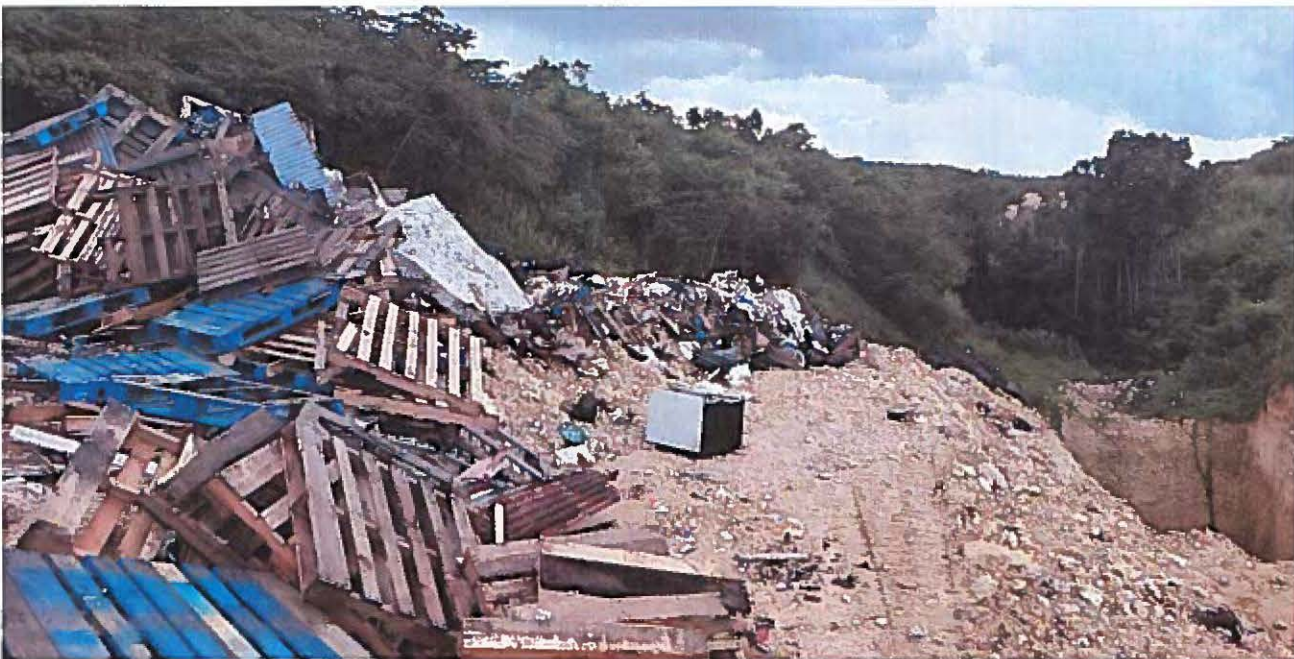
Pic. 6

Location: Lot No. 3339-4-A- R5, Disposal Site 2: Pit area ridge

Description: Miscellaneous solid waste consisting of trash, cardboard, metal tanks scrap metal wooden pallets, plastic pallets, and mattresses.

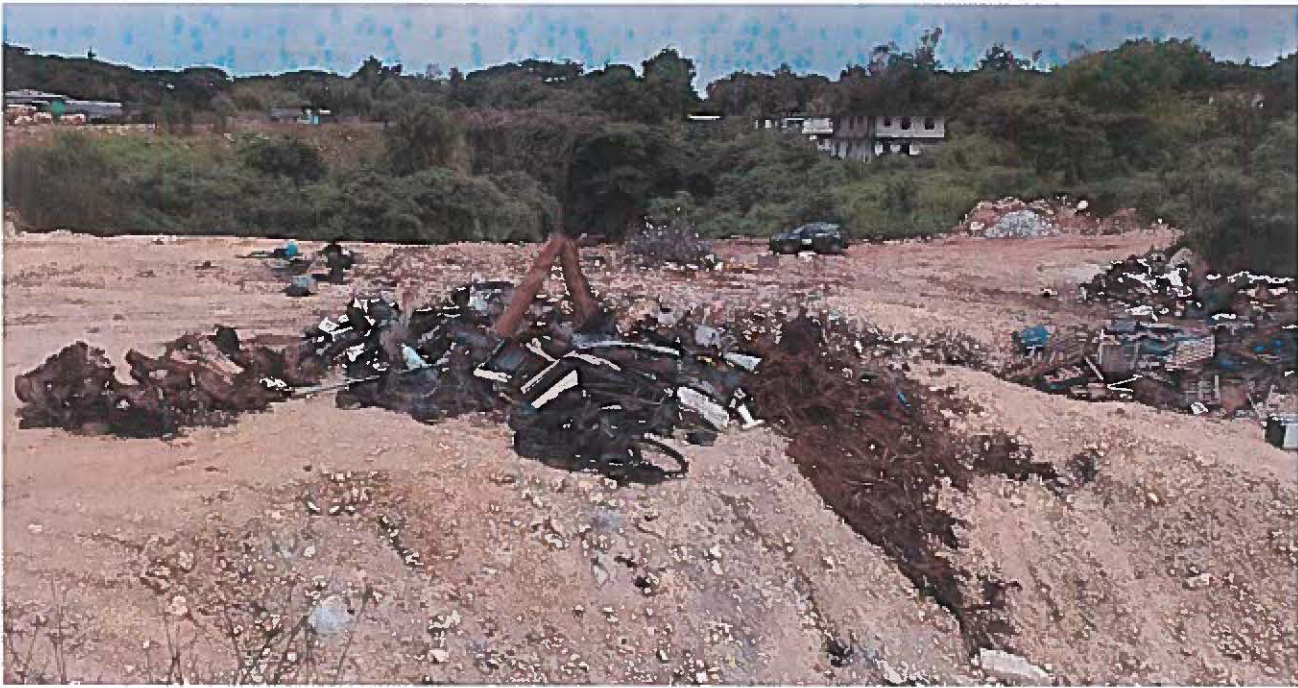
Pic. 7

Location: Lot No. 3339-4-A-R5, Disposal Site 2: Between ridge and Wood Processing area

Description: Miscellaneous solid waste consisting of miscellaneous metal, wooden pallets and waste tire

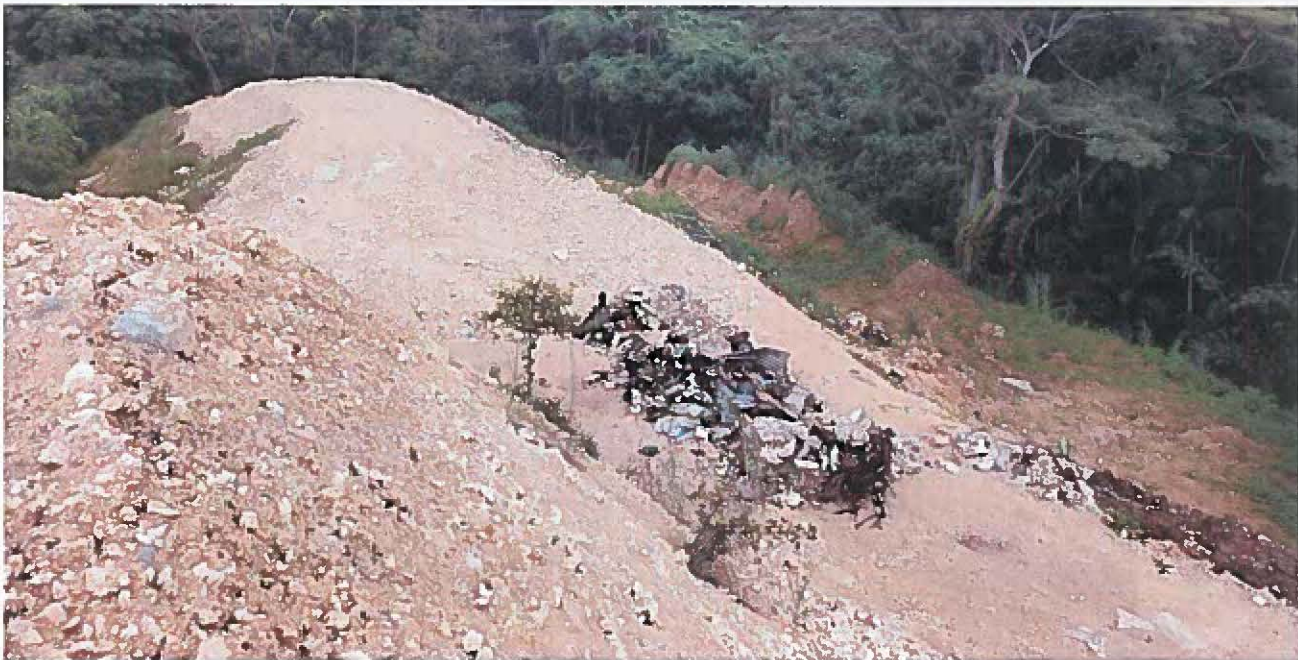
Pic. 8

Location: Lot No. 3339-4-A-4, Disposal Site 3: North Western area

Description: Miscellaneous metal, vegetation, and concrete rubble

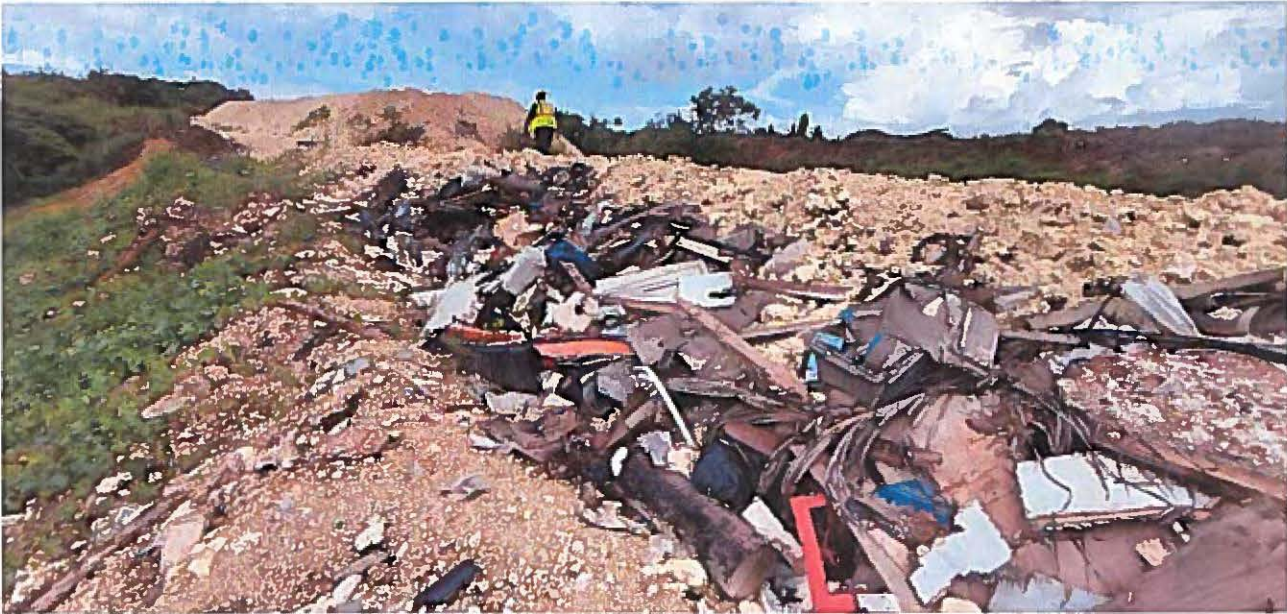
Pic. 9

Location: Lot No. 3339-4-A-4, Disposal Site 3: North western area

Description: Start of visible signs of partially buried solid waste consisting of wood, trash, metal, & cardboard

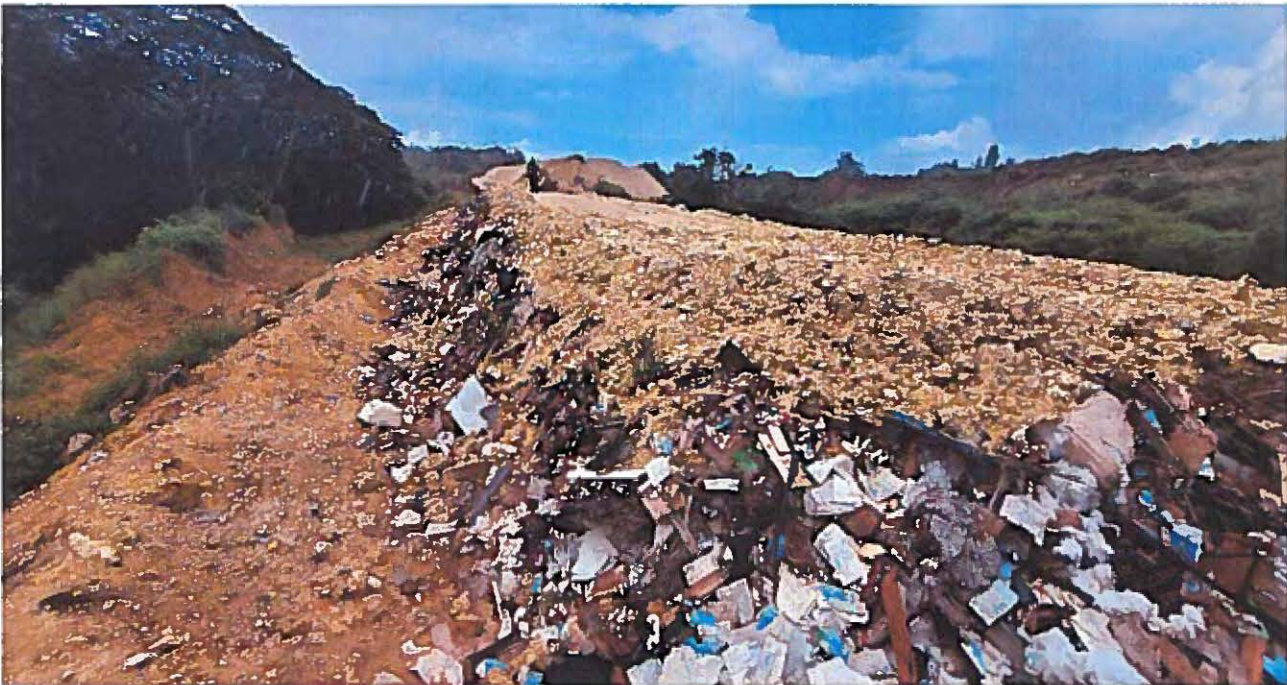
Pic. 10

Location: Lot No. 3339-4-A-4, Disposal Site 3: North Western area

Description: End of partially buried miscellaneous solid waste consisting of vegetation, wood, trash, & metal

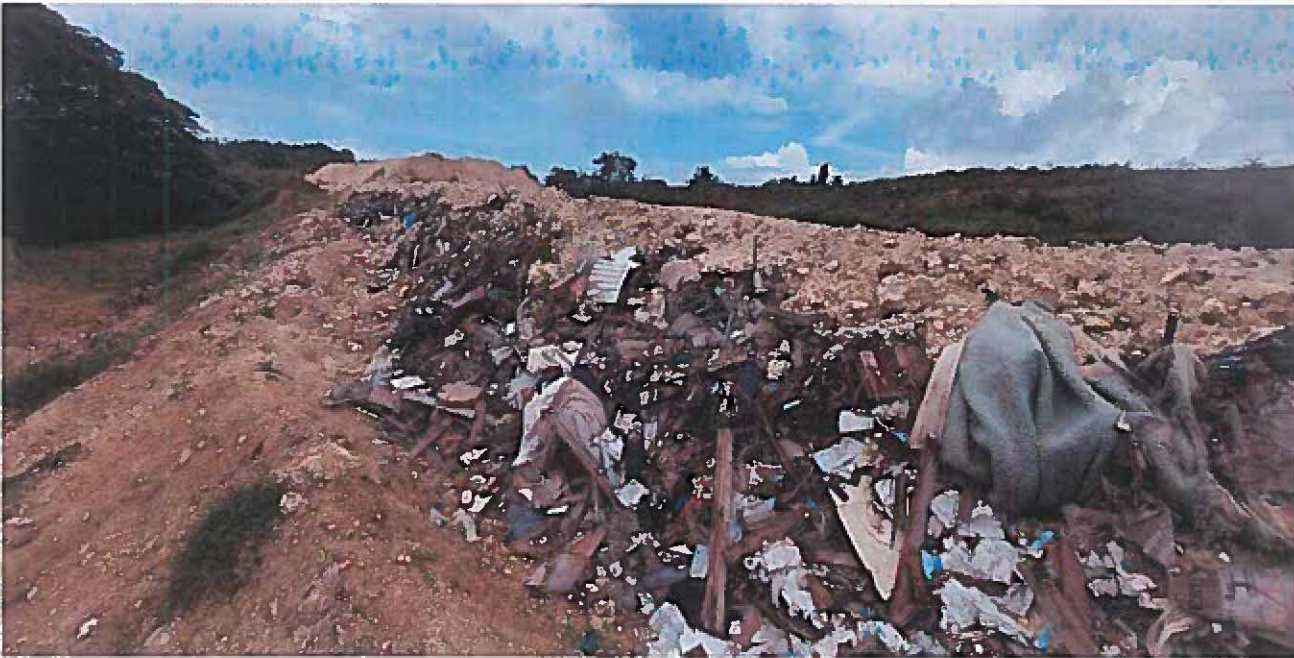
Pic.11

Location: Lot No. 3339-4-A-4, Disposal Site 3: North Western area

Description: North side of partially buried miscellaneous waste consisting of vegetation, wood, trash, & metal

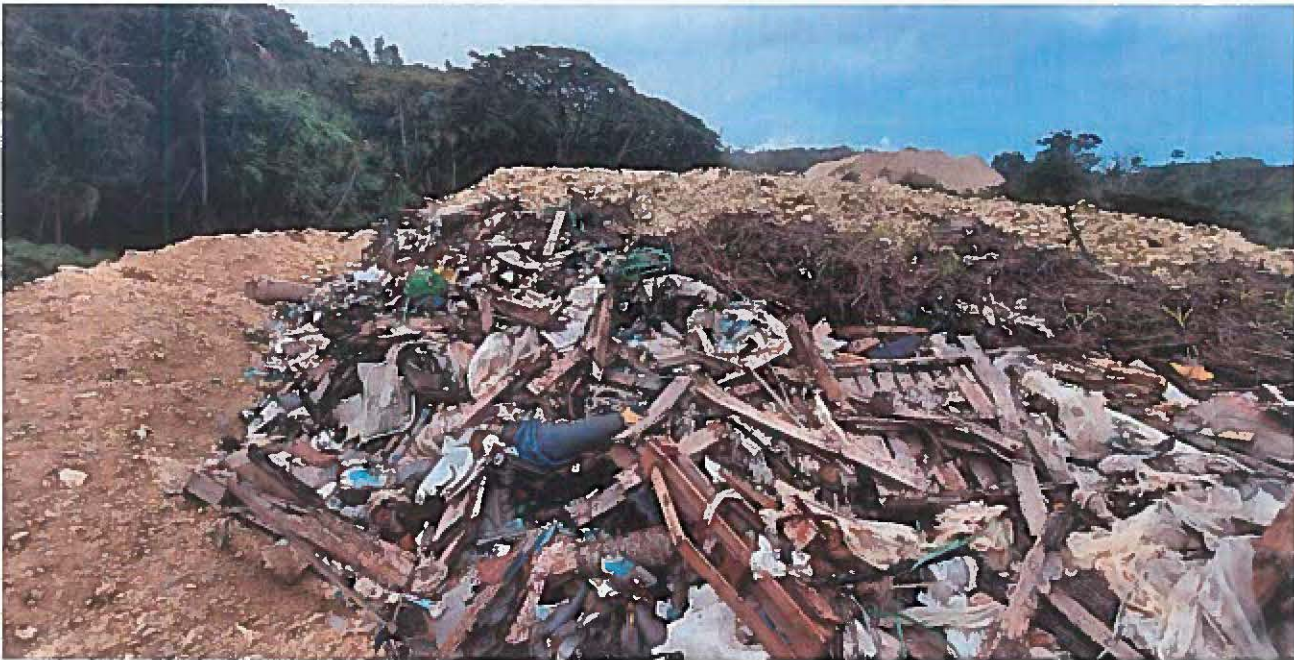
Pic. 12

Location: Lot No. 3339-4-A-4, Disposal Site 3: North Western area

Description: End of partially buried miscellaneous solid waste consisting of vegetation, wood, trash, & metal

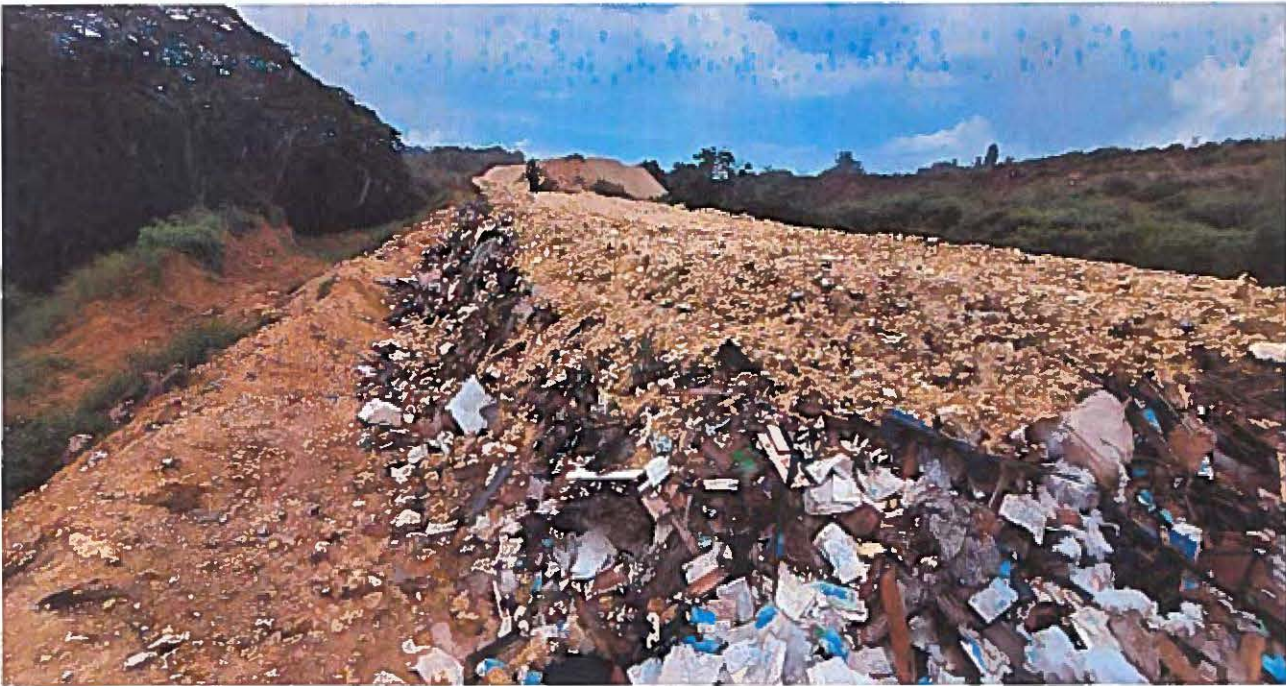
Pic. 13

Location: Lot No. 3339-4-A-4, Disposal Site 3: North Western area

Description: End of partially buried miscellaneous solid waste consisting of vegetation, wood, trash, & metal

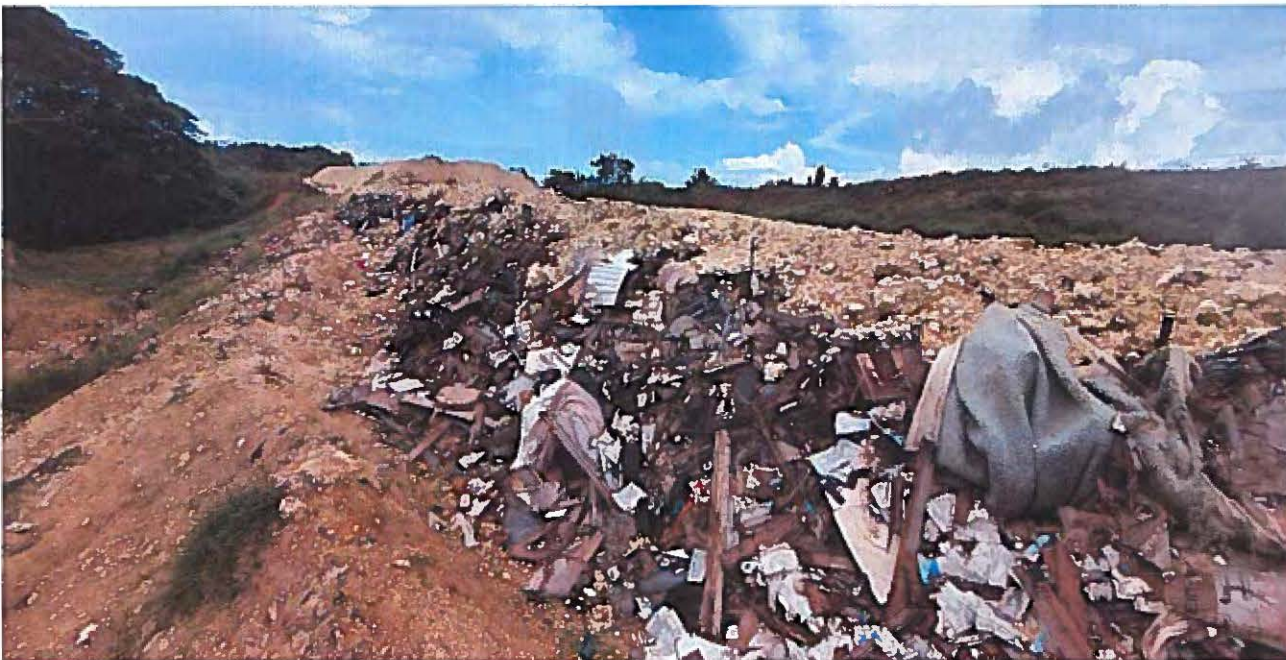
Pic.14

Location: Lot No. 3339-4-A-4, Disposal Site 3: North Western area

Description: North side of partially buried miscellaneous waste consisting of vegetation, wood, trash, & metal

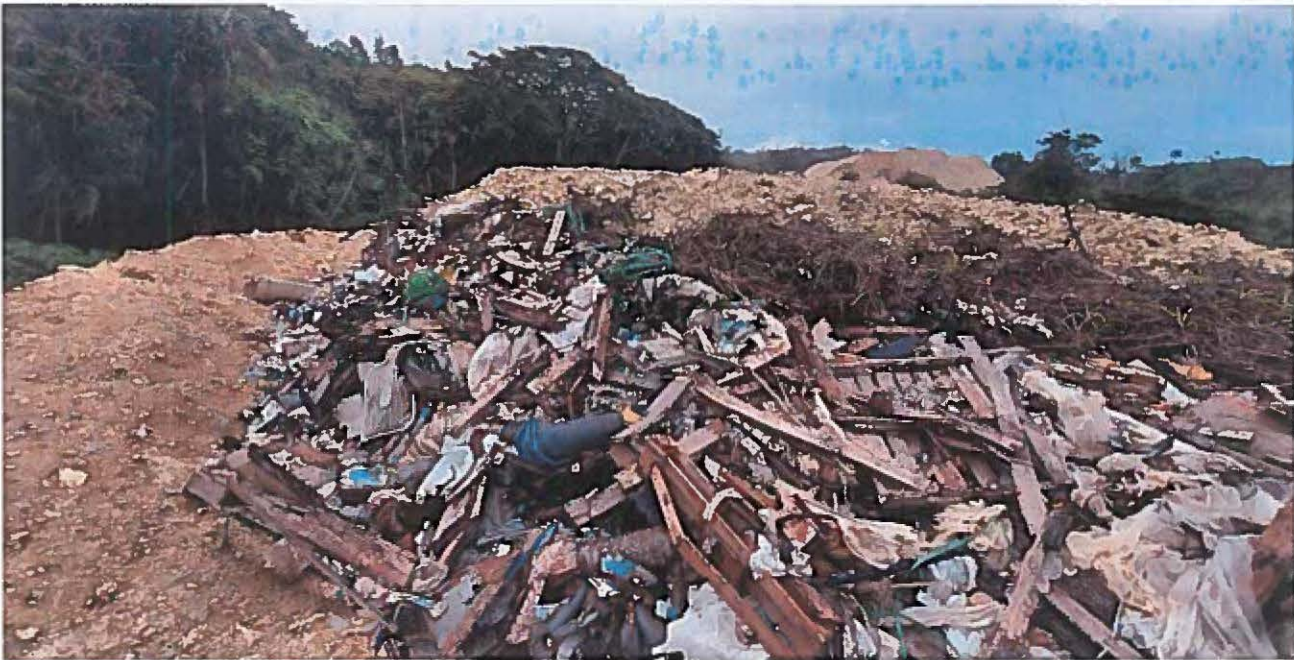
Pic. 15

Location: Lot No. 3339-4-A-4, Disposal Site 3: North Western area

Description: End of partially buried miscellaneous solid waste consisting of vegetation, wood, trash, & metal

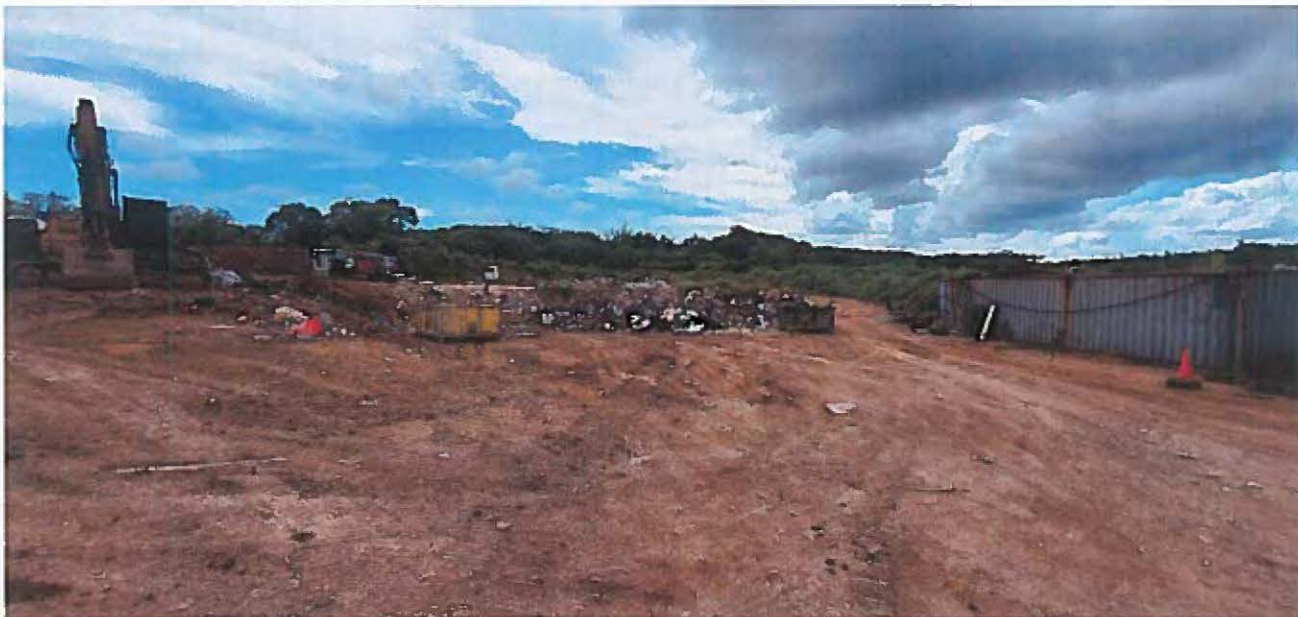
Pic. 16

Location: Lot No. 3339-4-A-4, Disposal Site 1: Screening Area

Description: Site 70% sorted and removed.

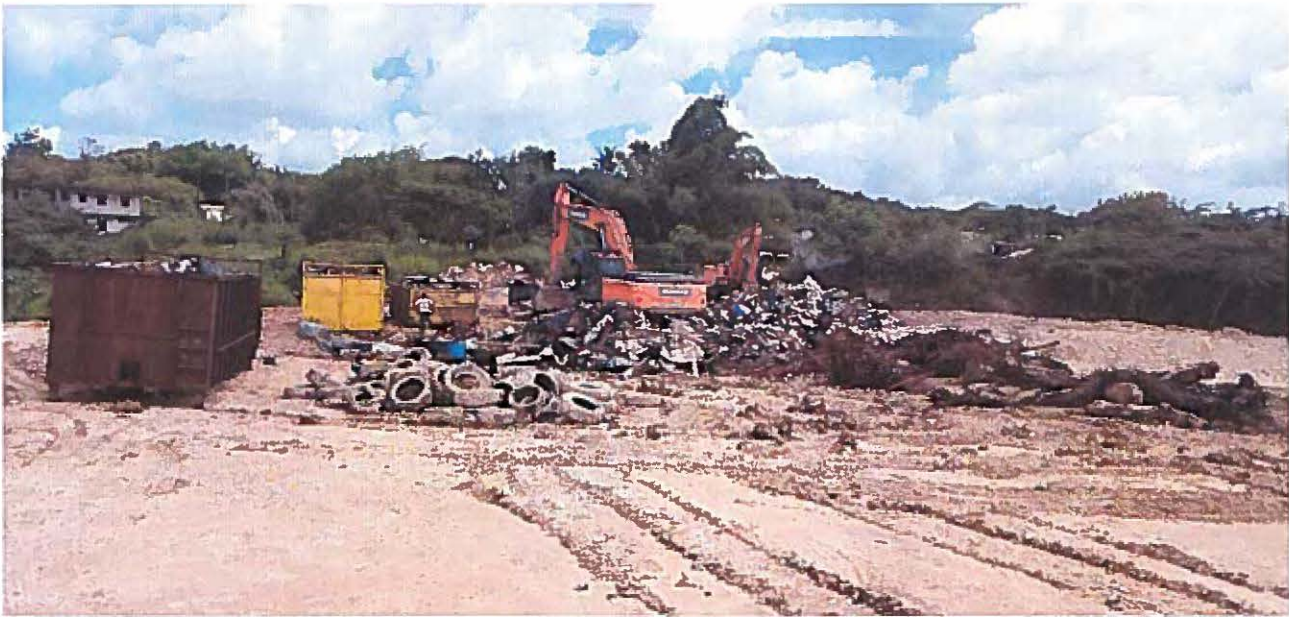
Pic. 17

Location: Lot No. 3339-4-A- R5, Disposal Site 2: Pit area ridge

Description: Debris removed for sorting (tires, metals, wood, and trash) and disposal

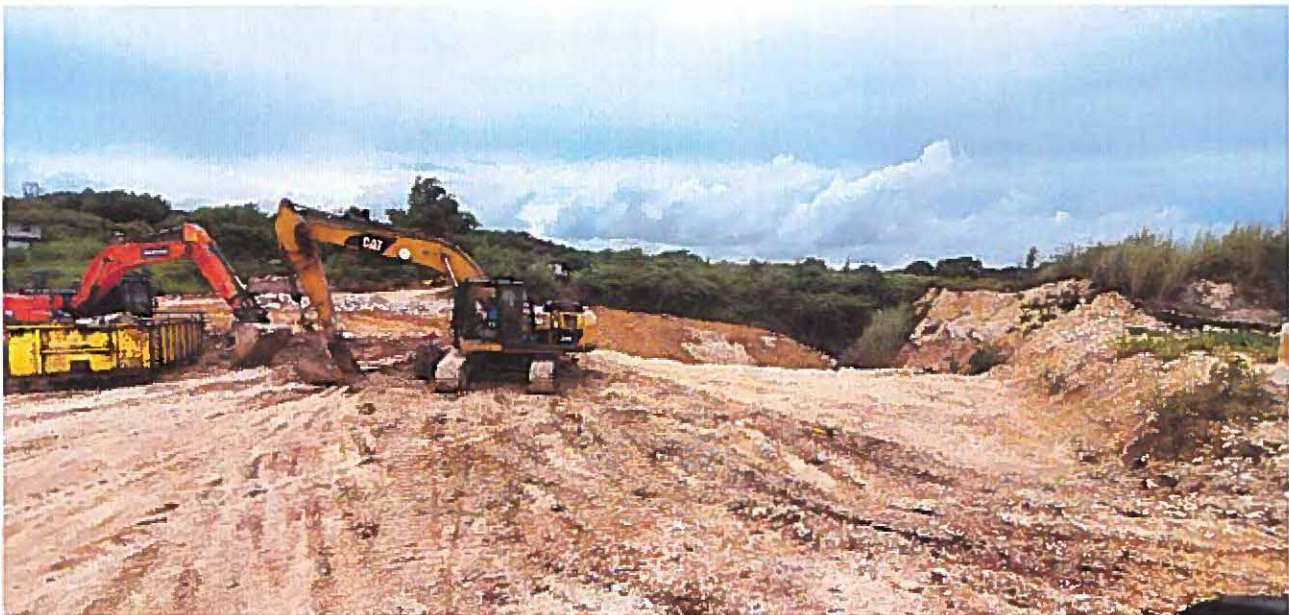
Pic. 18

Location: Lot No. 3339-4-A- R5, Disposal Site 2: Pit area ridge

Description: Last of Disposal Site 2 debris collected for disposal.

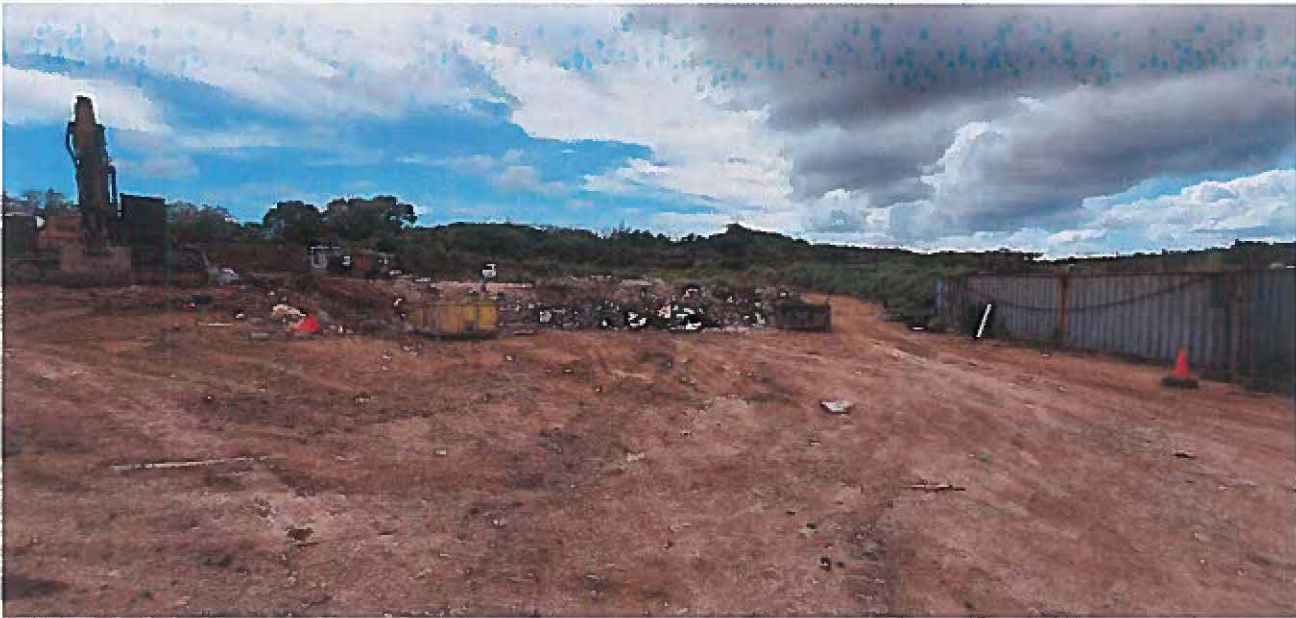
Pic. 19

Location: Lot No. 3339-4-A-4, Disposal Site 1: Screening Area

Description: Site 80% sorted and removed.

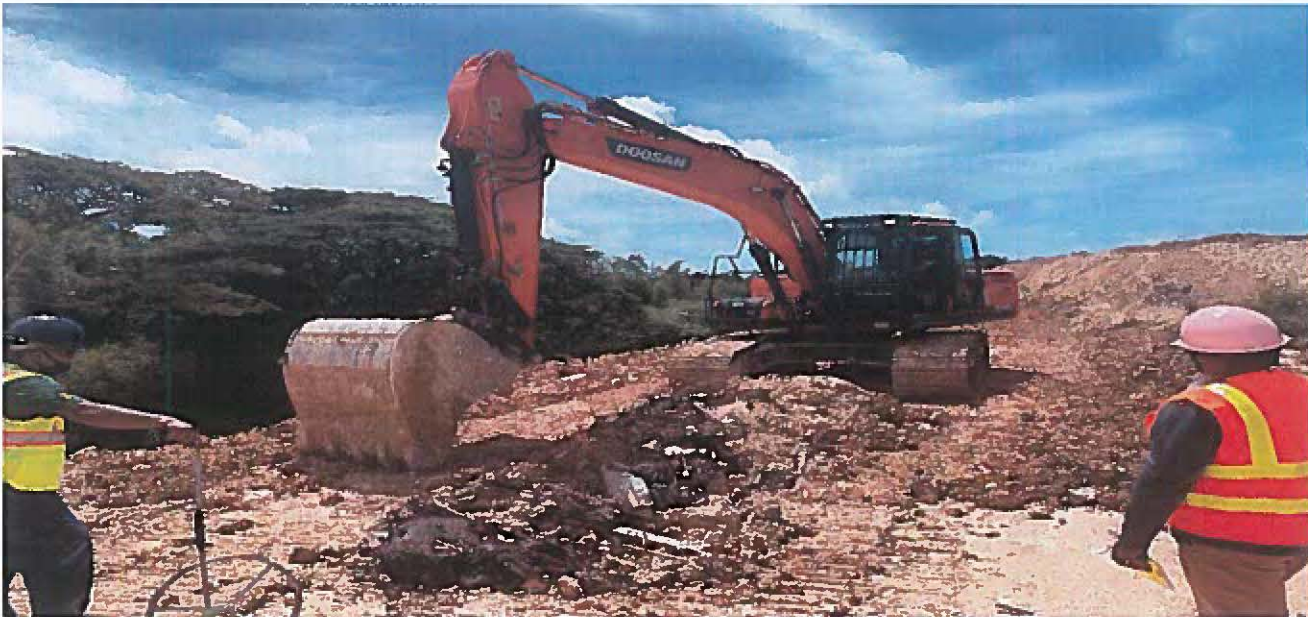
Pic. 19

Location: Lot No. 3339-4-A-4, Disposal Site 3: North Western area

Description: Exploratory trench starting from visible signs of debris along the side slope excavating back every 10 ft.

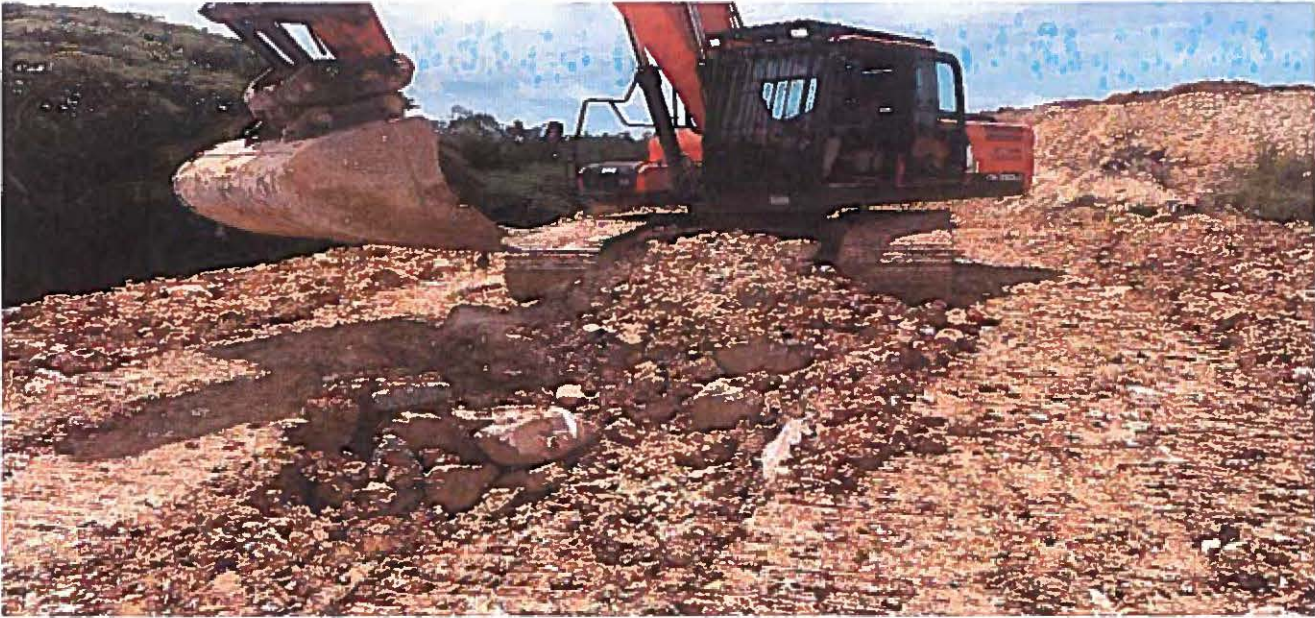
Pic. 20

Location: Lot No. 3339-4-A-4, Disposal Site 3: North Western area

Description: Exploratory trench stop at approx. 155 ft. concrete rubble and dirt.
