RE: Notice of Violation, Order of Compliance, and Administrative Penalty Order  
(NOV/OC/APO) No. SW 21-002

## **Solid Waste Compliance Evaluation Inspection Report**

**Date of Investigation:** July 12, 2021

**Facility Name:** UMS Hardfill

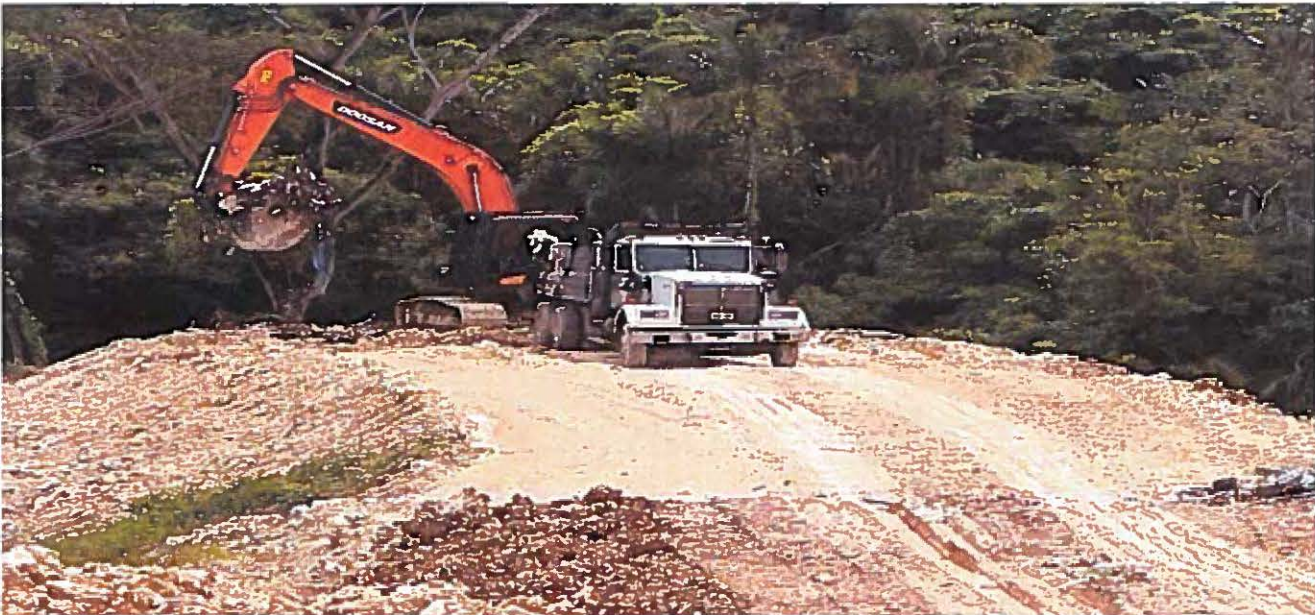
Pic. 21

Location: Lot No. 3339-4-A-4, Disposal Site 3: North Western area

Description: Debris removal starting at the end of the NWA

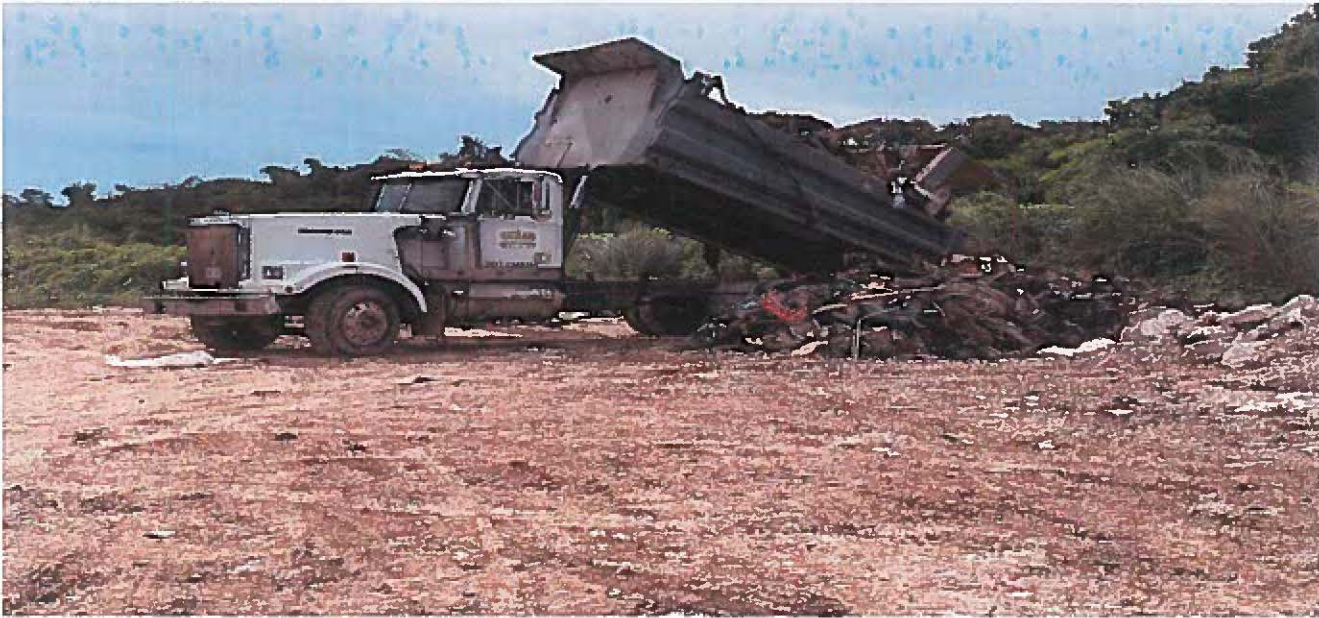
Pic. 22

Location: Lot No. 3339-4-A- R5, across wood chipping area

Description: Debris staging from NWA across Wood Processing area

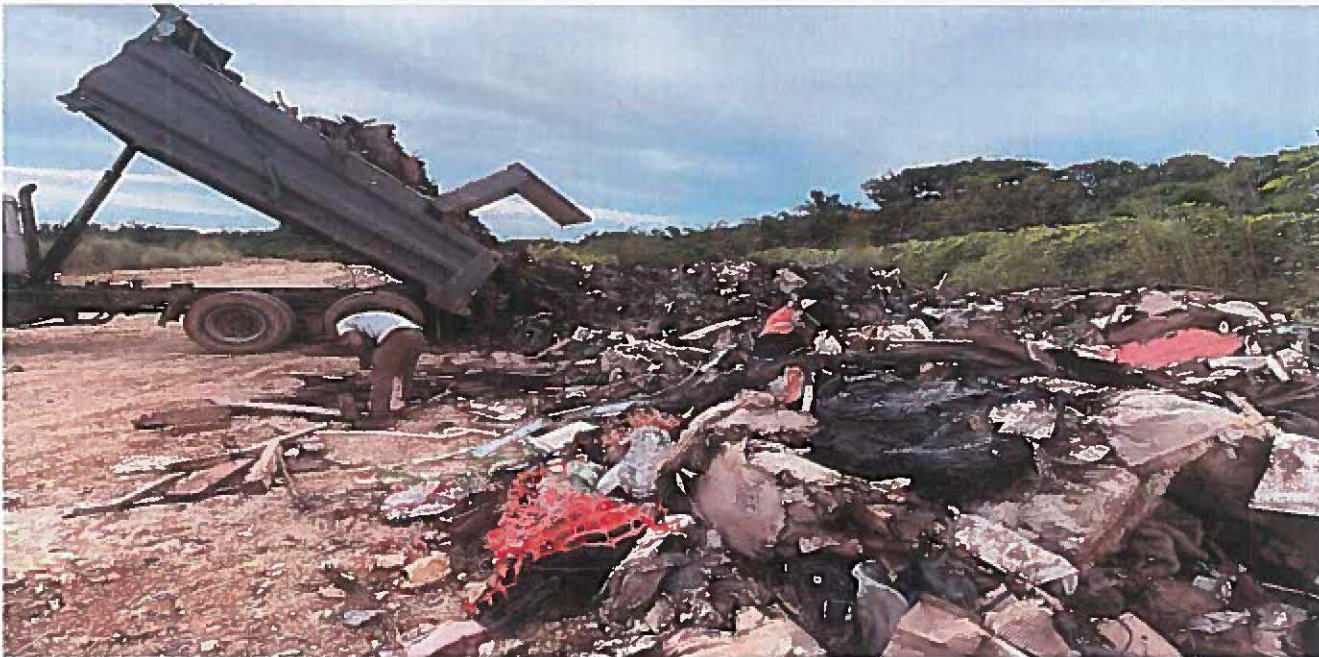
Pic. 23

Location: Lot No. 3339-4-A- R5, across wood processing area

Description: Debris staging for D3 site

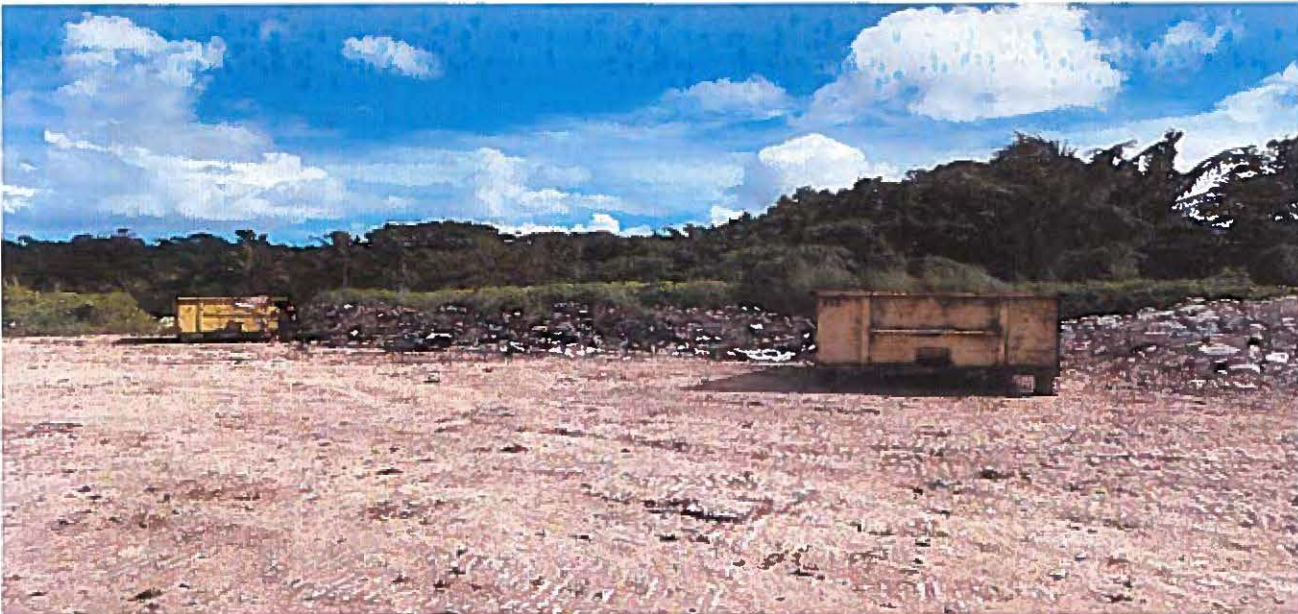
Pic. 24

Location: Lot No. 3339-4-A- R5, across Wood Processing area

Description: Debris staging site for D3 waste

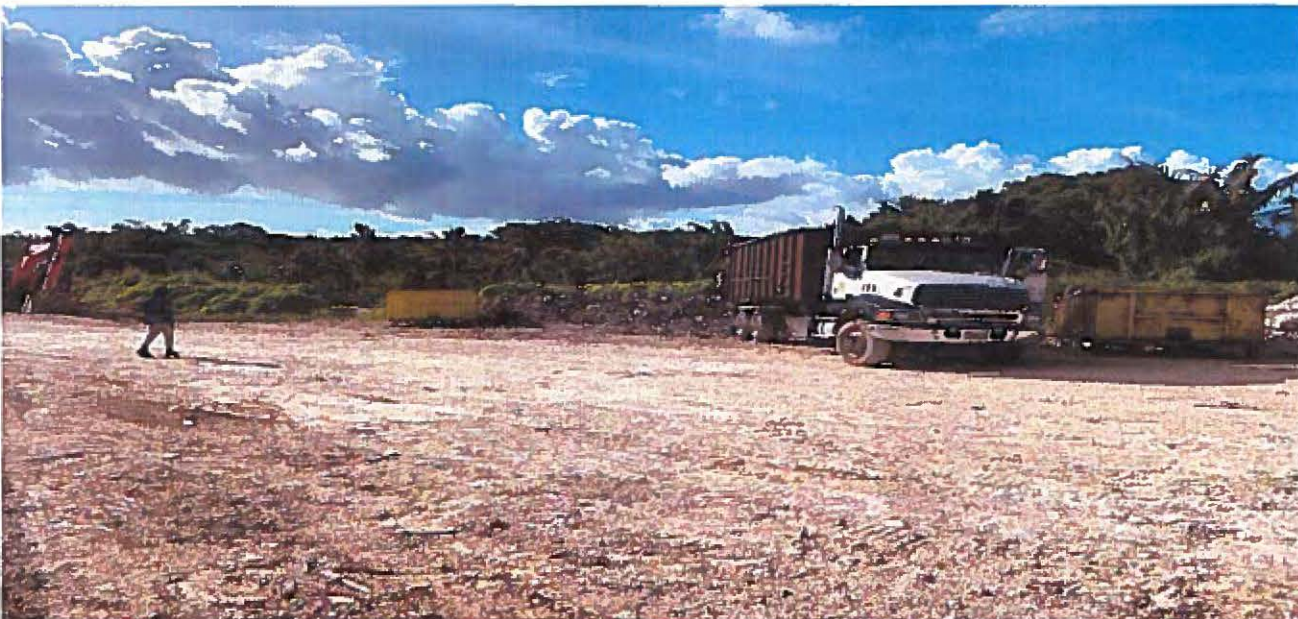
Pic. 25

Location: Lot No. 3339-4-A- R5, across Wood Processing area

Description: Debris staging site for D3 waste

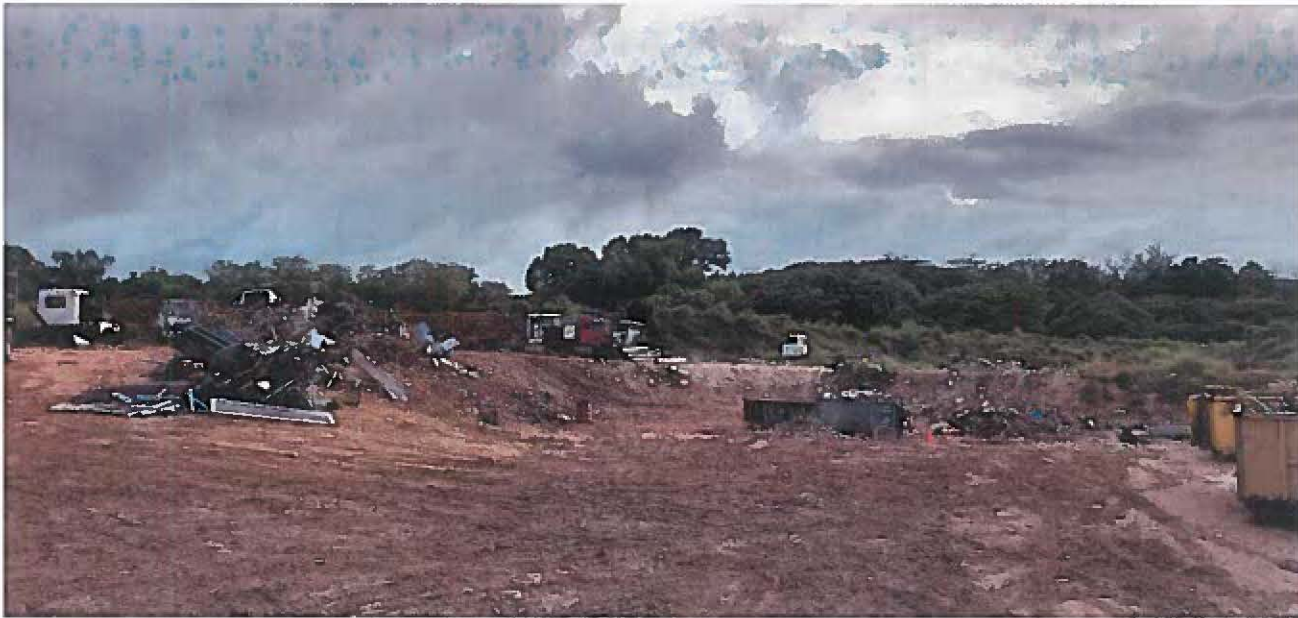
Pic. 26

Lot No. 3339-4-A-4 Disposal Site 1: Screening Area

Description: Trash removed and metals separated for removal

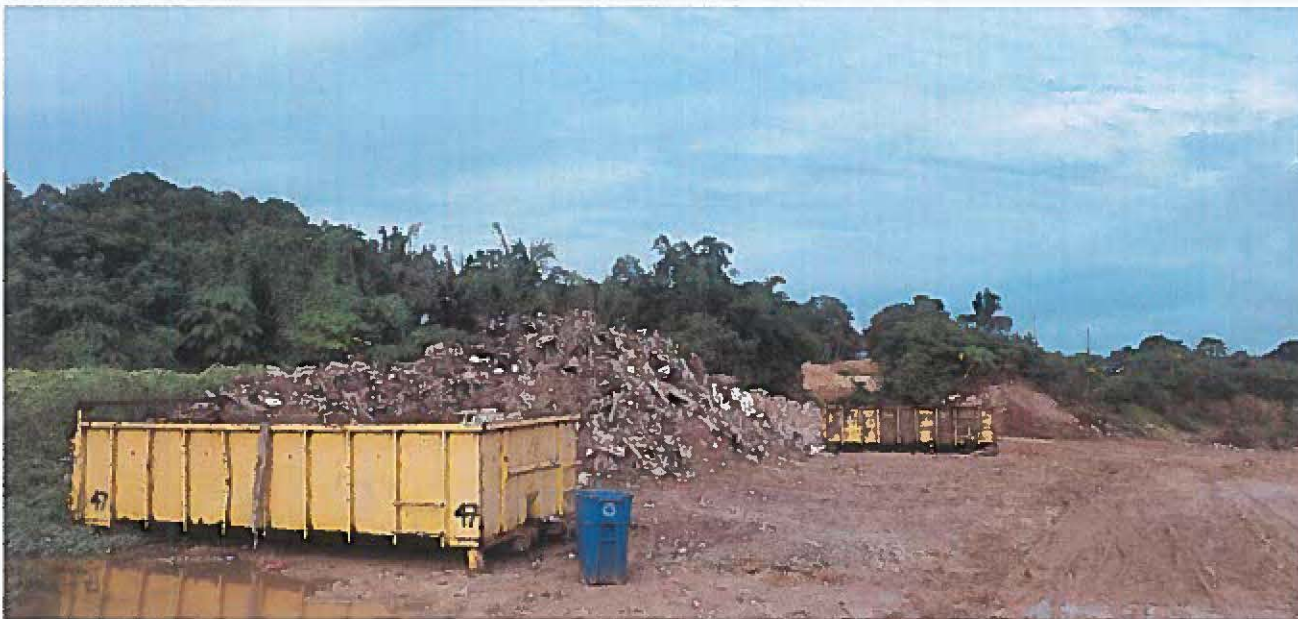
Pic. 27

Location: Lot No. 3339-4-A- R5, across Wood Processing area

Description: Debris staging site for D3 waste

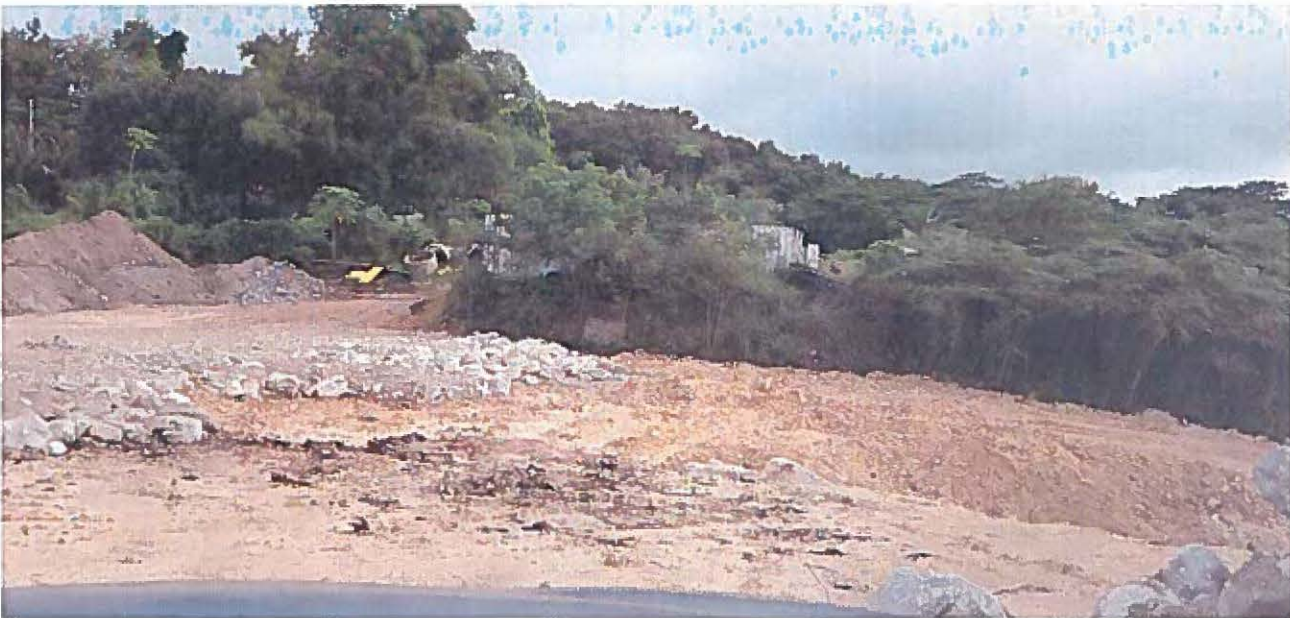
Pic. 28

Location: Lot No. 3339-4-A-4, Disposal Site 3: North Western area

Description: Debris staging from NWA across Wood Processing area Roll off bins prepositioned for waste disposal

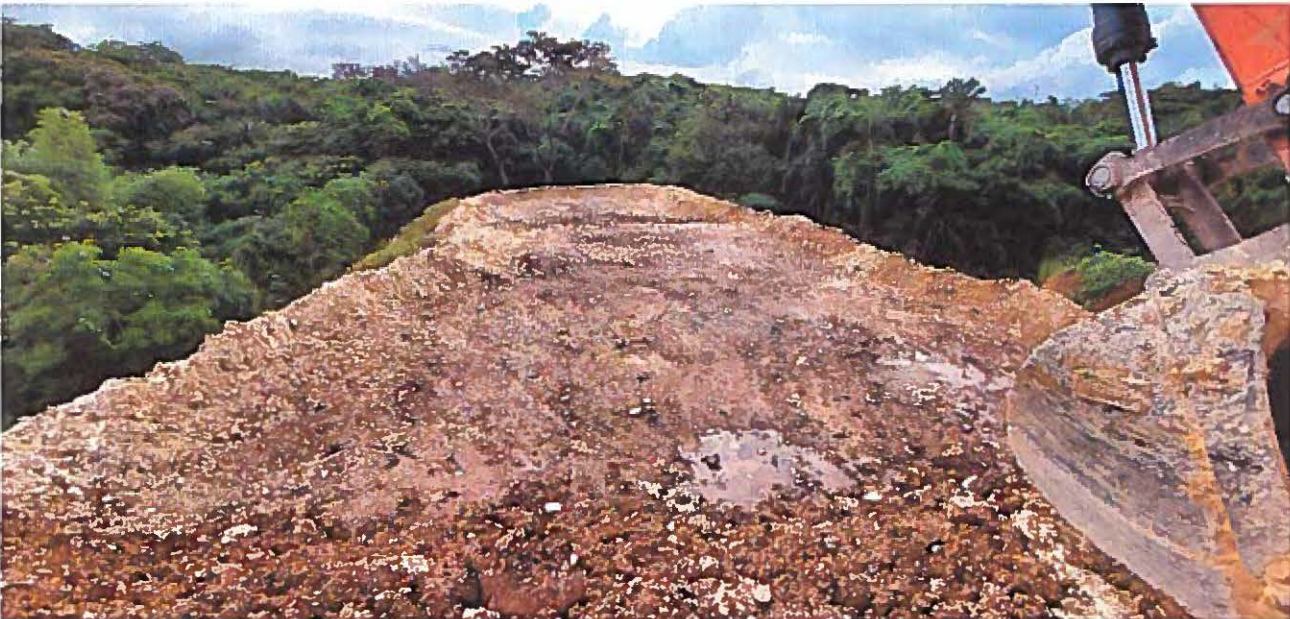
Pic. 29

Location: Lot No. 3339-4-A-4, Disposal Site 3: North Western area

Description: Site 3 cleaned
