**2022-2024 INTEGRATED REPORT  
GUAM EPA**

**APPENDIX A**

**Marine and Surface Water  
Monitoring and Assessment Methodology**

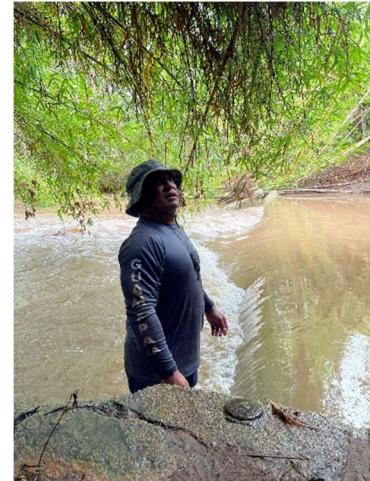
Pago River upper during wet conditions.

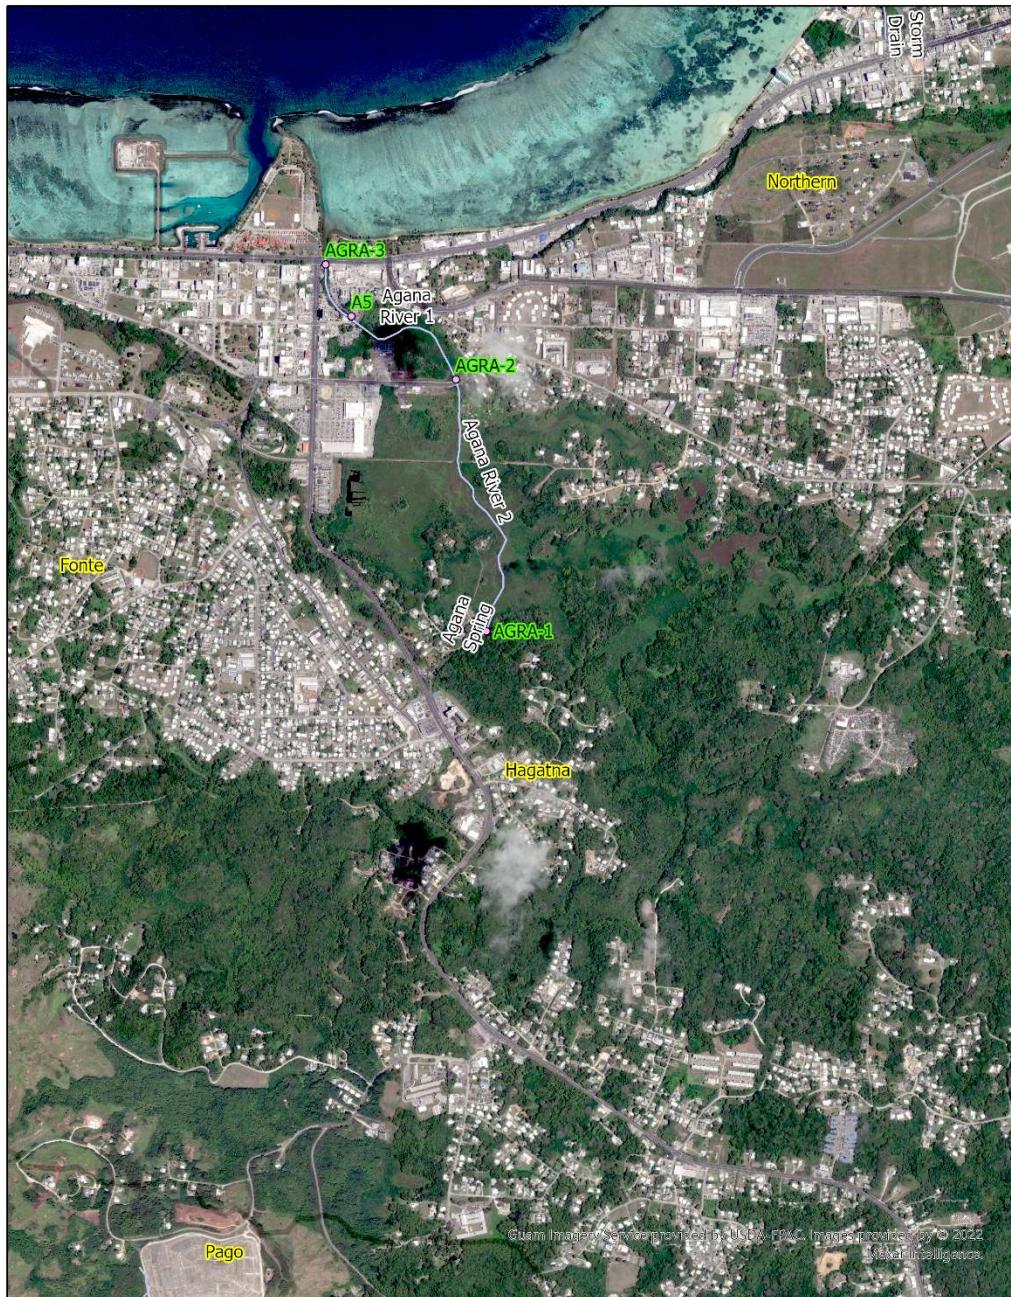
## Agana

Assessment Unit	Site ID	Watershed	Status ALUS	Parameter
Agana River 1	AGRA-3	Agana	Impaired	DO, Enterococci
Agana River 1	A5	Agana	Threatened	DO
Agana River 2	AGRA-2	Agana	Threatened	DO
Agana Springs	AGRA-1	Agana	Threatened	DO, E. coli, Nitrate

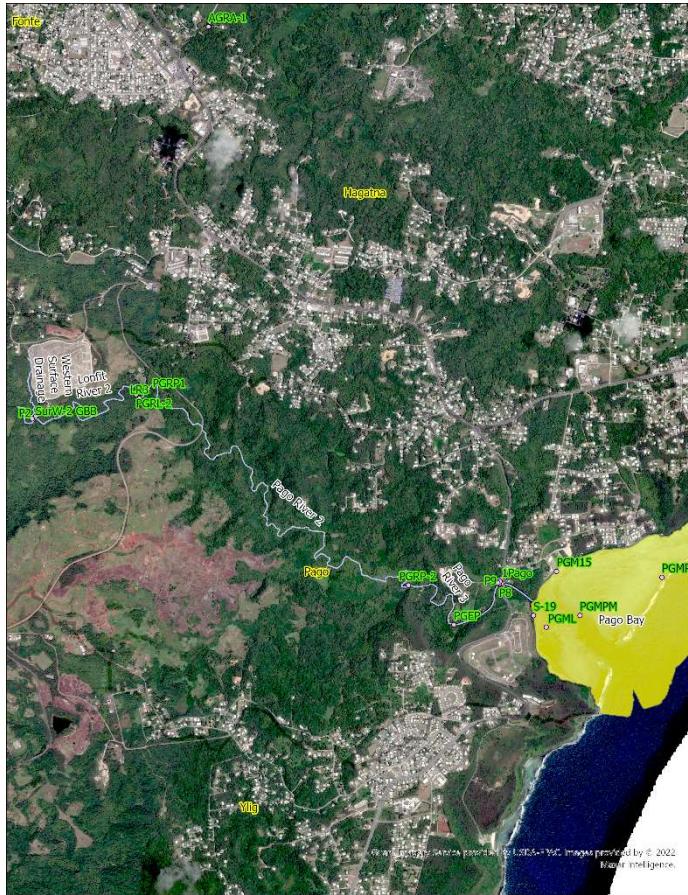
## Pago

Assessment Unit	Site ID	Watershed	Status ALUS	Parameter
Lonfit River 2	PGRL-2	Pago	Impaired	Salinity, Enterococci, E. coli, Total Coliform, Temperature, Turbidity, (iron)
Lonfit River 3 (small section to confluence)	LR3 / PGRP-1-51B	Pago	Impaired	Salinity, Enterococci, E. coli, Total Coliform, Temperature, Turbidity
Pago River 1	PGRP-1	Pago	Impaired	DO, E. coli, Turbidity storm flows
Pago River 2	PGRP-2	Pago	Impaired	DO, E. coli
Pago River 3	PGEP	Pago	Threatened	DO
Pago River 4	PGMPW / 1Pago / P8 / P9	Pago	Impaired	Turbidity
Pago River 4	PGMPW / 1Pago / P8 / P9	Pago	Threatened	DO
West Surface Drainage	SURW (SurW-2)	Pago	Impaired	Nitrate, TSS
West Surface Drainage	SURW (SurW-2) / P2	Pago	Threatened	DO
Pago Bay	S-19, PGM15, PGML, PGMR, PGMPM	Pago	Impaired	DO, Nitrate, Enterococci

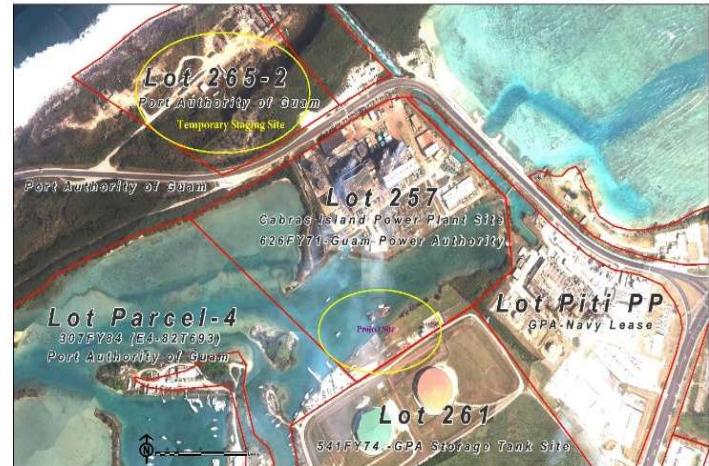
Figure 1. Proposed Temporar ADV Staging Area., PAG Lot 265-2.

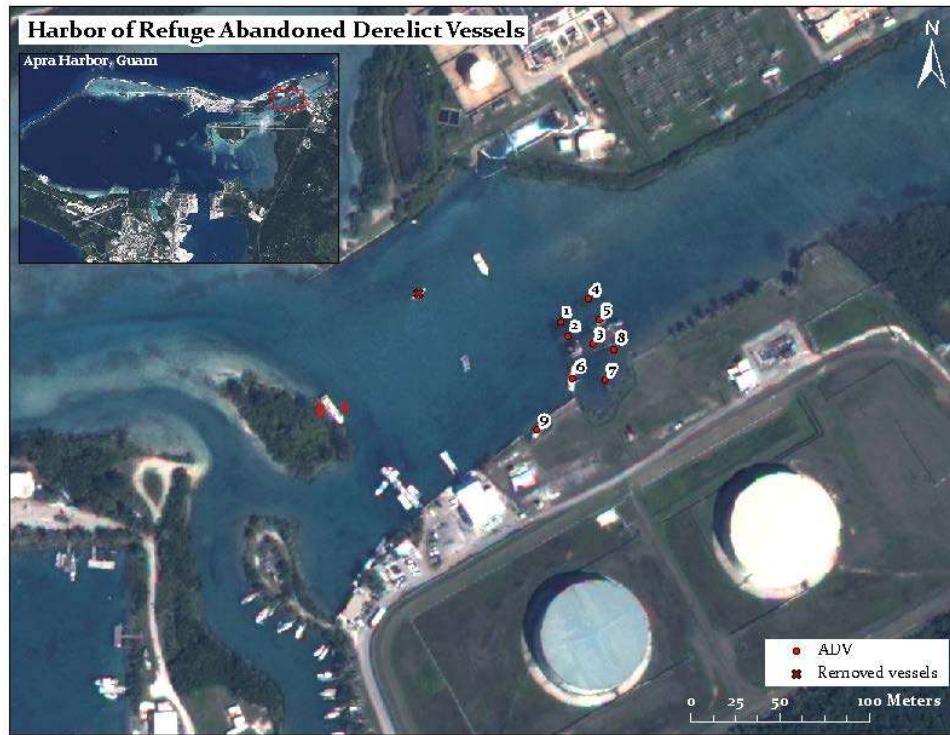
Figure 2. Location of ADVs to be removed within Harbor of Refuge, Piti Guam.

Commander Task Force 73 (CTF-73) salvage teams were quickly mobilized with the first targets, ADV #9 and ADV#B, brought to shore on October 4, 2021. ADV#3 was the last to be removed on March 7, 2022, with the demolition completed in June, 2022. The removal dates for all ADVs are listed in Table 1 below. The project lasted approximately 273 days with the site fully cleared and secured on June 30, 2022. See Appendix B for photographs of removal process.

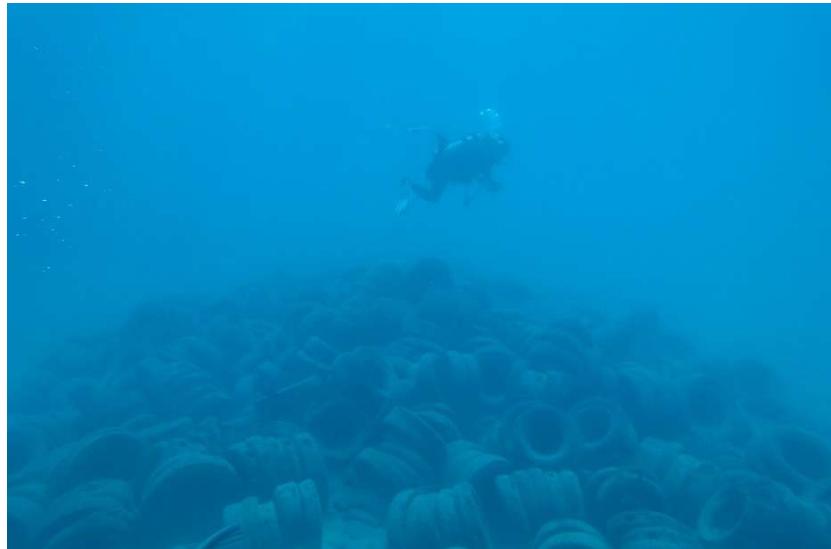
General view of CARB. (Photograph courtesy of GEPA).

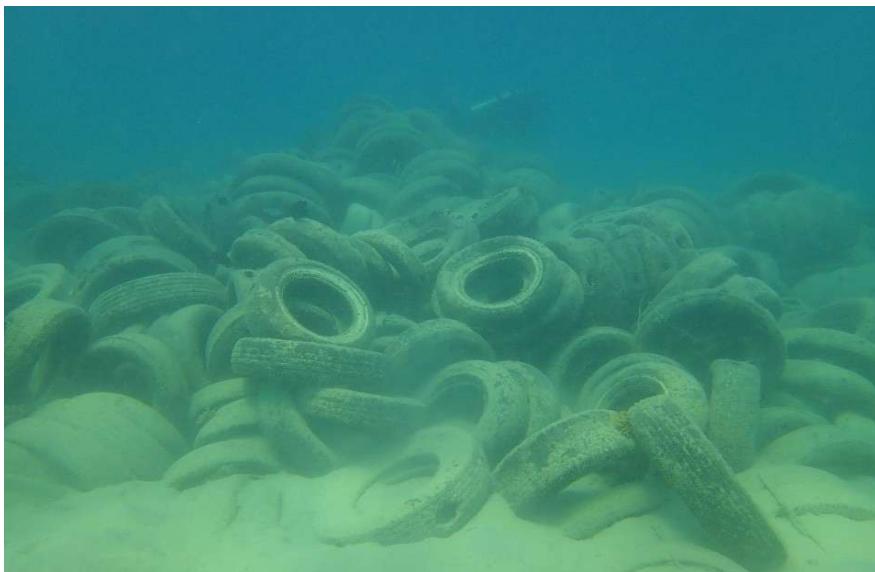
CARB (SIDE VIEW). (Photograph courtesy of GEPA).

at a depth of 20 feet, and is located at the coordinates 13.255248N, 144.665588E. CARB was constructed to test the vertical placement of the artificial fish shelters. At this site, tires were tied together in groupings of five using nylon rope to create tire tubes. The tire tubes were dumped randomly on top of each other

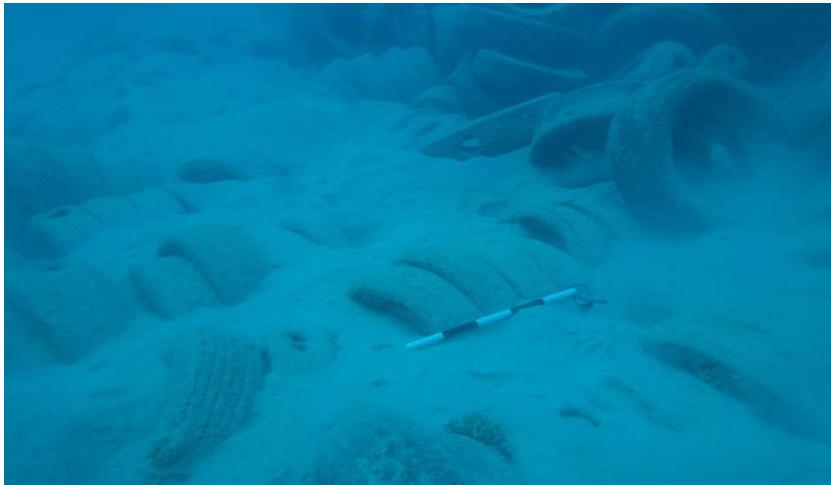
Groups of tires buried under sediment at CARB. (Photograph courtesy of GEPA).

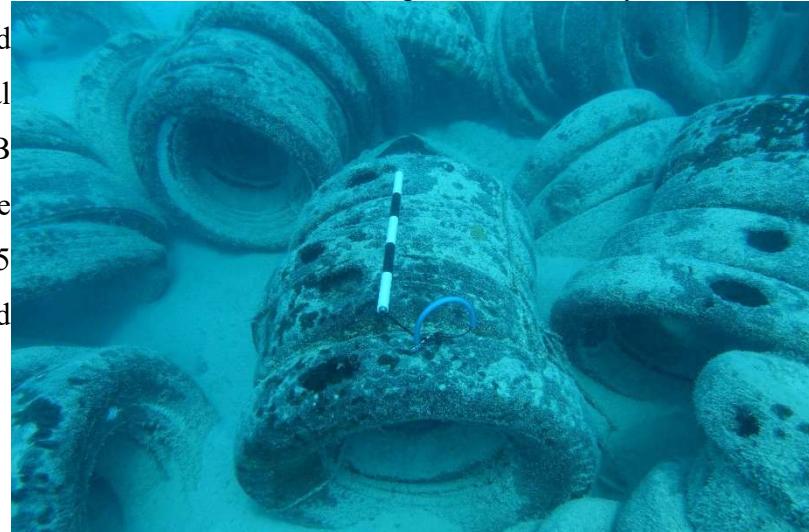
Close-up of CARB. (Photograph courtesy of GEPA).

and is located at the coordinates 13.255248N, 144.665588E with a current estimated volume of 21,531 ft<sup>3</sup> (48.5 x 45.3 ft x 9.8 ft). Original documentation states that it was constructed with approximately 2,482 tires

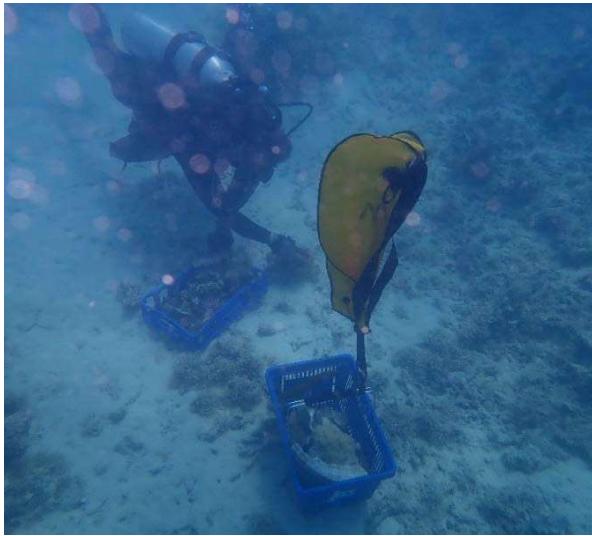
Divers collecting Coral fragments for transplanting  
(Photograph courtesy of GEPA).

Coral heads and encrusting colonies suitable for transplant were identified, and removed from the tire substrate. Corals were removed by chipping off the living portion of the colony from the point of attachment on the tire using a chisel and hammer. All encrusting species (e.g. *Leptastrea purpurea*, *Pavona chiriquiensis*, *P. varians*) suffered damage (split and shattered) when removed from the tire substrate. Small non-encrusting species were relocated if all or a significant portion of the colony can be removed from the tire intact.

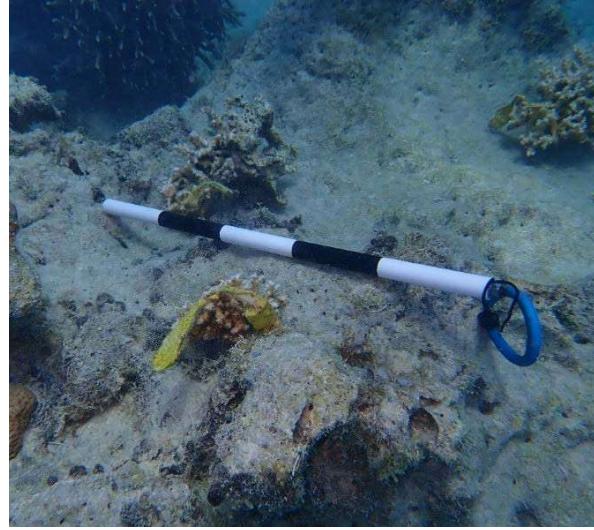
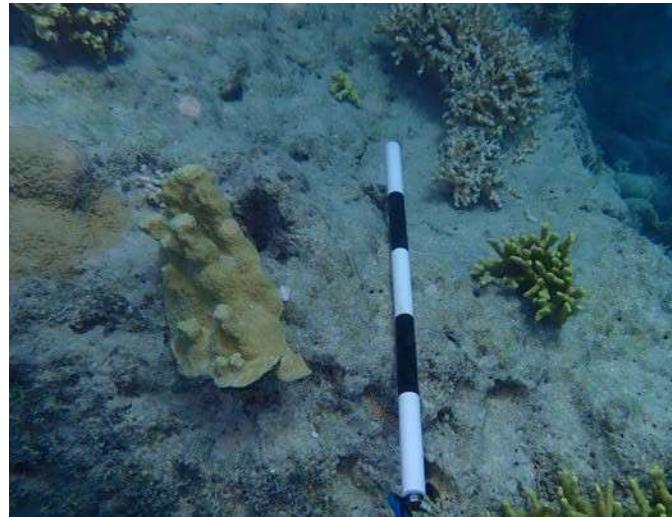
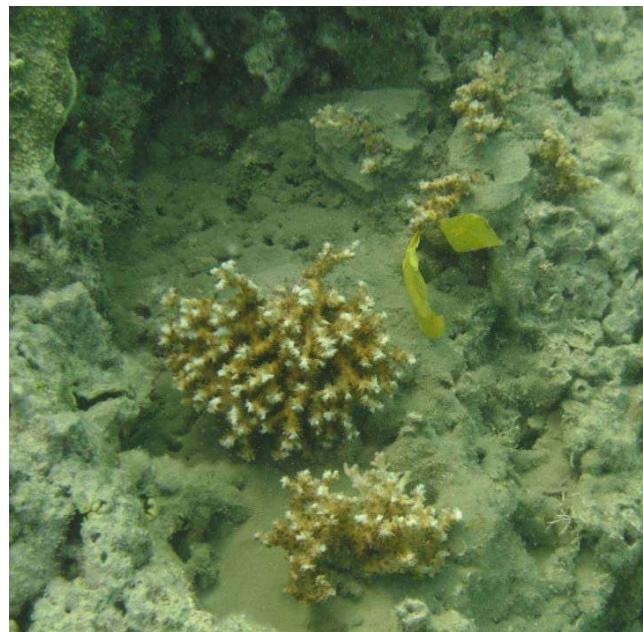
Coral fragments reattached at transplant site with concrete. (Photograph courtesy of GEPA).

Coral fragments reattached at transplant site with concrete.  
(Photograph courtesy of GEPA).

The Transplant site 1 is located approximately 87 meters shoreward (13.25602N and 144.66573E) of CARB at a depth of 5 meters. Transplant site preparation entailed removing any type of sand, sediment, or biological growth with scrapers or wire brushes right before transplanting to ensure the maximum effectiveness of concrete or other adhesive materials. The adhesive mixture was prepared and mixed topside in a vessel. The adhesive mixture was then placed into large re-sealable bags, dispensed onto the cleaned substrate by divers and then the coral colony was placed into the adhesive mixture. Cable ties, concrete nails, or rebar was not needed as all transplanted corals were fragments. Transplanted coral fragments will be monitored as described below.

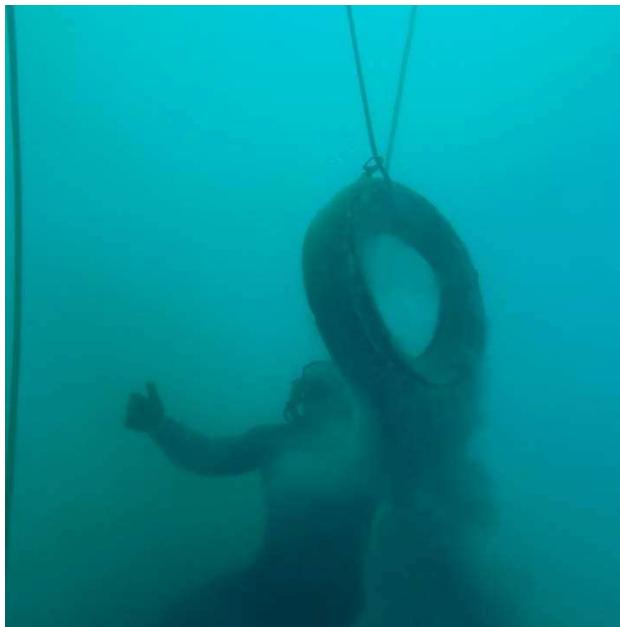
Tire retrieval. (Photograph courtesy of Guam EPA).

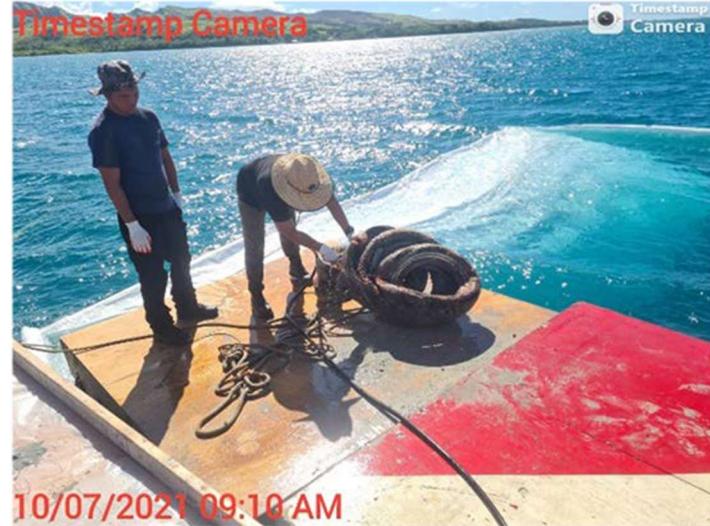
First set of tire recovered (Photograph courtesy of Unitek).

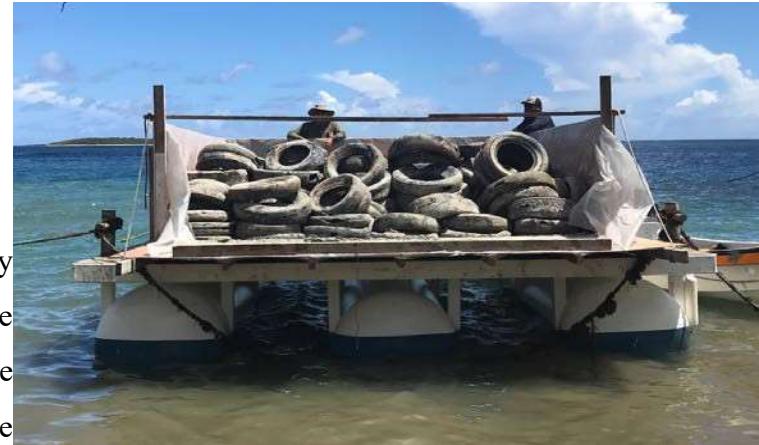
Tires being transported to shore. (Photograph courtesy of Unitek).

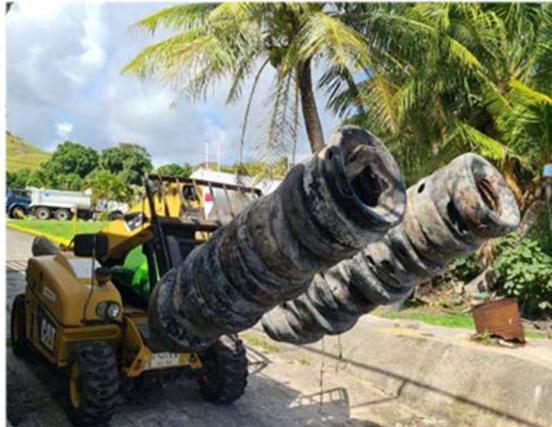
Telescopic forklift offloading Tires. (Photograph courtesy of Unitek).

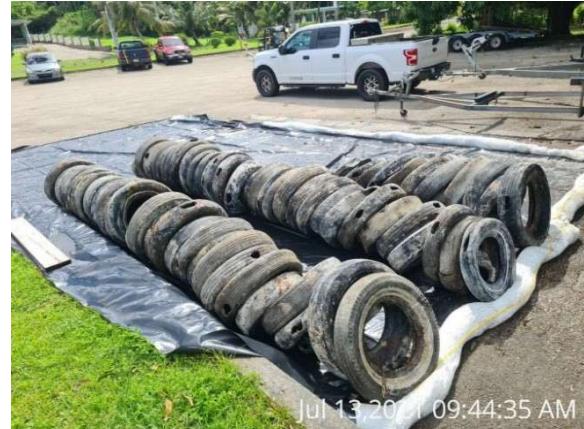
Removed Tires within temporary containment area. (Photograph courtesy of Unitek).

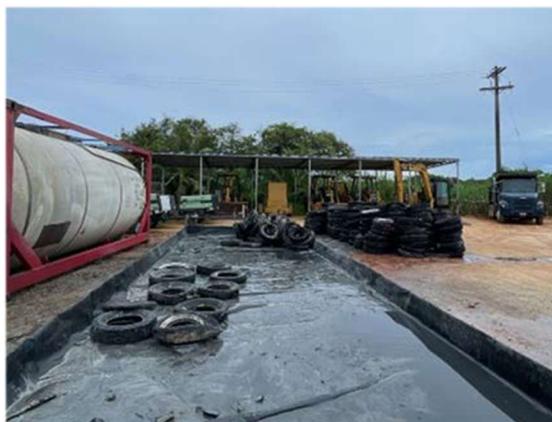
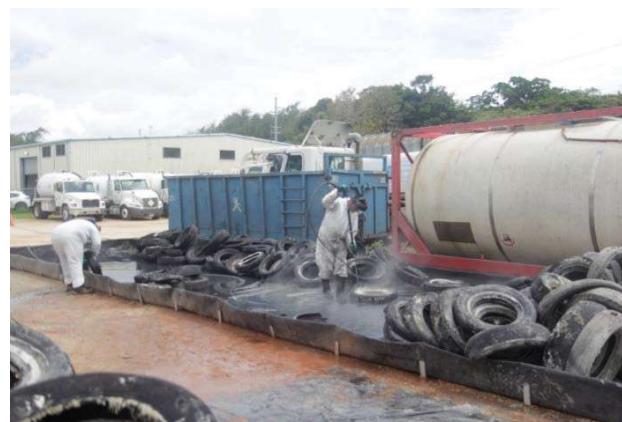
Recovered tires being cleaned and processed at the Unitek primary facility. (Photograph courtesy of Unitek).

Waste water collected during the cleaning and rinsing phase was treated and disposed of through the Unitek NPDES permitted water processing facility (NPDES No. GU0020346). Other solid waste, solids and dry sediment were disposed of at Guam Solid Waste Layon Landfill.

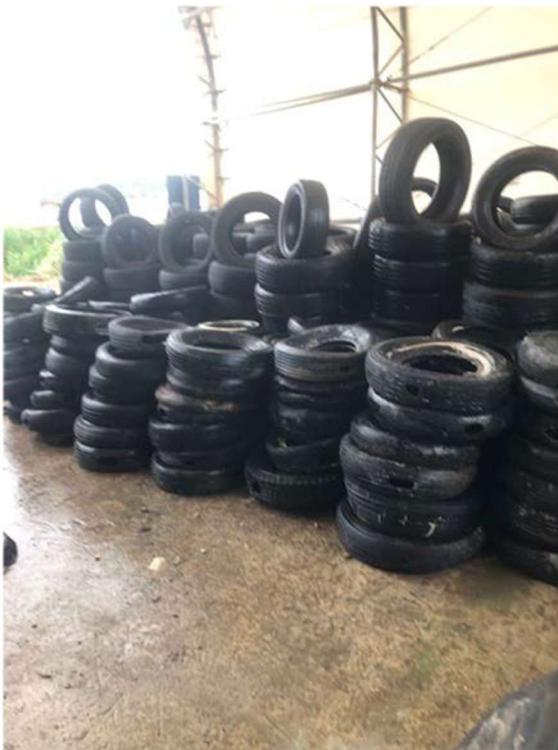
Stacked cleaned tires waiting to be shredded at the Tire Processing facility.  
(Photograph courtesy of Unitek).

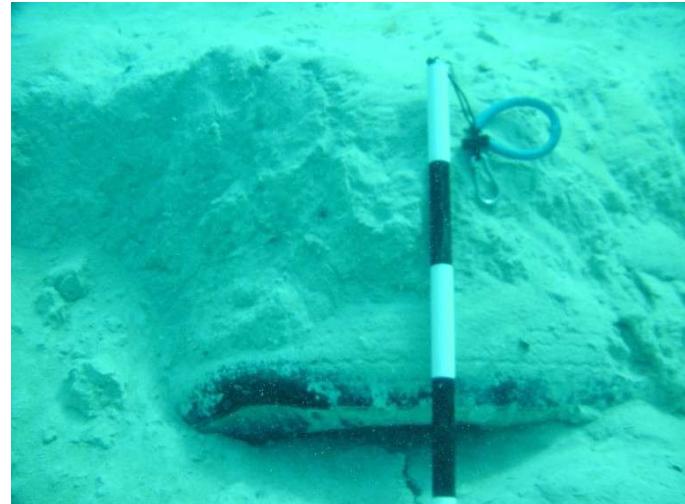
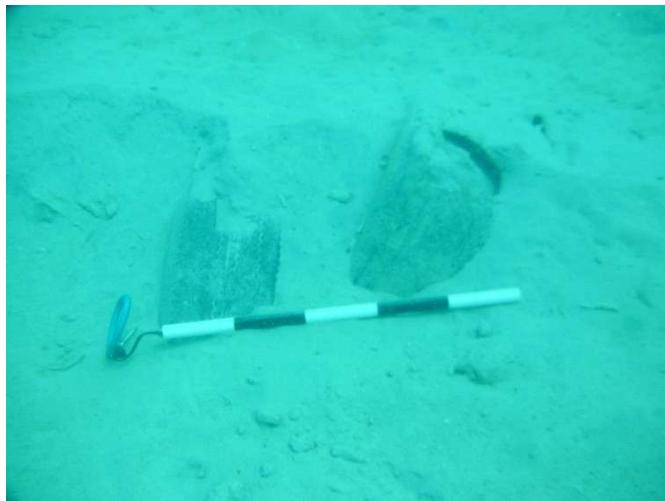
Partially exposed bottom layer of CARB not removed..  
(Photograph courtesy of GEPA).

Partially exposed bottom layer of CARB not removed.  
(Photograph courtesy of GEPA).

A total of one thousand eight hundred twenty-nine (1,829) or 74% of the tires were removed from the CARB site out of a reported 2,482 tires, during the sixteen (16) days of in water work. Post inspections dives were conducted by Guam EPA divers on July 30, 2021, and verified that all project objectives were met and the project was completed. During this post dive inspection, a layer of tires could be made out just under the surface or partially exposed from the removal of upper tire layers. These remaining tires (approximately 653 or CCC, buried within the
