**DRAFT**  
**Development of**  
**Guam Northern Watershed**  
**Bacteria TMDLs**

December 16, 2009

*Prepared for:*  
USEPA Region 9  
Guam Environmental Protection Agency

*Prepared by:*  
Tetra Tech, Inc.  
10306 Eaton Place, Suite 340  
Fairfax, VA 22030

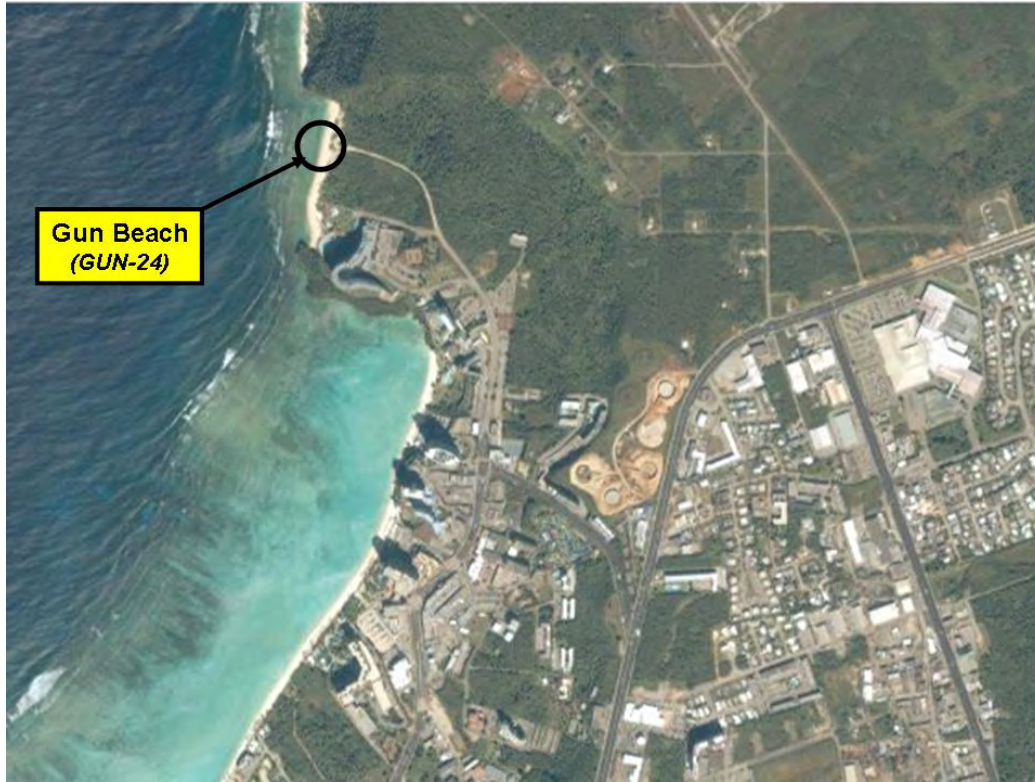
Figure 8-18. Air photo of Gun Beach vicinity.

Figure 8-18 shows an air photo of the area adjacent to Gun Beach. This provides a different perspective, which highlights the secluded nature of Gun Beach in comparison to other project area monitoring locations.

In addition to previous assessments and GIS information, Guam EPA staff identified other potential sources that could affect water quality at Gun Beach. Specifically, there is a low depression in natural topology in the immediate vicinity. This feature could result in a runoff ponding area that may collect storm drain runoff.

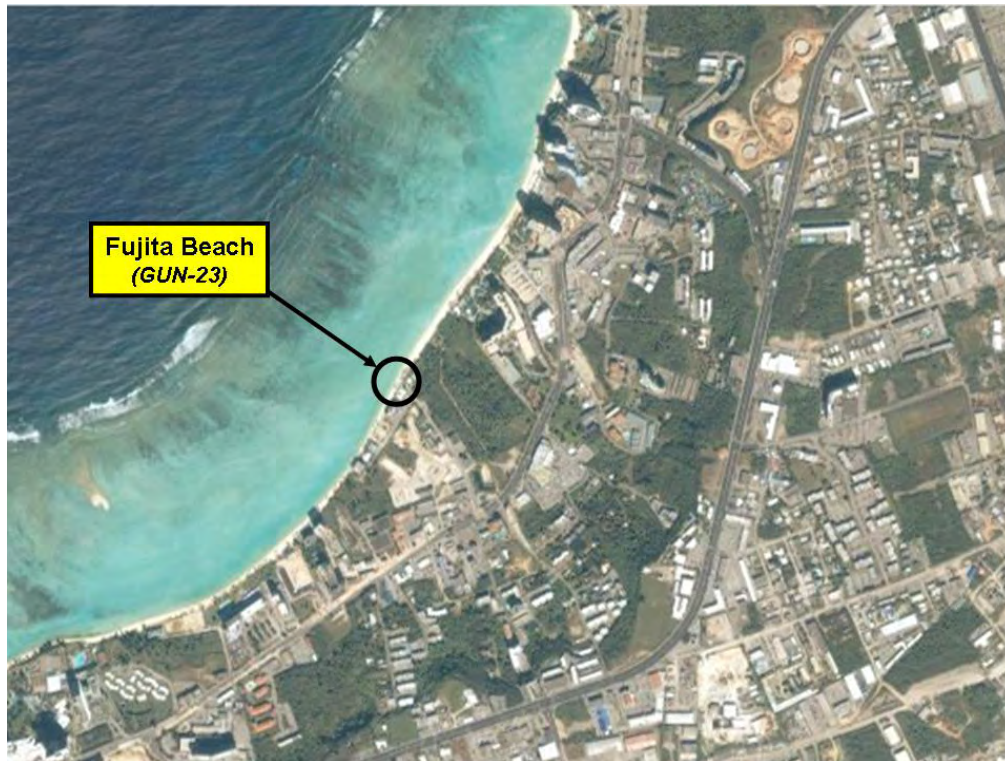
Figure 8-45. Air photo of Fujita Beach vicinity.

Figure 8-45 shows an air photo of the area adjacent to Fujita Beach. This provides a different perspective, which highlights the high density of roads and buildings in the area adjacent to Fujita Beach.

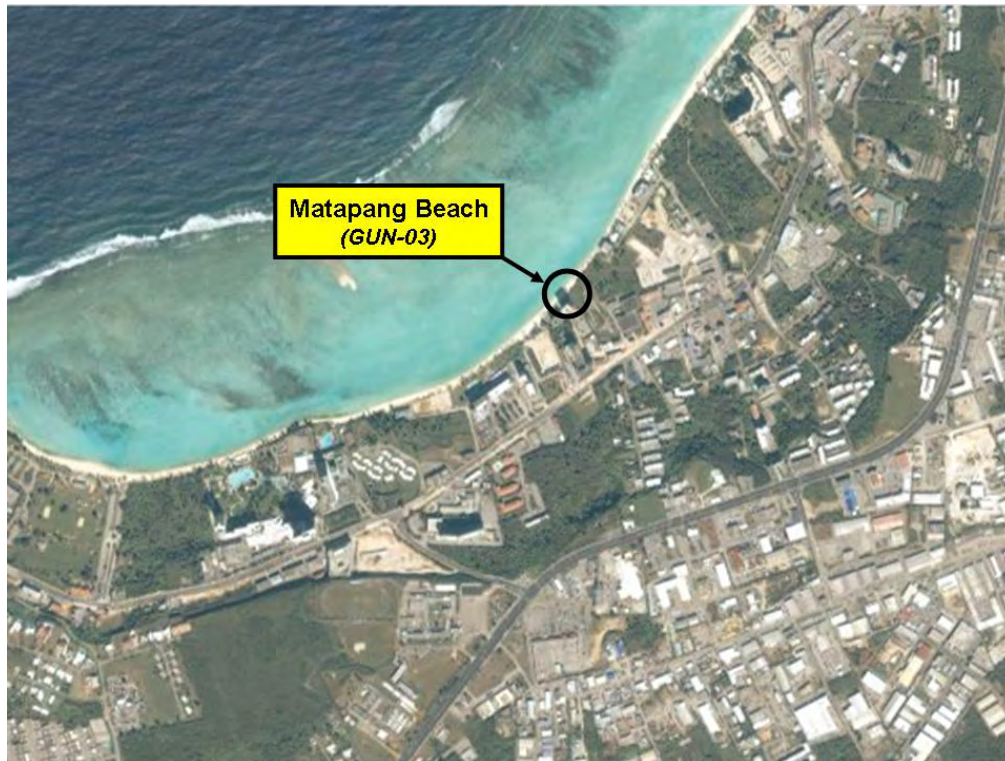
Figure 8-54. Air photo of Matapang Beach vicinity.

Figure 8-54 shows an air photo of the area adjacent to Matapang Beach. This provides a different perspective, which highlights the high density of roads and buildings in the area adjacent to Matapang Beach.

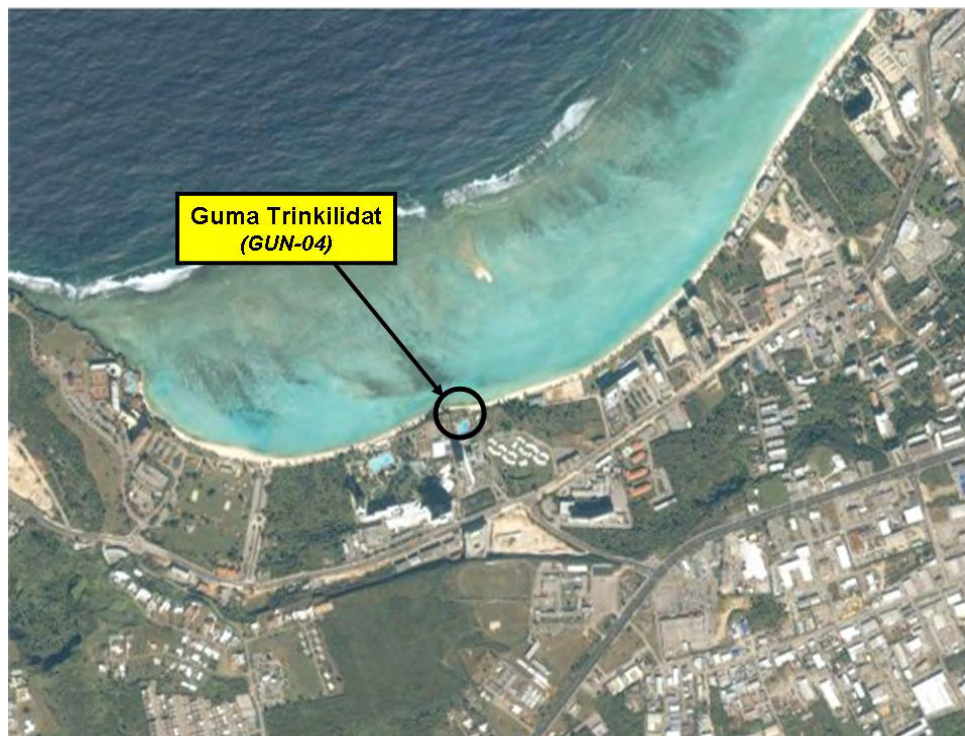
Figure 8-63. Air photo of Guma Trinkilidat Beach vicinity.

Figure 8-63 shows an air photo of the area adjacent to Guma Trankilidat Beach. This provides a different perspective, which highlights the high density of roads and buildings in the area adjacent to Guma Trankilidat Beach.

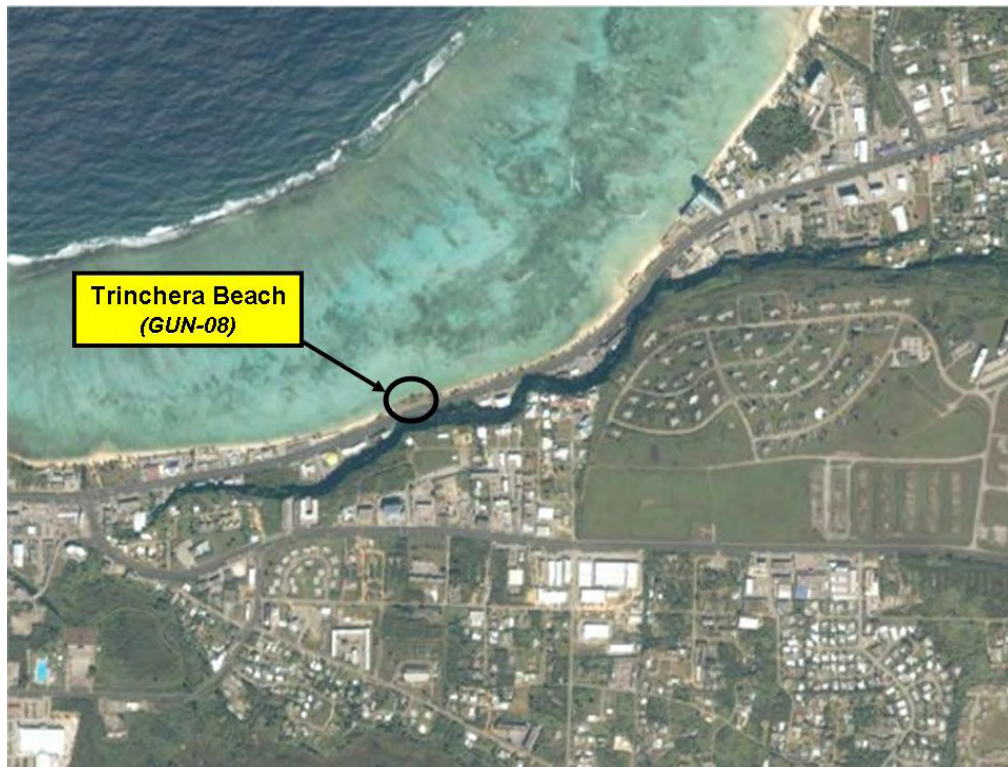
Figure 8-108. Air photo of Trinchera Beach vicinity.

Figure 8-108 shows an air photo of the area adjacent to Trinchera Beach. This provides a different perspective, which highlights the high density of roads and buildings in the area adjacent to Trinchera Beach.
